Phase 1 Site Investigation Report

Blocks 9, 10 & 11, Section 21 Hume
(Stage 3, Hume West Estate)

Prepared for
Land Development Agency (LDA)

6th June 2016

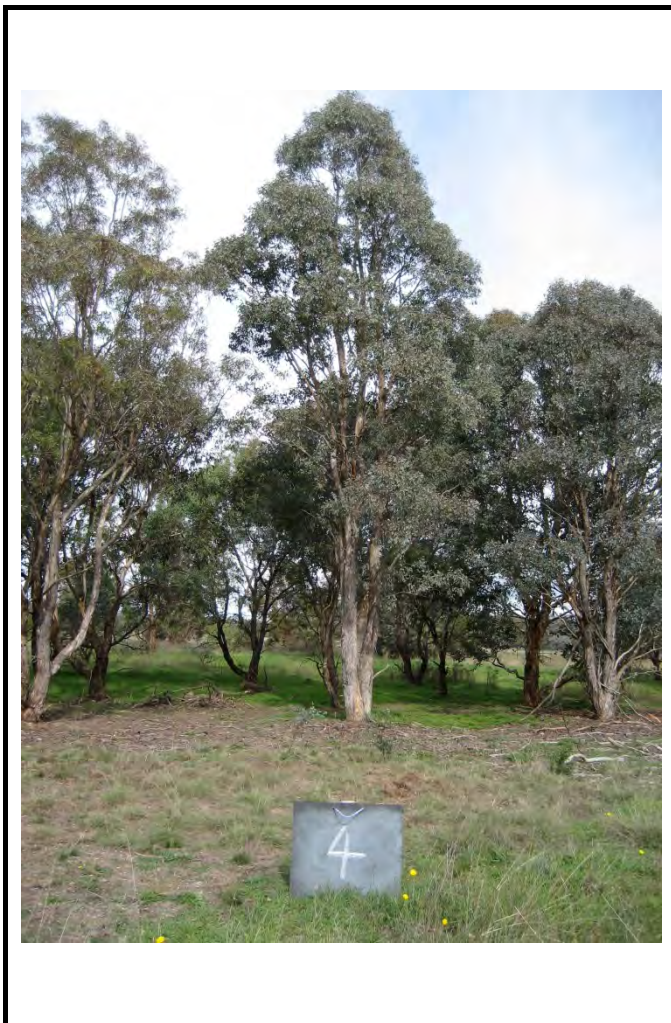
SUMMARY			
TREE NUMBER/GROUP			4
REGULATED TREE			Y
REGISTERED TREE			
TREE ASSESSMENT			
ARBORCULTURAL ASSESSMENT			M
URBAN AMENITY ASSESSMENT			M
RECOMMENDATION	NAME		
Arborist	J.L. & S.T.		
Landscape Architect	Indesco		
GENERAL TREE DATA			
Assessment Date	30.4.14		
Species	Eucalyptus polyanthemos		
Common Name	Red Box		
LOCATION			
E:		N:	
Height (M)	13	Canopy (M)	4
Trunk Circum	1800	No of Trunks	2
TREE MANAGEMENT			
POTENTIAL TO REDUCE RISK			2
POTENTIAL TO IMPROVE AMENITY			2
NOTES			
Acute angled unions

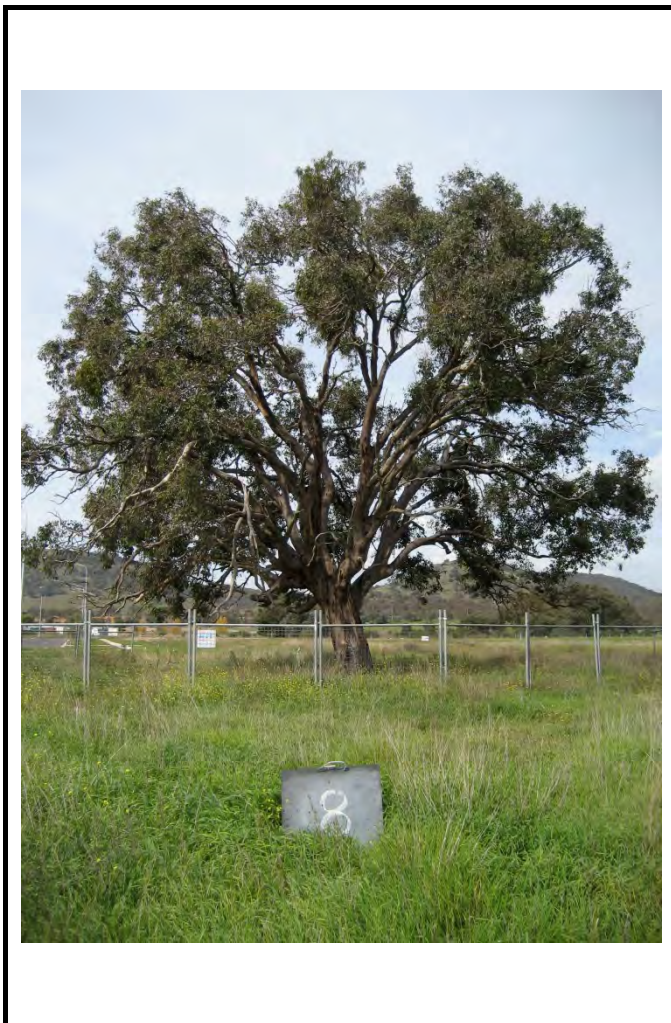
SUMMARY			
TREE NUMBER/GROUP			8
REGULATED TREE			Y
REGISTERED TREE			
TREE ASSESSMENT			
ARBORCULTURAL ASSESSMENT			M
URBAN AMENITY ASSESSMENT			H
RECOMMENDATION	NAME		
Arborist	J.L. & S.T.		
Landscape Architect	Indesco		
GENERAL TREE DATA			
Assessment Date	30.4.14		
Species	Eucalyptus blakelyi		
Common Name	Blakelys Red Gum		
LOCATION			
E: 212610.892		N: 590203.321	
Height (M)	19	Canopy (M)	21
Trunk Circum	3700	No of Trunks	1
TREE MANAGEMENT			
POTENTIAL TO REDUCE RISK			2
POTENTIAL TO IMPROVE AMENITY			2
NOTES			
Previous tag 1855 Exposed dead roots

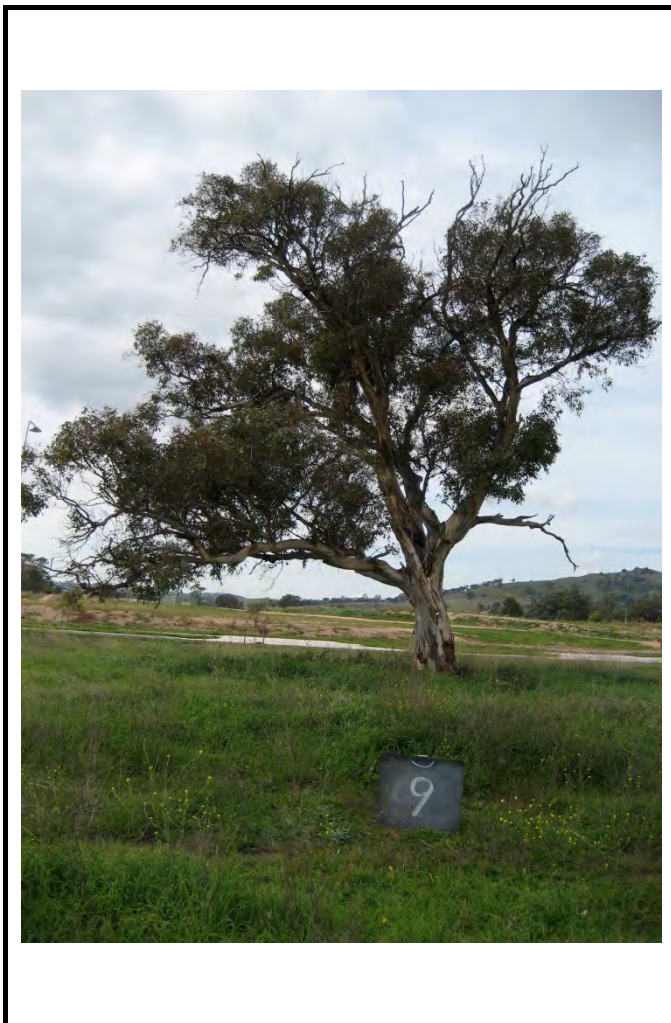
SUMMARY			
TREE NUMBER/GROUP			9
REGULATED TREE			Y
REGISTERED TREE			
TREE ASSESSMENT			
ARBORCULTURAL ASSESSMENT			P
URBAN AMENITY ASSESSMENT			L
RECOMMENDATION	NAME		
Arborist	J.L. & S.T.		
Landscape Architect	Indesco		
GENERAL TREE DATA			
Assessment Date	30.4.14		
Species	Eucalyptus blakelyi		
Common Name	Blakelys Red Gum		
LOCATION			
E: 212616.123		N: 590338.257	
Height (M)	12	Canopy (M)	12
Trunk Circum	2700	No of Trunks	1
TREE MANAGEMENT			
POTENTIAL TO REDUCE RISK			3
POTENTIAL TO IMPROVE AMENITY			3
NOTES			
Previous tag 1853 Major structural cracks and rot

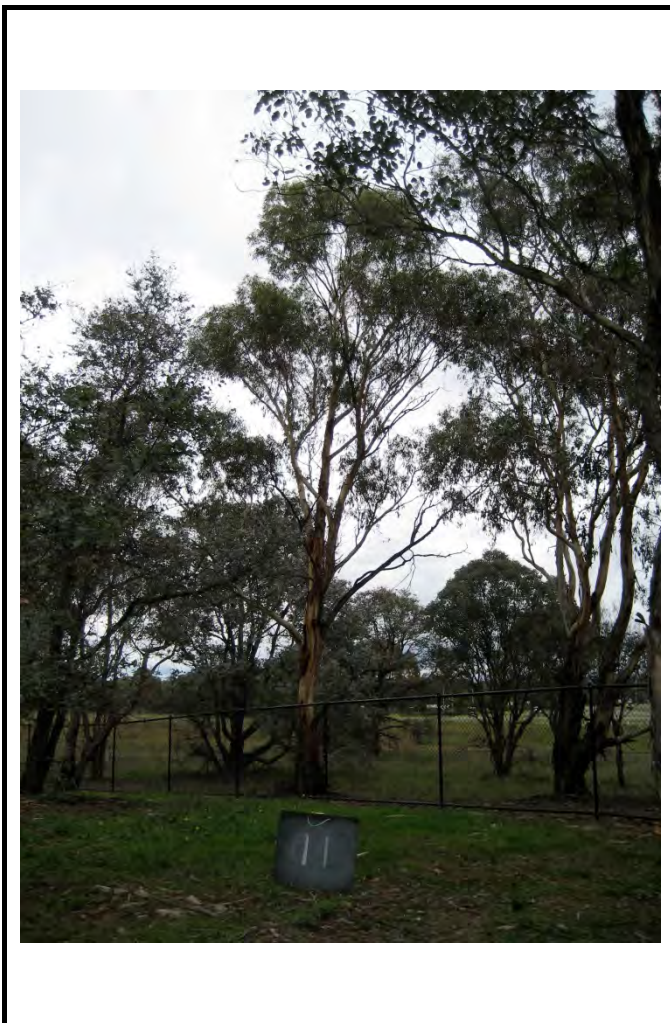
SUMMARY			
TREE NUMBER/GROUP			11
REGULATED TREE			Y
REGISTERED TREE			
TREE ASSESSMENT			
ARBORCULTURAL ASSESSMENT			P
URBAN AMENITY ASSESSMENT			L
RECOMMENDATION	NAME		
Arborist	J.L. & S.T.		
Landscape Architect	Indesco		
GENERAL TREE DATA			
Assessment Date	30.4.14		
Species	Eucalyptus melliodora		
Common Name	Yellow Box		
LOCATION			
E:		N:	
Height (M)	15	Canopy (M)	7
Trunk Circum	1600	No of Trunks	1
TREE MANAGEMENT			
POTENTIAL TO REDUCE RISK			2
POTENTIAL TO IMPROVE AMENITY			2
NOTES			
Major scars at base

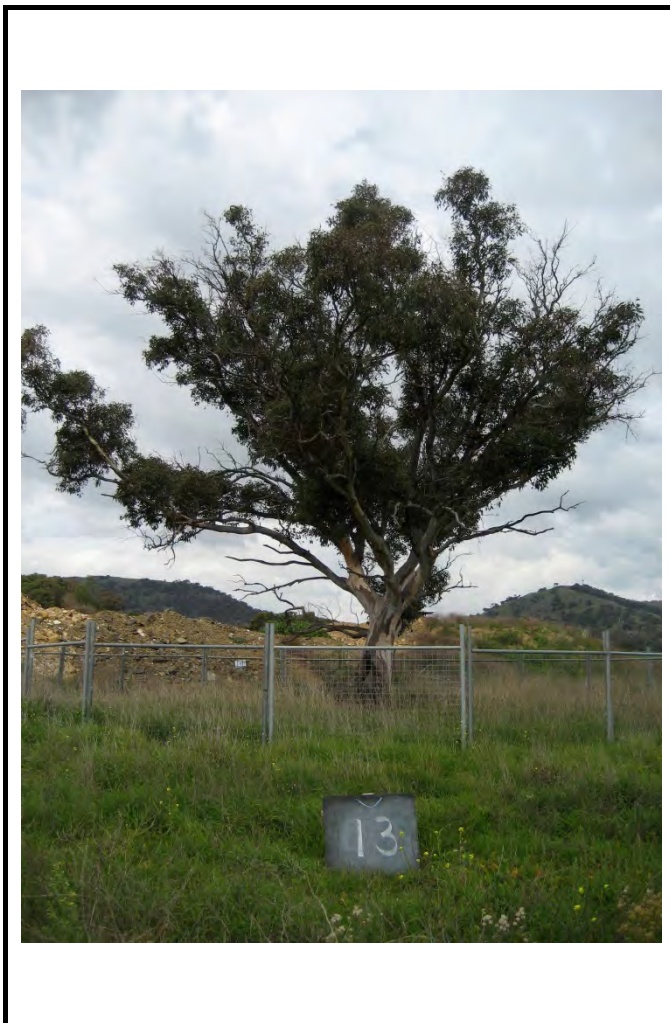
SUMMARY			
TREE NUMBER/GROUP		13	
REGULATED TREE		Y	
REGISTERED TREE			
TREE ASSESSMENT			
ARBORCULTURAL ASSESSMENT		P	
URBAN AMENITY ASSESSMENT		L	
RECOMMENDATION	NAME		
Arborist	J.L. & S.T.		
Landscape Architect	Indesco		
GENERAL TREE DATA			
Assessment Date	30.4.14		
Species	Eucalyptus blakelyi		
Common Name	Blakelys Red Gum		
LOCATION			
E: 212735.841		N: 590205.598	
Height (M)	11	Canopy (M)	12
Trunk Circum	2800	No of Trunks	1
TREE MANAGEMENT			
POTENTIAL TO REDUCE RISK			2
POTENTIAL TO IMPROVE AMENITY			2
NOTES			
Scar and rot at base

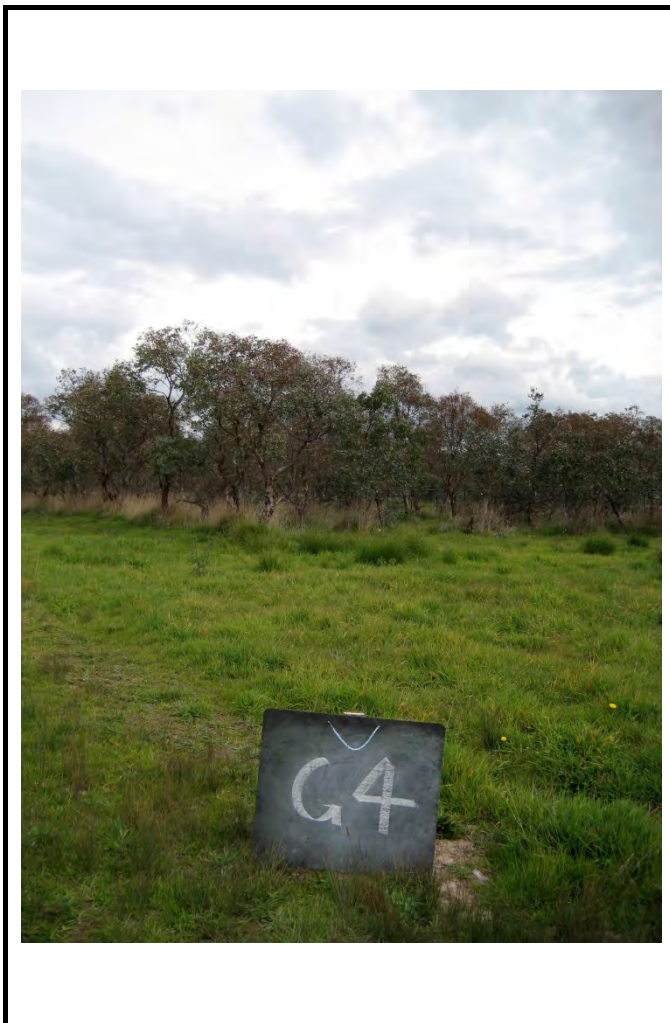
SUMMARY			
TREE NUMBER/GROUP			G4
REGULATED TREE			N
REGISTERED TREE			
TREE ASSESSMENT			
ARBORCULTURAL ASSESSMENT			P
URBAN AMENITY ASSESSMENT			L
RECOMMENDATION	NAME		
Arborist	J.L. & S.T.		
Landscape Architect	Indesco		
GENERAL TREE DATA			
Assessment Date	30.4.14		
Species	Mixed Eucalypts		
Common Name			
LOCATION			
E:		N:	
Height (M)	4	Canopy (M)	2
Trunk Circum	700	No of Trunks	0
TREE MANAGEMENT			
POTENTIAL TO REDUCE RISK			2
POTENTIAL TO IMPROVE AMENITY			2
NOTES			
Close planted, stunted, poor form
