13 October 2022

Subject: P22102 – Gap Analysis and Review of Contamination Risks, Denman Prospect Estate 2 – Stromlo Reach

Review of Site Audit Report

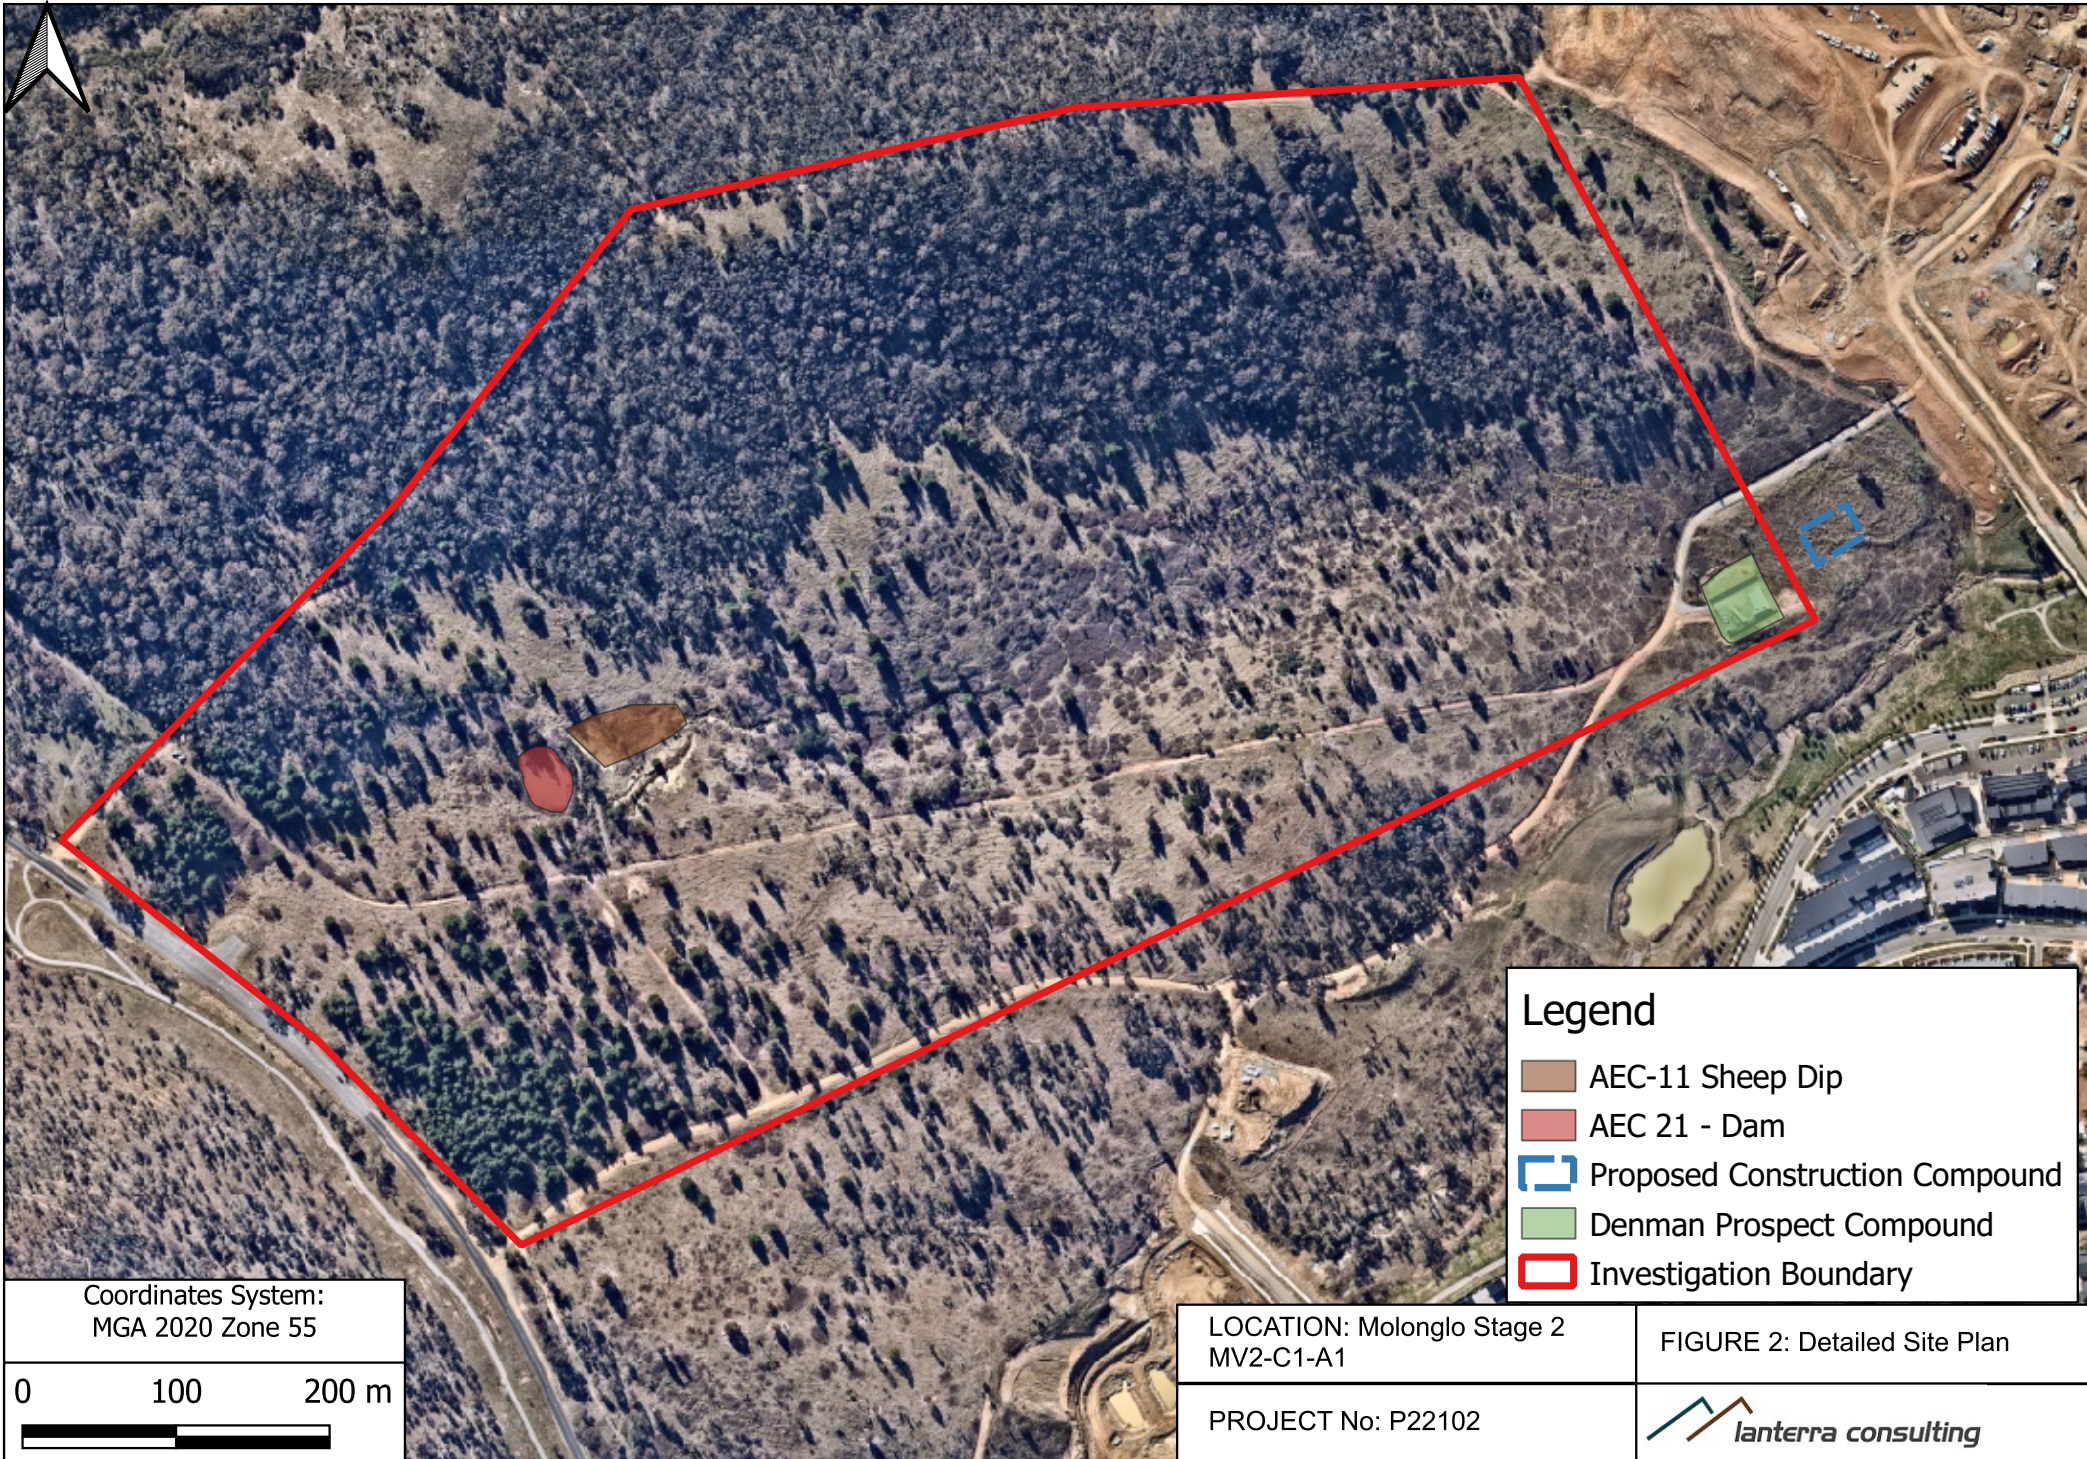
FIGURE 2: Detailed Site Plan

The locations of these AECs are presented on **Figure 2**.

The analytical results of soil samples indicated that contamination associated with the former sheep dip was located in the vicinity of AEC 11 and through the sampling that was completed by AECOM, this did not represent a significant, widespread contamination problem and remediation of the sheep dip would make the site suitable for the proposed land uses.

A surface water sample collected from the dam which formed AEC 21 indicated that concentrations of copper and zinc slightly above the adopted ANZECC (2000) criteria which was applied at the time of the investigation. It is noted that this has been superseded by the Water Quality Guidelines (2018)

- The four (4) excavations from the remedial works in 2015 were still present. At the time of the site visit, there was water in the base of each excavation. The sides of each excavation had thick vegetation of grass and shrubs.
- Extended periods of rain had been experienced prior to the site visit and water was actively seeping into the excavations.
- No evidence of contamination were noted around the excavations.

The dam, which was AEC 21 was located to the west of the sheep dip. At the time of the site visit, the dam was full and appeared to have a healthy ecosystem with abundant aquatic plants in the dam and abundant frogs around the dam.

It is understood that a new construction compound is to be established adjacent to the eastern boundary of the site as shown on **Figure 2**. The compound should not have any adverse impact on the suitability of the site for the permissible site uses, while it is inferred that upon the decommissioning of the compound upon completion of construction works in the future, a validation assessment would be completed to assess the suitability of the compound area for future use.

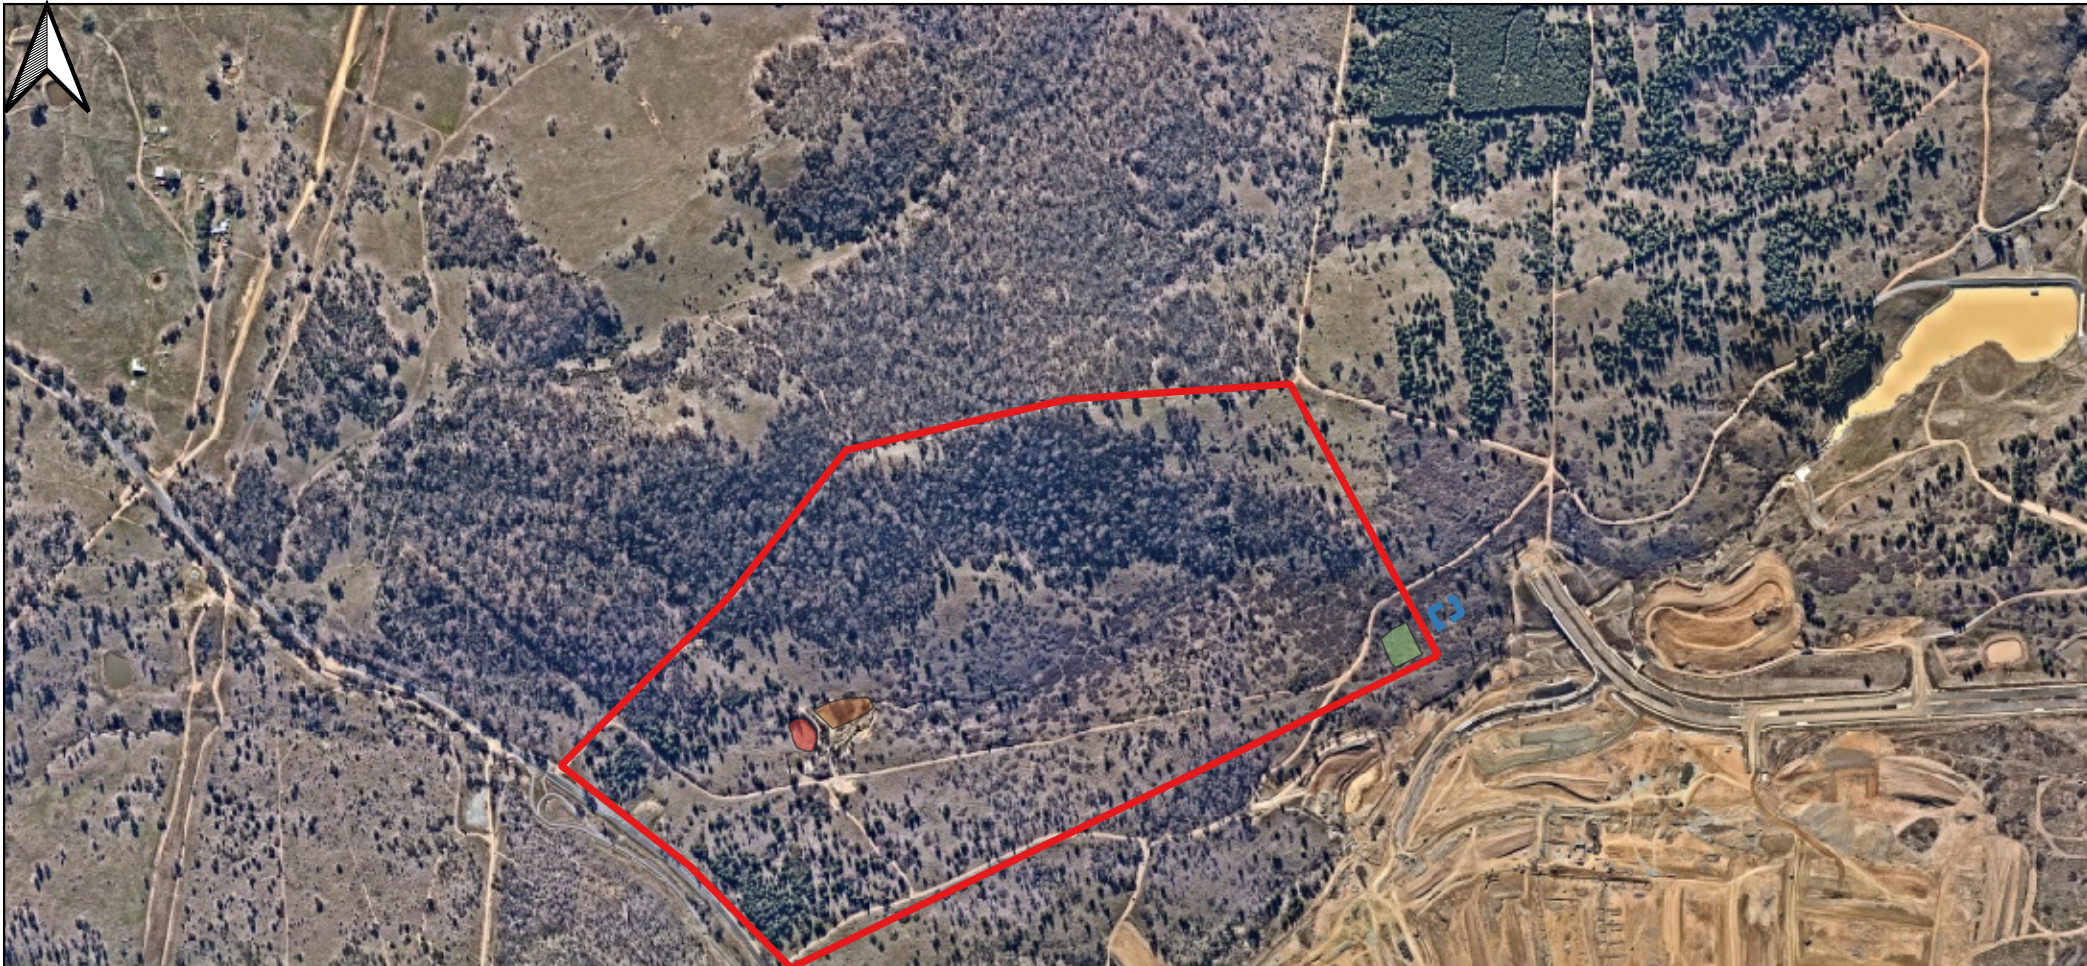
FIGURE 3: 2017 Aerial
Photograph

Date	Source	Description of the Subject Site	Description of Surrounding Land
July 2017	Nearmap	The site is vegetated grassland. Unsealed tracks are located along the southern and northern boundaries. AEC21 (dam) is visible in the western section of the site and is approximately 70% with water. AEC11 (sheep dip) is located immediately east of the dam and the remedial excavations are clearly visible. Visible water is present in two of the excavations. To the south of the sheep dip excavations, a levelled area with three (3) small stockpiles of rock is present.	The Denman Prospect sub-division is visible to the southeast of the site, although no buildings have been constructed. To the east of the site, undeveloped grassland and forest is present.
July 2018	Nearmap	The site is essentially unchanged. AEC21 (dam) is dry, while only the easternmost excavation contains water.	No significant changes to the surrounding area and the Denman Prospect shops have been constructed.

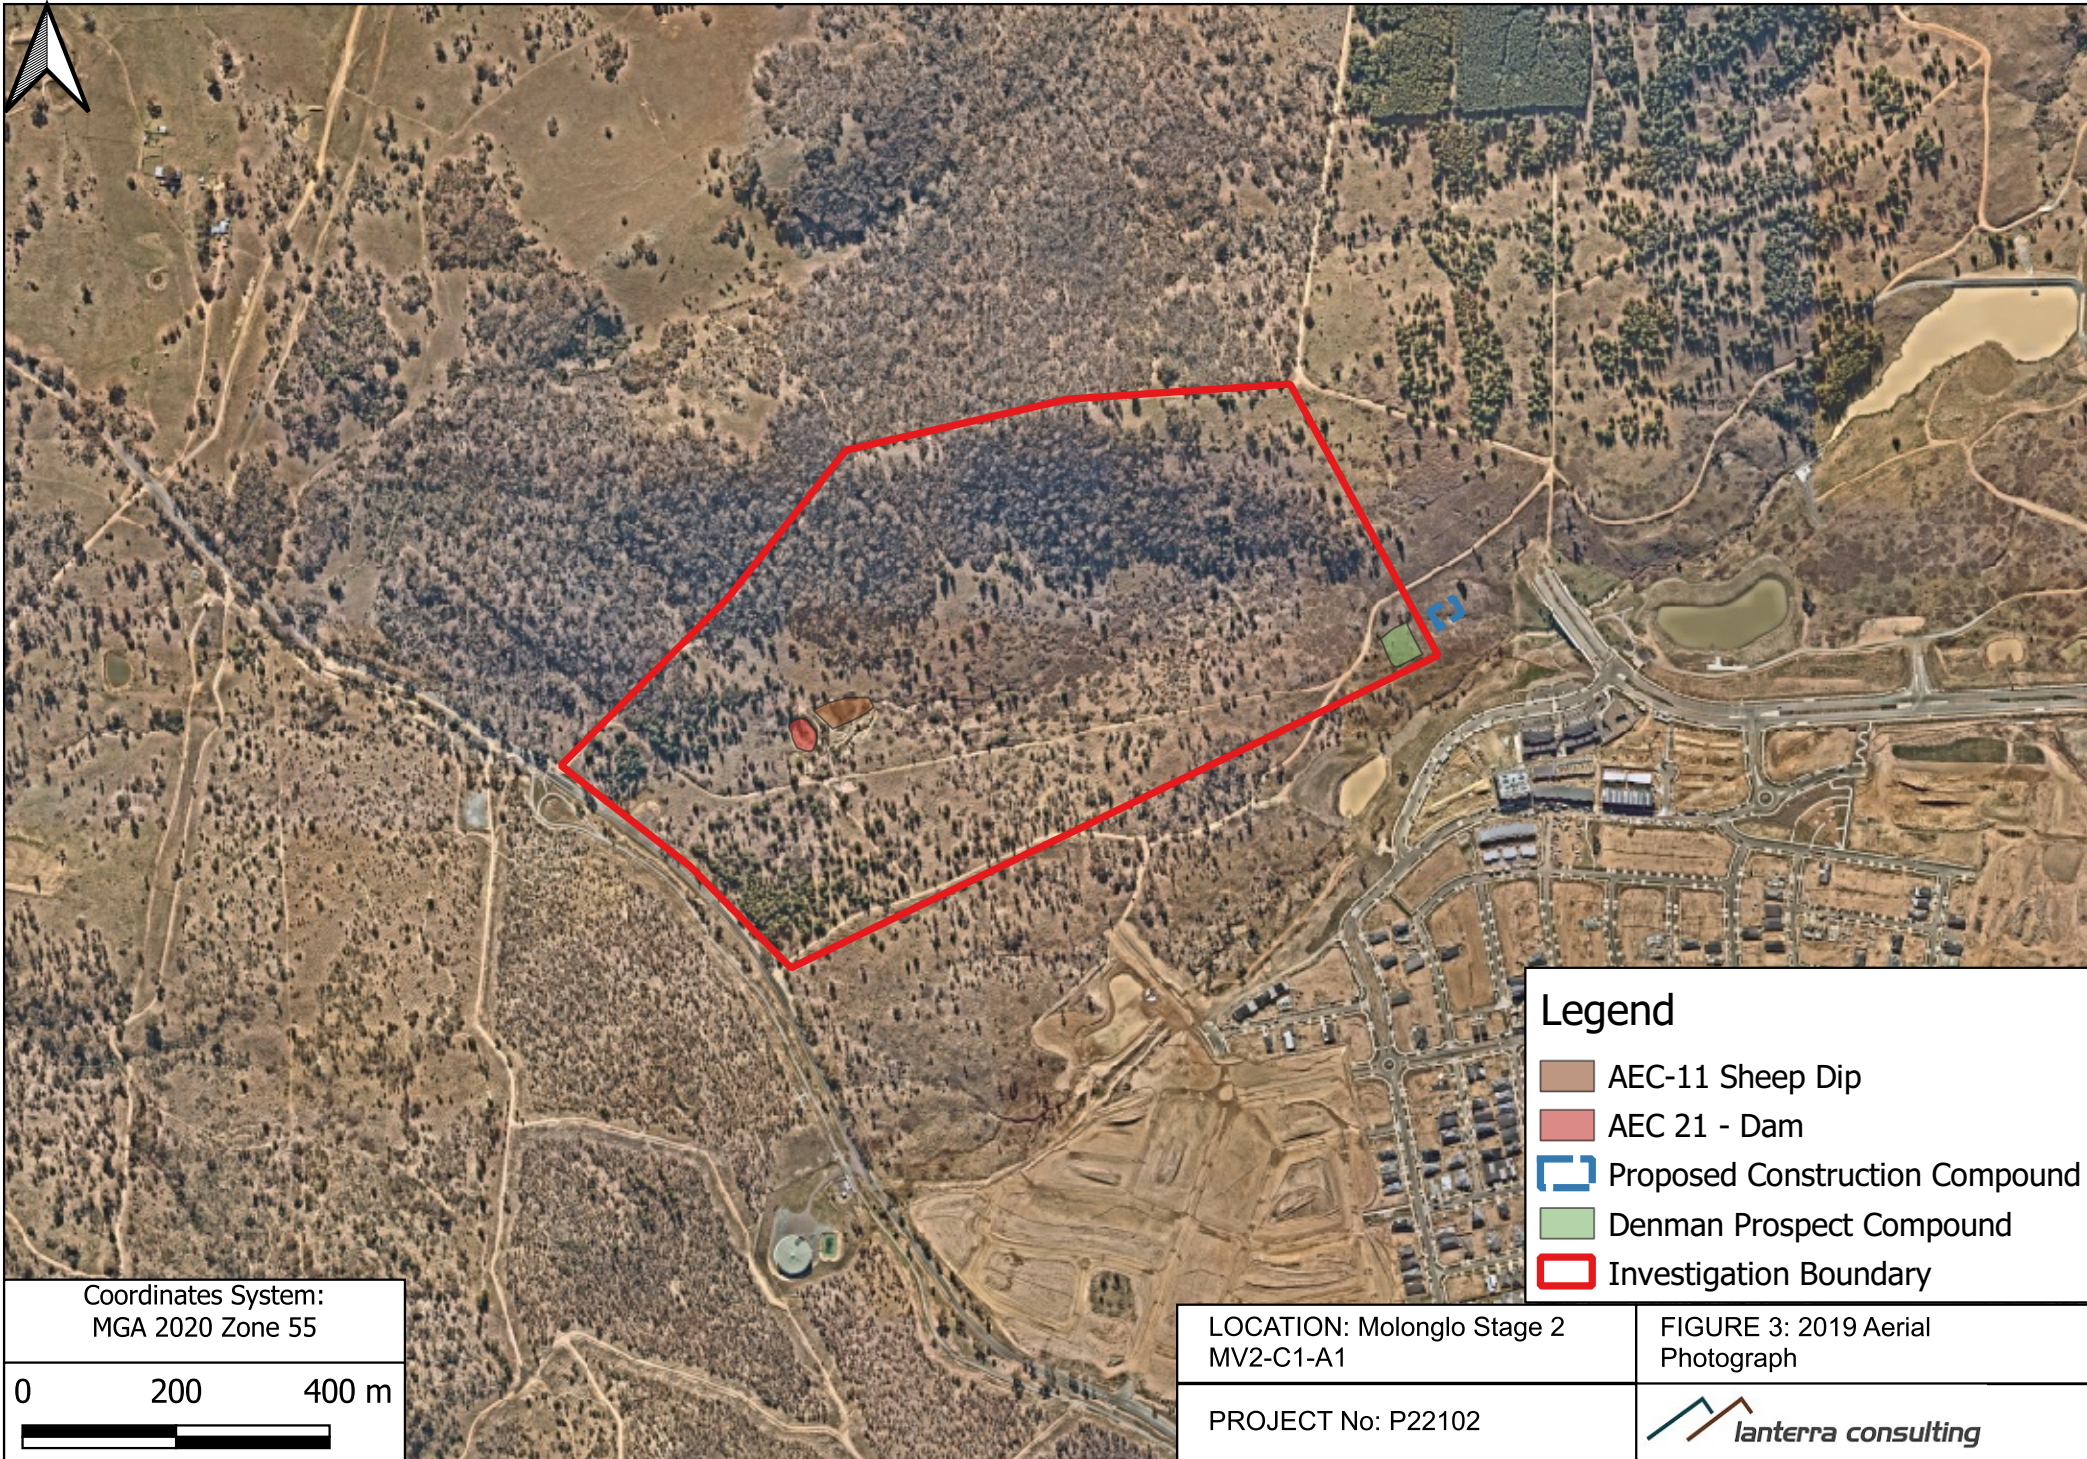
FIGURE 3: 2019 Aerial
Photograph

July 2019	Nearmap	No significant changes to the site were noticeable. Vegetation around AEC11 (sheep dip) is increasing.	No significant changes to the surrounding area with the exception of apartment buildings and residential houses in Denman Prospect to the south.
June 2020	Nearmap	No significant changes to the site were noticeable. Vegetation around AEC11 (sheep dip) is increasing and there is water visible in the dam (AEC21).	No significant changes to the surrounding area with the exception of additional apartment buildings and residential houses in Denman Prospect to the south.
July 2021	Nearmap	No significant changes to the site were noticeable. Vegetation around AEC11 (sheep dip) is increasing.	More residential buildings have been constructed in Denman Prospect to the south. Trees have been cleared to the east.
July 2022	Nearmap	No significant changes to the site were noticeable with the exception of the Denman Prospect compound in the southeast corner of the site.	Further residential buildings have been constructed to the south of the site, while sub-division earthworks for the new Stage of Denman Prospect have commenced to the east of the site.

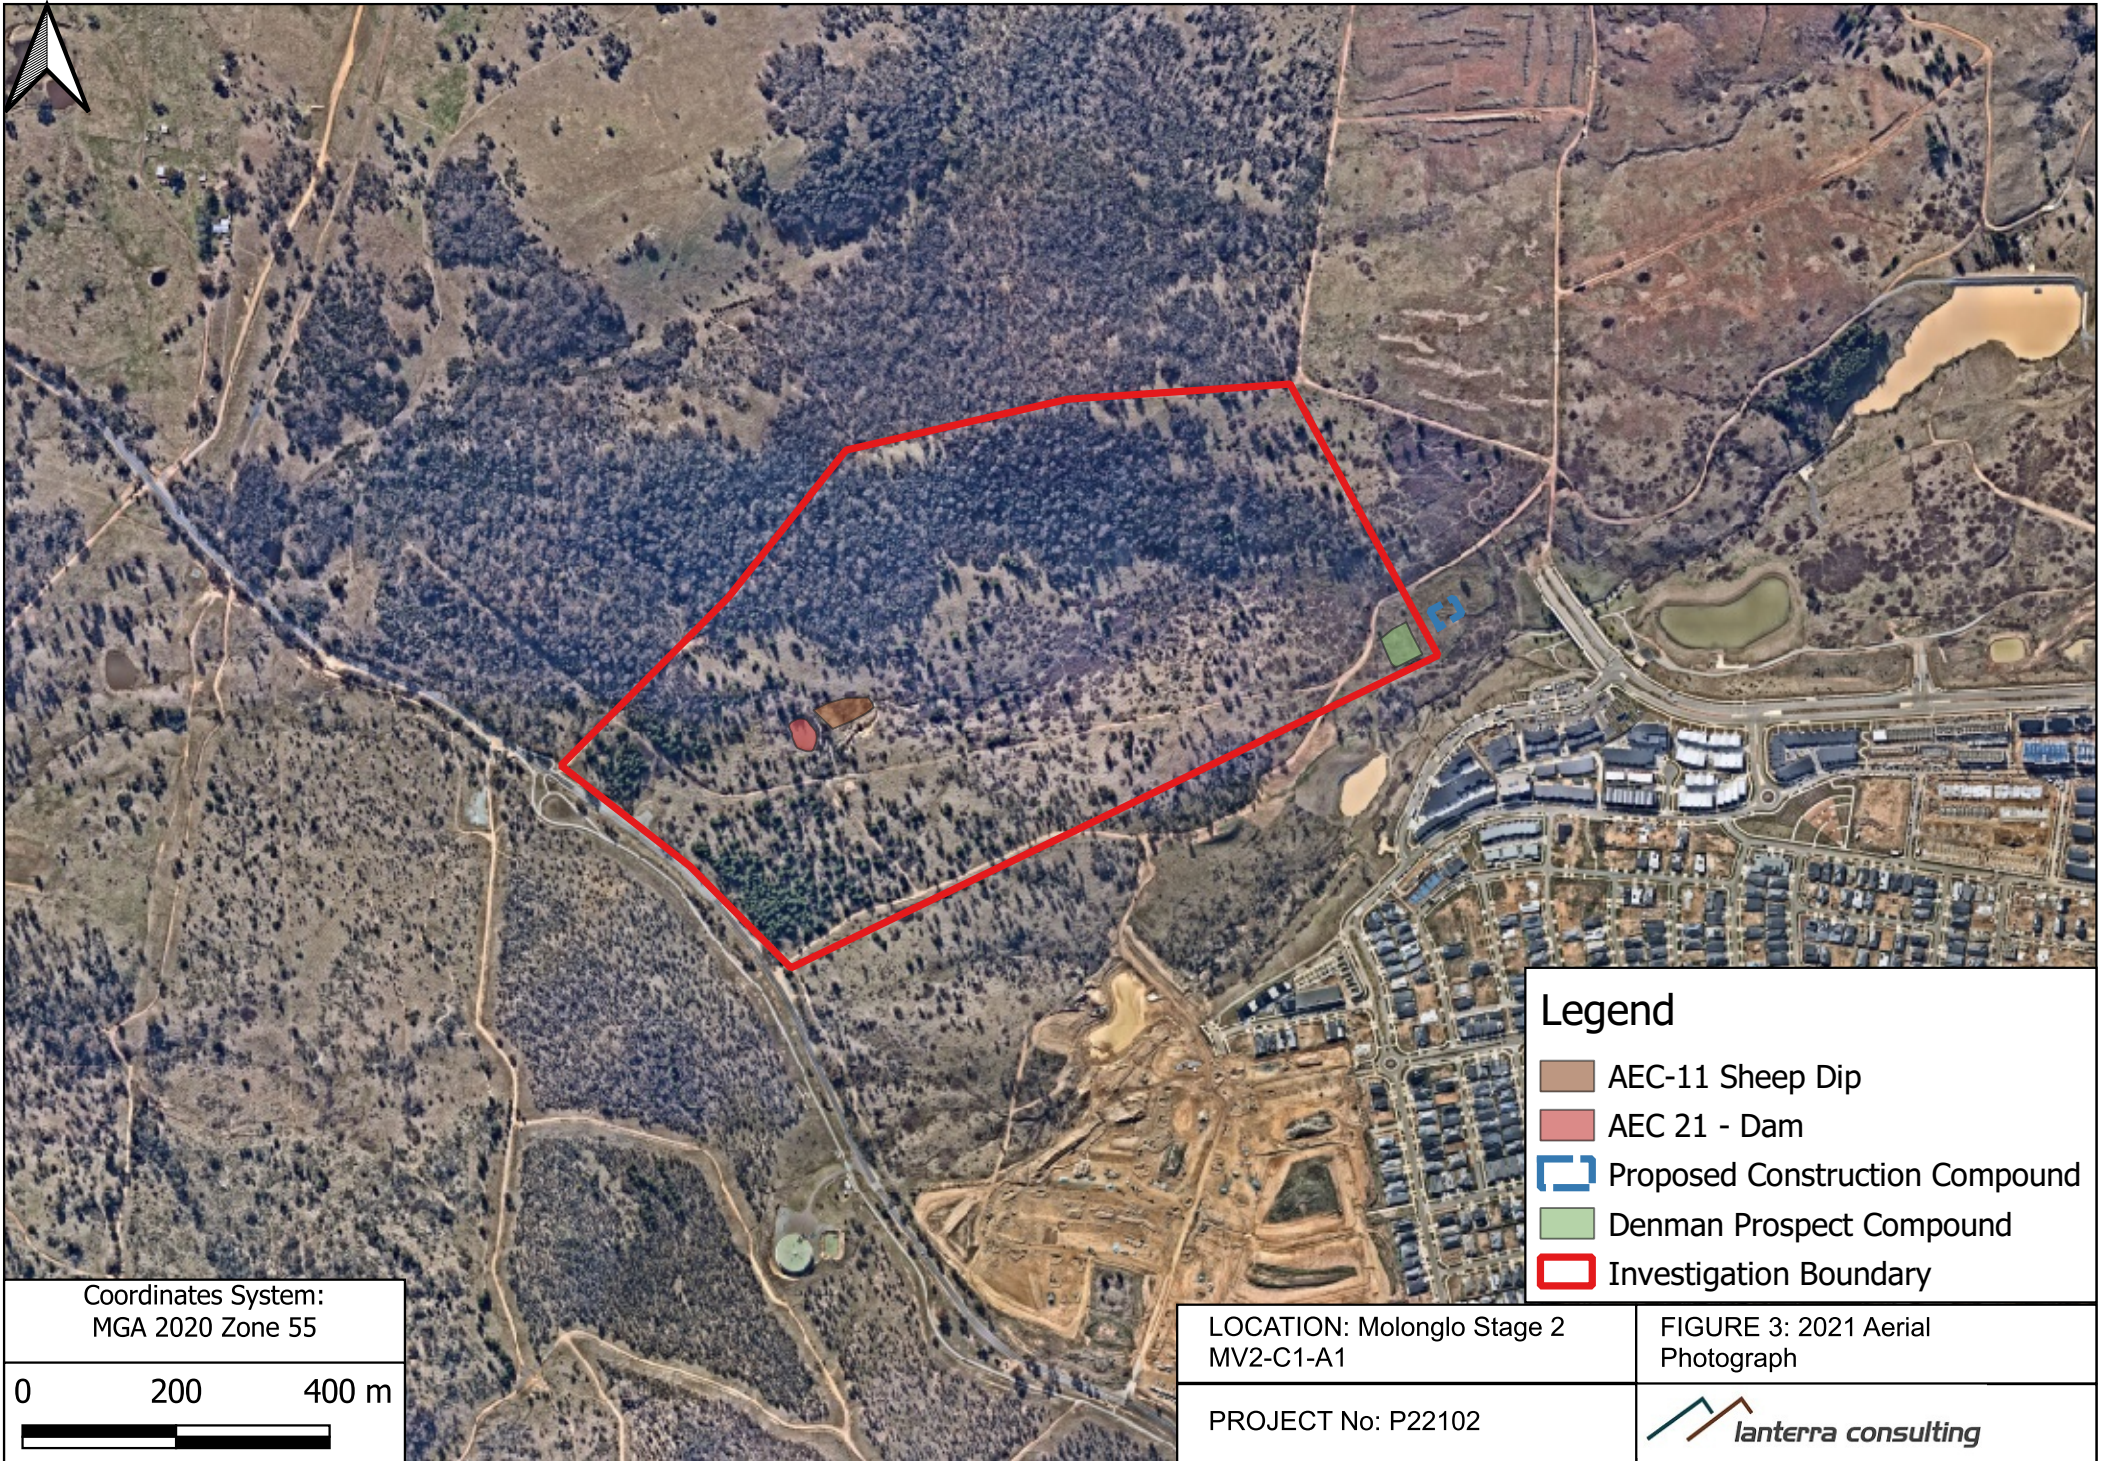
FIGURE 3: 2021 Aerial
Photograph

Based on the review of the aerial photographs, the site has not changed significantly since 2017 with the exception of the establishment of the Denman Prospect compound located in the southeast corner of the site. From the review of aerial photographs, the compound was established between October 2021 and December 2021 and a description of the compound is present in the section below.
