Report on  
Preliminary Site Investigation (Contamination)

Proposed Transmission Line Realignment  
Coree, Stromlo, Belconnen

Prepared for  
Riverview Projects (ACT) Pty Ltd for the Ginninderry  
Joint Venture

Project 225017.00  
January 2024

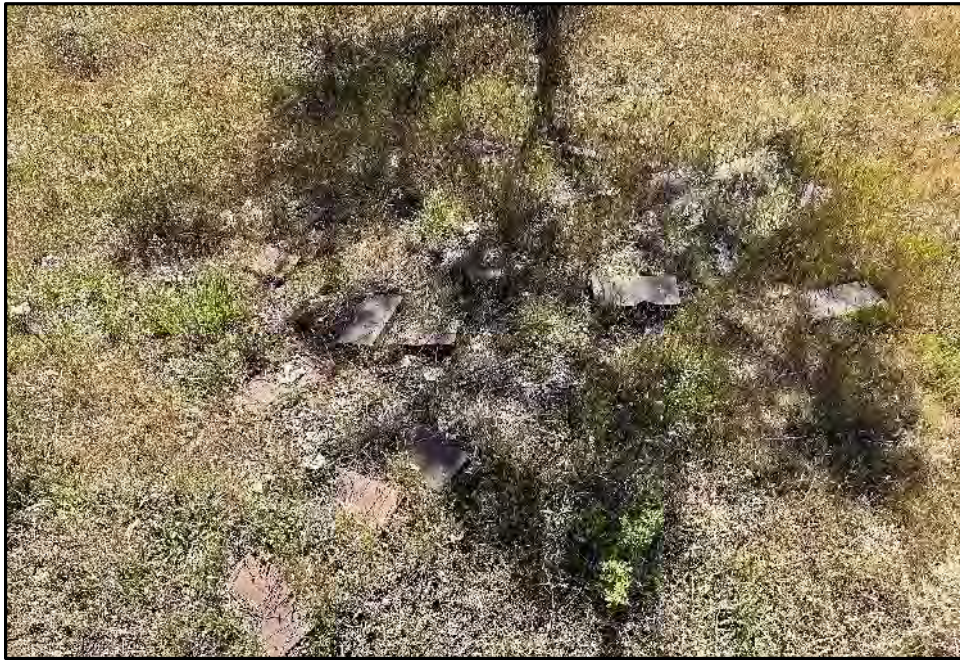
- Scattered bricks were observed on the surface within the area of proposed tower 267A within Rural Block 1602, Belconnen (refer to Drawing 2, Appendix A and Photograph 19, Appendix E);

**Photo 19: View of bricks (possible fly-tipping) at proposed tower location 267A**

Based on the assessment findings, Douglas recommends that an intrusive soil investigation is required within Rural Blocks 1614, 1602 and 1461, Belconnen (within proposed tower locations 229A, 230A, 267A and 268A) due to the identified PFAS contamination and identified potential fill. It is noted that the works should be conducted as part of the Development Application (DA) submission (noting that this PSI will form part of an EIS submission). A HAZMAT survey is also recommended prior to the demolition of the existing towers where the tower footings will be exposed and removed. It is noted that the works should be conducted as part of the DA submission. Validation sampling of the soil where footings were located should also be conducted should HBM be identified in the HAZMAT survey and demolition works.

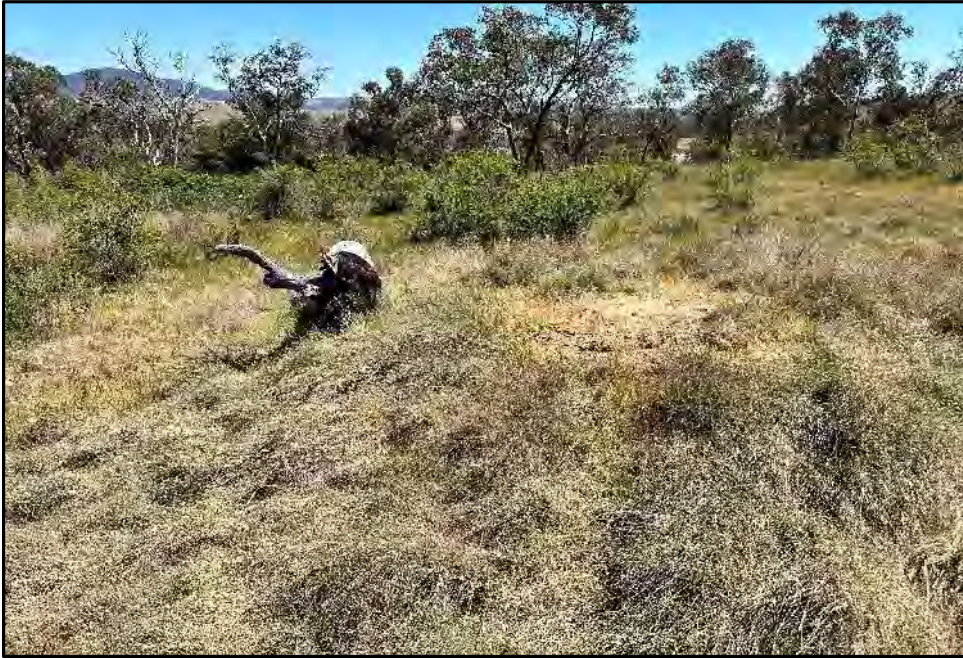
- Disturbed ground was noted across the portions of the site with Rural Block 487, Stromlo. Upon closer inspection, the disturbed ground appeared to be the result of several rabbit warrens and wombat burrows. A potential fill mound was observed in the area of proposed tower 230A within Rural Block 1602, Belconnen (refer to Drawing 2, Appendix A and Photograph 21, Appendix E);

**Photo 21: View of the possible fill mound within the location of proposed tower location 230A**
