Molonglo Stage 3 Future Urban Release: Sub Surface testing report and further studies

Prepared for Environment and Sustainable Development Directorate

14 July 2017

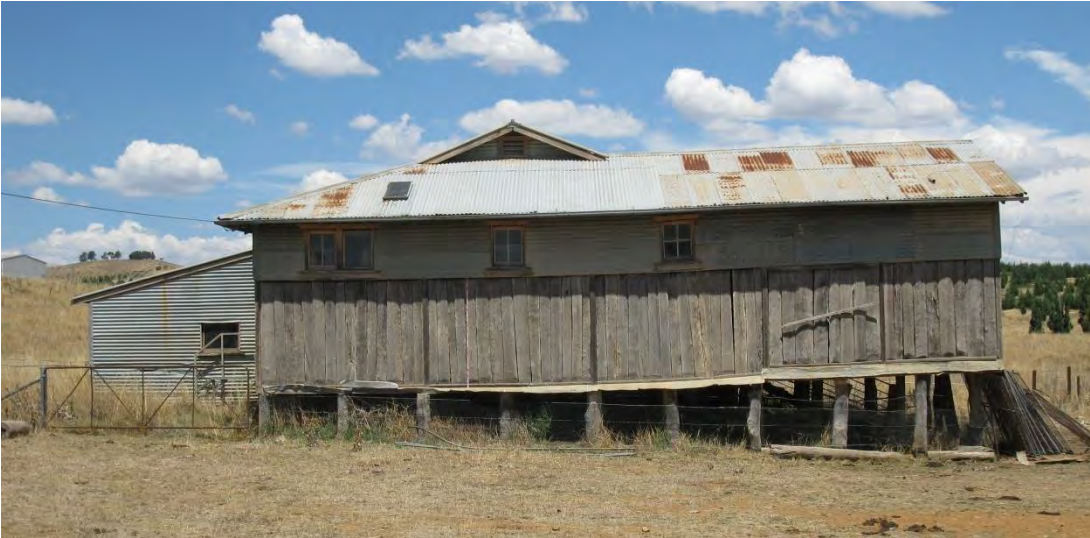
Plate 1. West elevation of shed. Note collapsed and sunken stumps

The stumps are all 'in the round' up to 1.5 m above ground. Several have sunk (some by as much as 1 metre) and many no longer support the floor, with past slumping evident from various packing pieces between the stumps and floor joists.

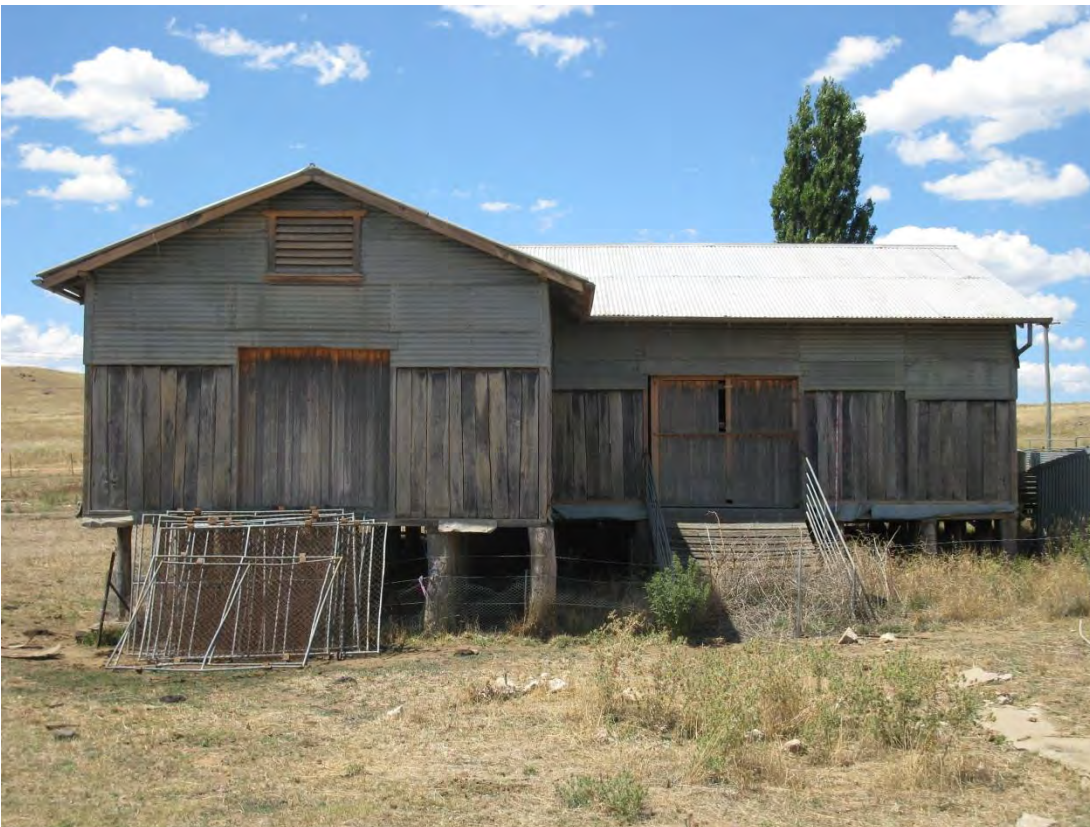
Plate 2. South elevation note sheep ramp on right

The layout of the shed is typical, generally described as an "across the board" plan, with the sheep entry ramp on the south side leading up to sweating pens, fill pens and catching pens. The shearing floor is then to the north, while the trapdoors to the chutes (to let out the shorn sheep) are in the north wall beside each shearing stand. A small shelf below a window is located immediately above each chute.

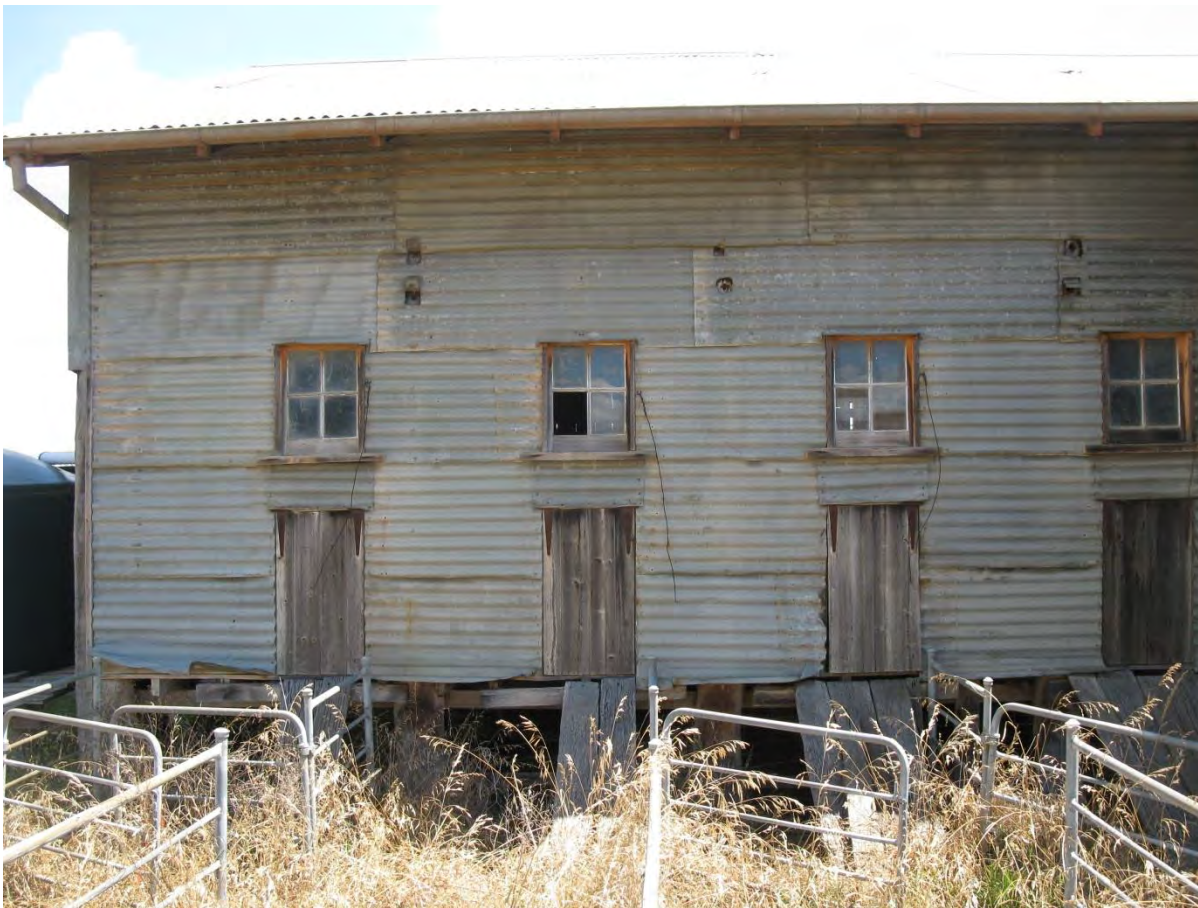
Plate 3. Part north elevation showing sheep chutes – note holes for lineshafting above and right of windows

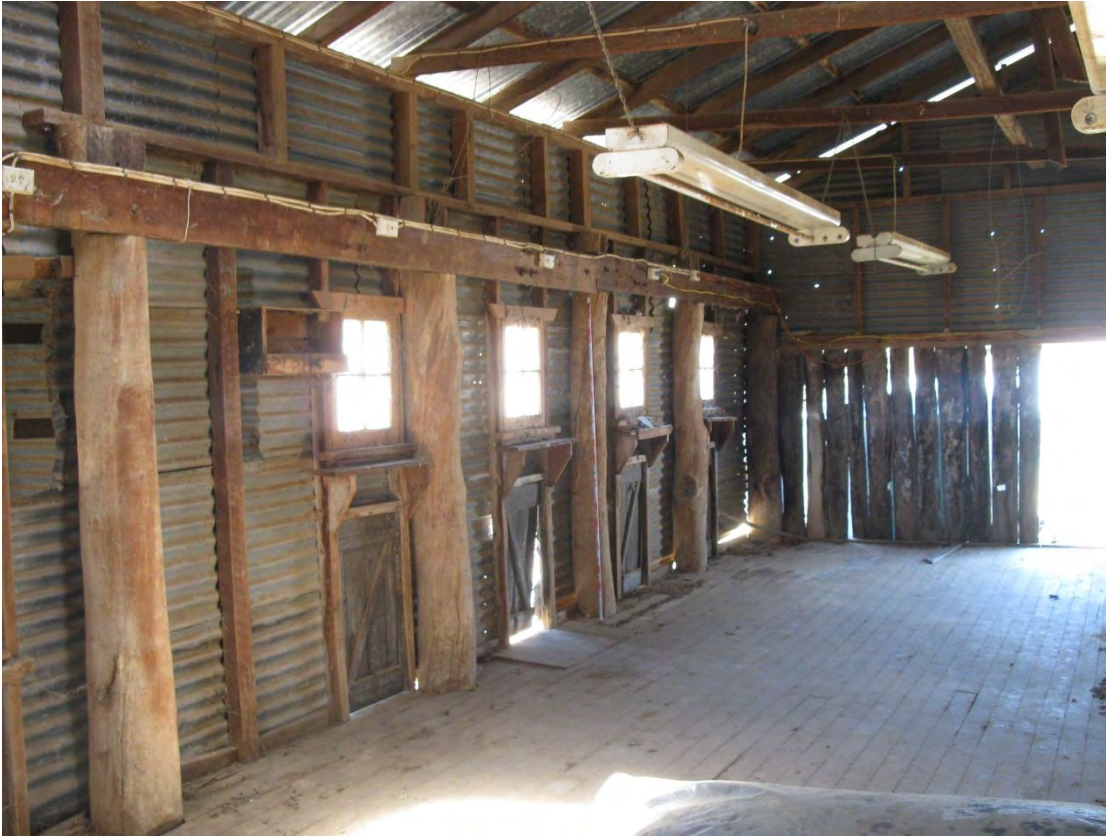
Plate 4. Shearing stands showing large posts and lineshaft rail, and trap doors.

The shearing floor has modern power points for four stands (plus one spare) attached to a large Oregon beam formerly used for attaching the lineshafting and flywheels for the shearing handset drive. Four sets of three bolt holes indicate the positions of the bearing carriers for the lineshaft and handset drive pulleys or bevel gears. Two separate cutaways in the corrugated iron on the wall at the left end of the shearing board open into a small room, demonstrating where the drive was from a gas or other portable engine.

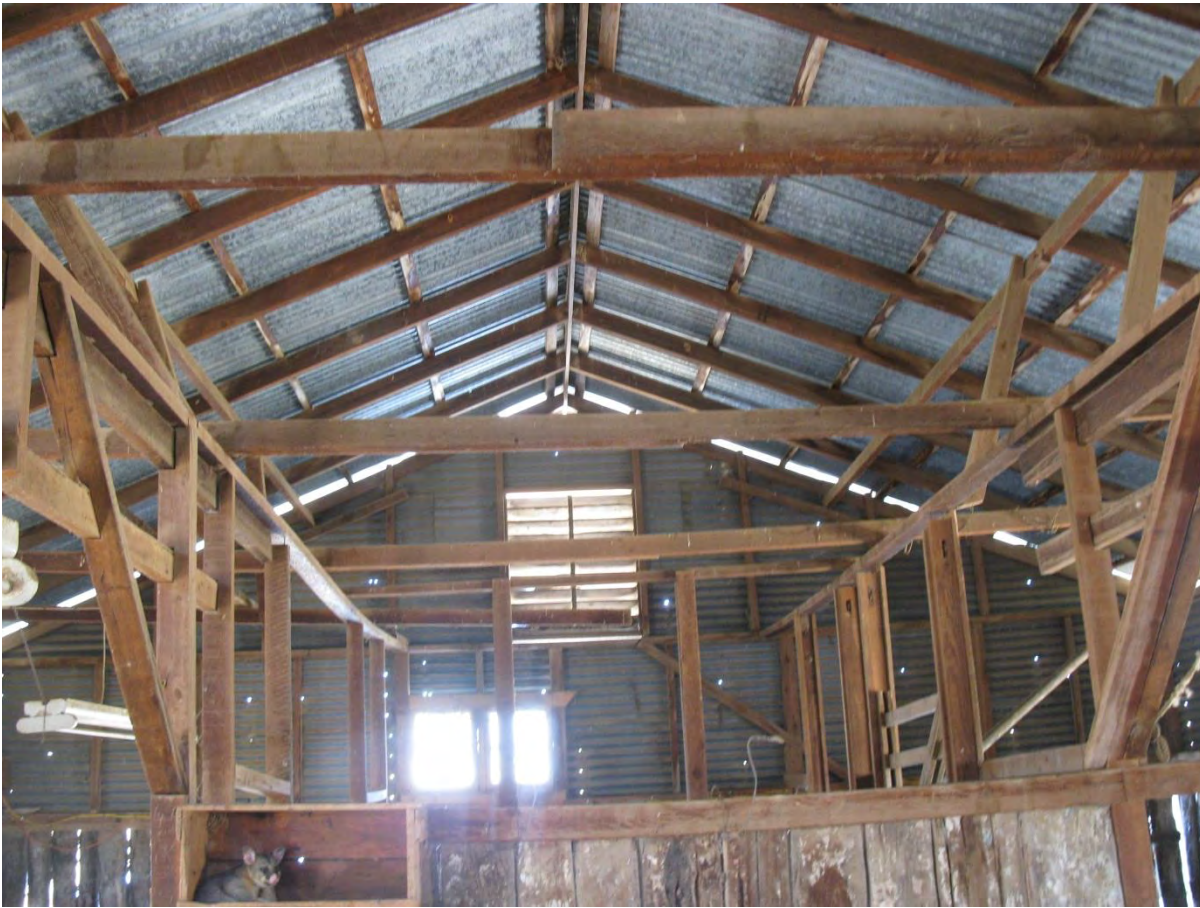
Plate 5. View of internal sheep pen framing and roof structure

The structure is composed of sawn hardwood framing, with simple nailed joints for the most parts. The roof framing employs a ridge and gable form without any trussing. Although some angled struts extend to the internal partition framing around the catching pens. These do not appear to be roof supporting, but probably relate to stiffening the pen framing.

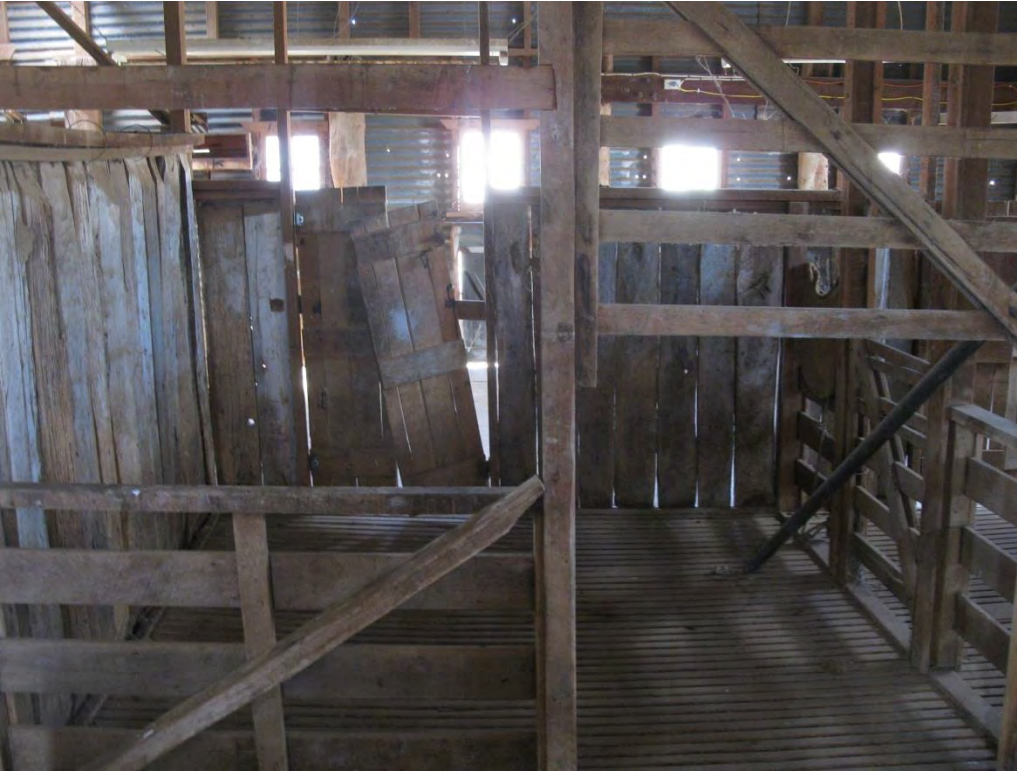
Plate 6. sheep pens showing lift gate and batten floor – note slab walls to left and rear

Floors are tongue and groove hardwood, with spaced battens over the sheep pen floors (to allow manure to drop through). Wall framing employs widely spaced square posts framing sections of vertical slabs with top and bottom plates. The slabs are held in place by battens nailed to the top and bottom plates on the inside and outside. Smaller framed sections about .6m high fill the spaces between the top of the slabs and the roof.

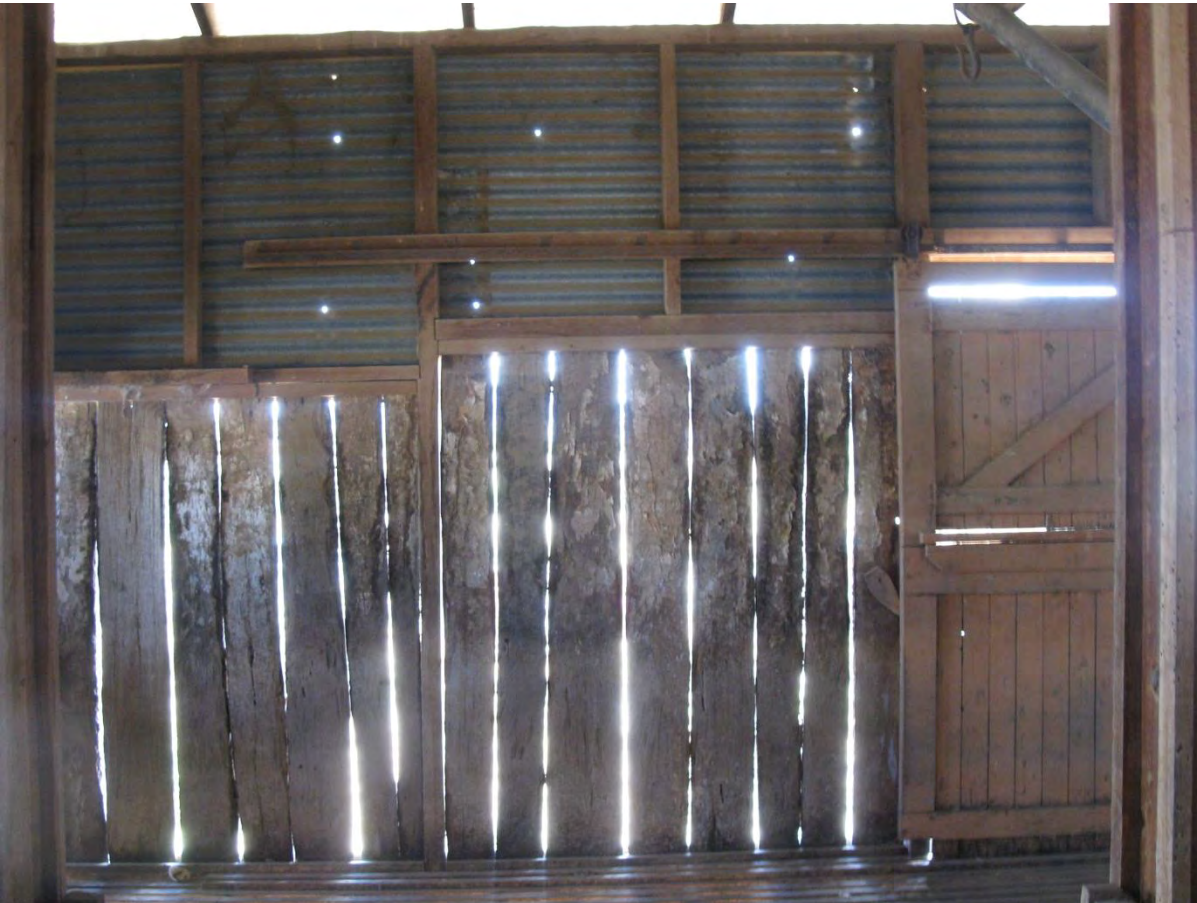
Plate 7. Inside of south wall showing different height slabs and framing for upper corrugated iron clad wall.

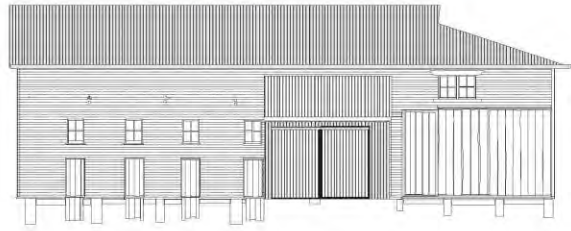
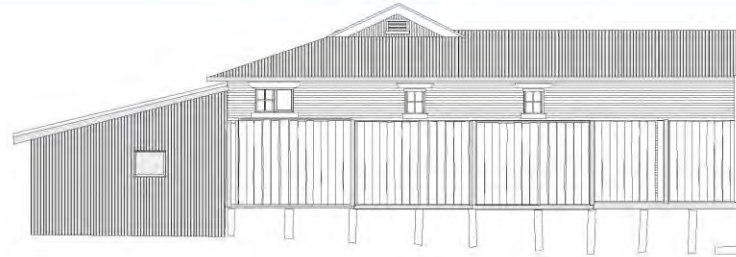
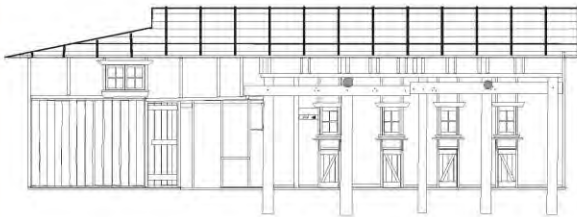
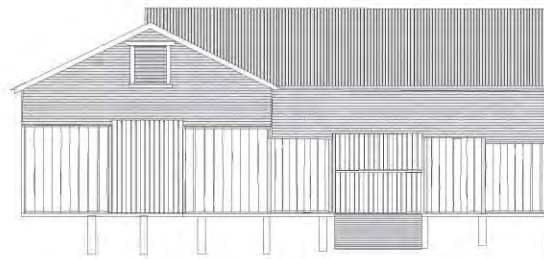
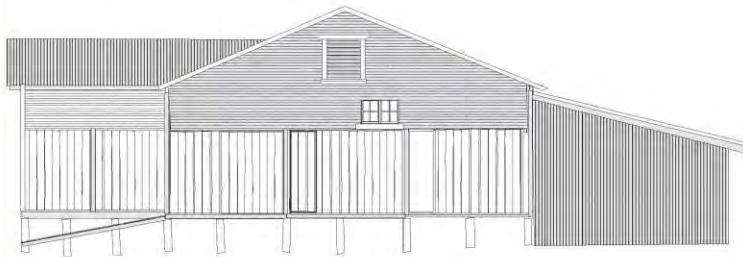
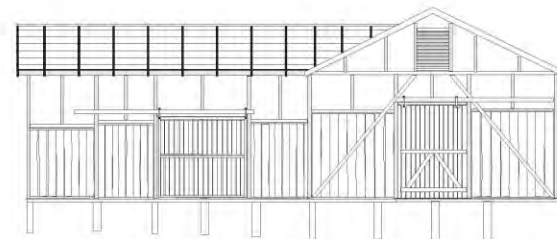
Plan 2: Elevation Plans of the Kallenia Rivers Woolshed

Kallenia Rivers Woolshed elevations

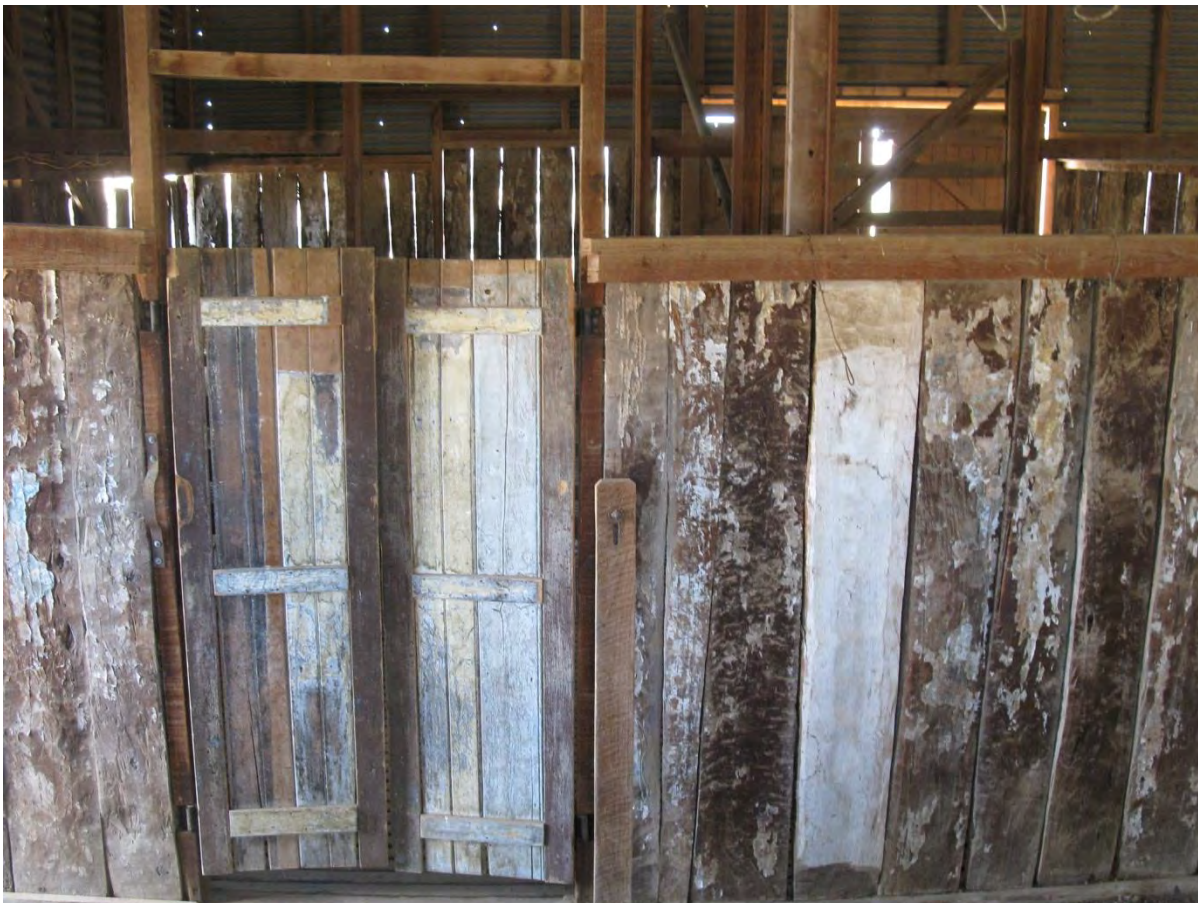
Plate 8. Internal sheep pen walls with catch doors.

Internal partitions are confined to the sheep pens and wool bins. The sheep pens have a combination of split timber slab walls, and some sawn and nailed timber hurdles. Three lift doors and two swing doors are incorporated for controlling sheep movement. There are two small doors in the east wall with remnants of timber ramps, these appear to have been an after thought, having been made by removing a few of the slabs.

The battens for holding the slabs in place are still visible across the door ways. A similar section of removed slab wall can be discerned between the surviving sheep pens and the main sheep ramp on the south side. Timber battens survive on the floor indicating a former wall position.

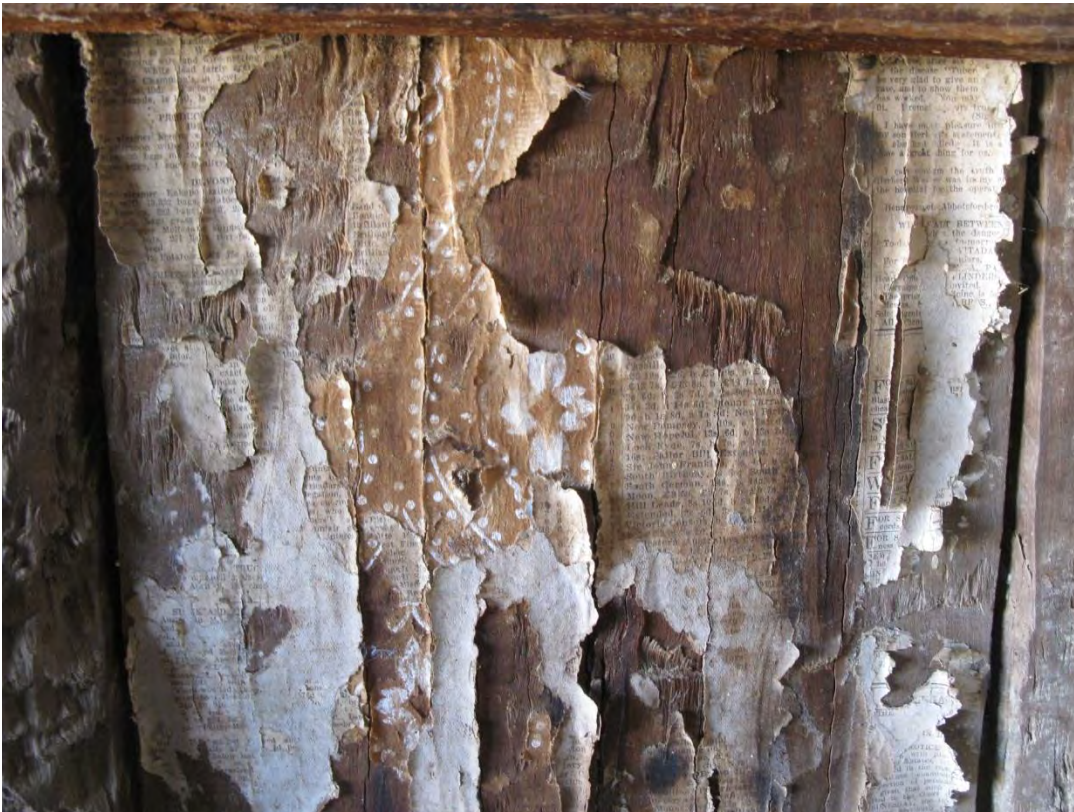
Plate 9. wallpaper overlaying newsprint on recycled timber slab walls

The timber slabs are in most cases covered in fragments of both commercial printed wall paper, and newspapers pasted over during the original occupation. Wallpaper patterns include yellow and white leaf patterns, a stylised fern and dot pattern in white on a buff background and a more ornate blue floral pattern.

Some slabs have paper on both sides indicating they originally came from internal walls. Most of the slabs have evidence of recutting at the ends, probably to make them fit the new structure, and perhaps to remove rotting caused from their original position.

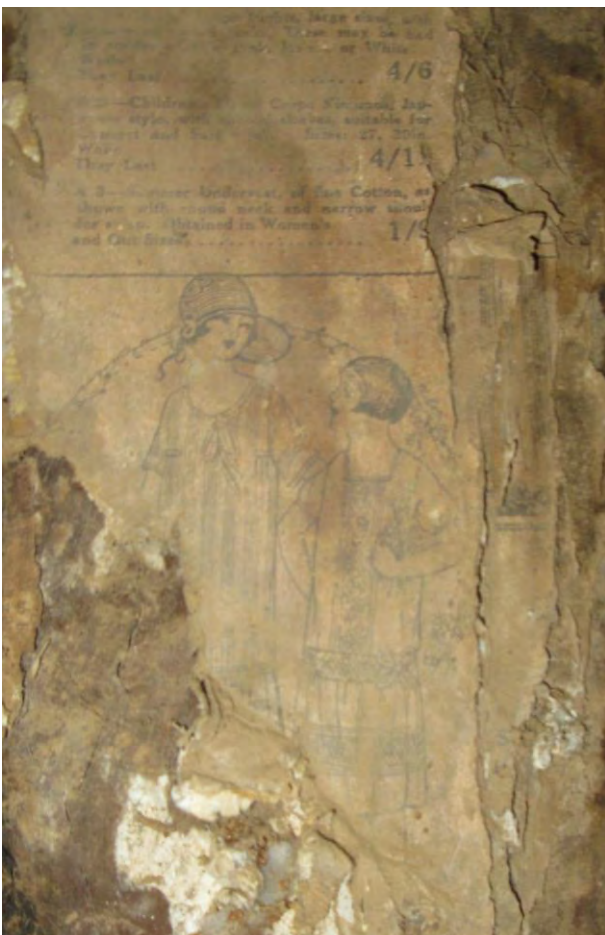
Plate 11. Late 1920s newspaper advertisement papering walls

There are several layers on top of each other indicating repeated papering, with a possible sequence as follows:

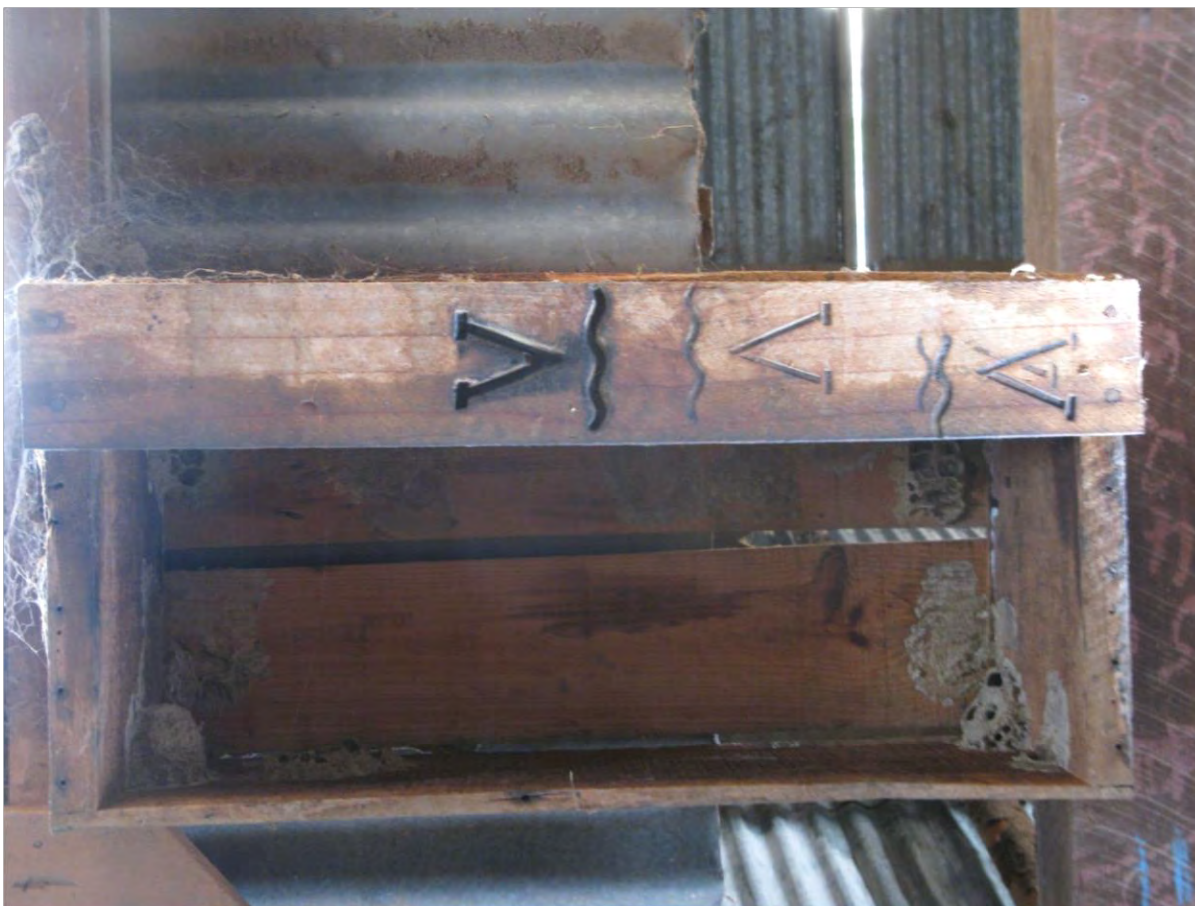
Plate 12. Brand burnt into shelf

A fruit box attached to the wall as a shelf has a brand mark burnt into the timber denoting a 'V' over a wavy line.

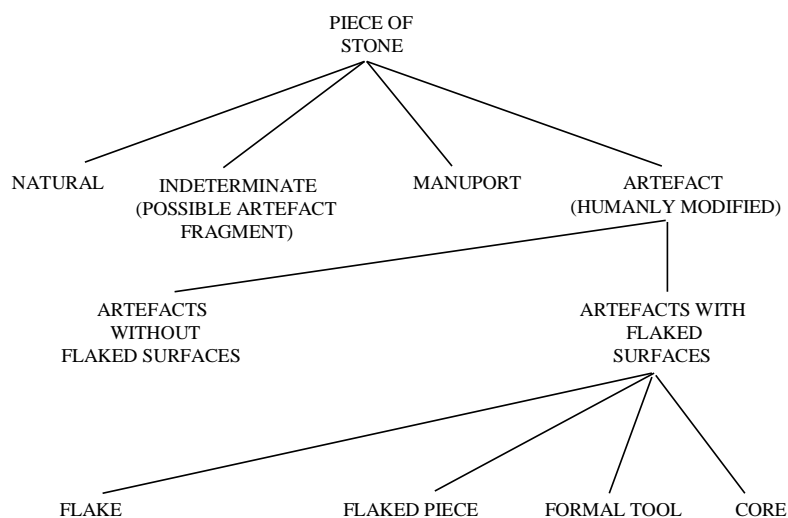
Figure G2: Stone artefact types/categories.

One of the most common artefact types that provides evidence of Aboriginal people are those made from stone. Types and categories are outlined below in **Figure G2**, with further definition of each in the glossary list.
