**RE-LOCATION OF 132KV  
TRANSMISSION LINES,  
MOLONGLO STAGE 3 URBAN  
AREA: SUPPORTING  
DOCUMENTATION**

Cultural Heritage Assessment

Project Director: Karina Carwardine  
Project Manager: Amanda Mulherin  
Technical Director: Nicola Roche  
Technical Manager: Ashley O'Sullivan  
Report No. 8139/R03/V5  
Date: December 2020

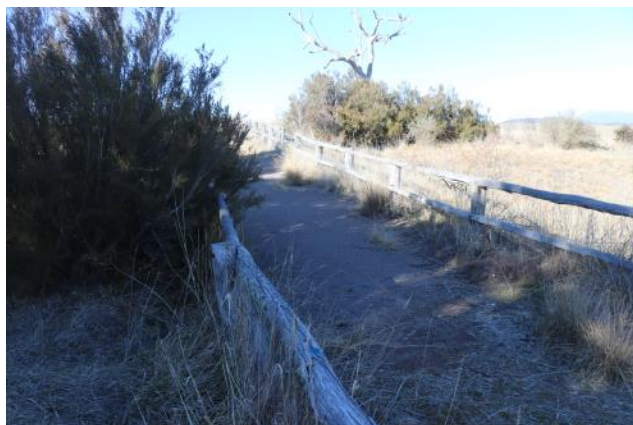
**Plate 6.1** Existing sheep track and general grass coverage in the southwest of the William Hovell Drive survey area.

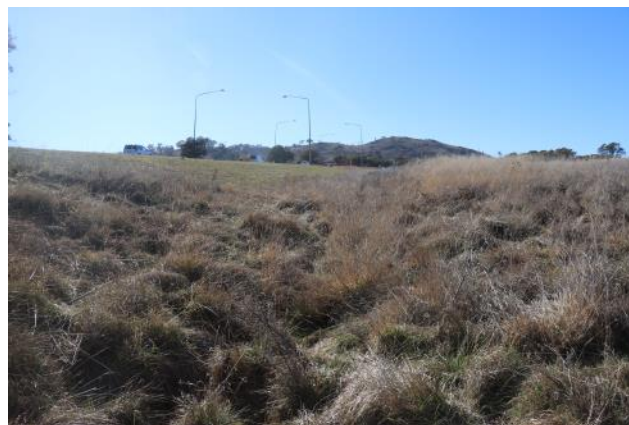
**Plate 6.2** General grass coverage along an existing drainage line, looking east on the south side of William Hovell Drive.

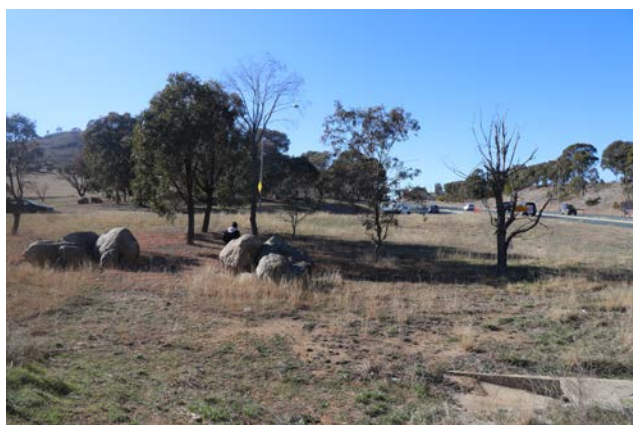
An area that forms a traffic island at the intersection of Coulter Drive and William Hovell Drive was also surveyed to determine if there were any Aboriginal objects in this disturbed context, but none were found (**Plate 6.3**).

**Plate 6.3** View across heavily disturbed area in the centre of the roadway..

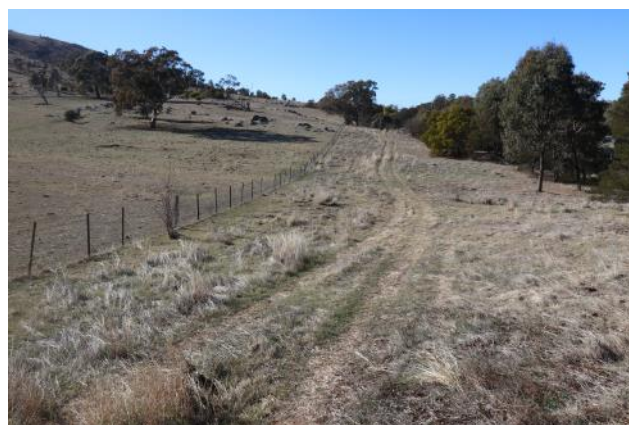
**Plate 6.4** Example of the grass coverage and track exposures in the north eastern part of the William Hovell Drive survey area.

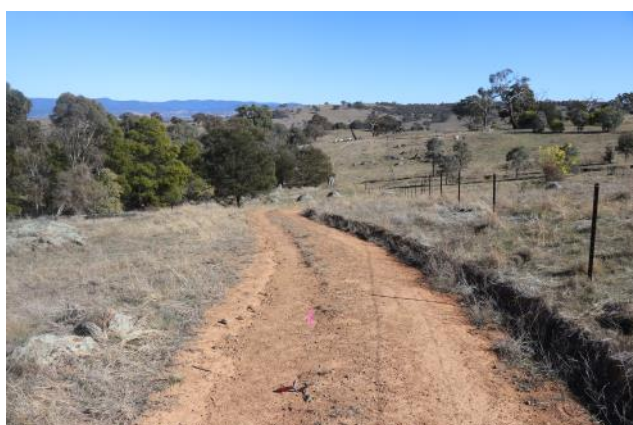
**Plate 6.5** Location of MV-HVL-IF-1 (pink, centre of track) along cut and exposed track. Looking west, towards proposed impact area.

- The newly identified site in proximity to the proposed works, MV-HVL-IF-1 should be inspected and fenced off prior to construction beginning (**Figure 6.1**). This fencing should give each site a 5m perimeter, to ensure that no direct or indirect impacts can occur during construction. Upon completion of construction, the fencing should be removed.
- No further Aboriginal or historical archaeological work is recommended, and the project may proceed with caution. Should unanticipated discoveries be made during construction, work should cease and the protocols provided in **Section 9.0 – Unanticipated Discovery Plan** should be followed.
- The three newly identified sites (MV-HVL-IF-1, MV-HVL-IF-2 and MV-HVL-IF-3) will be registered with ACT Heritage.
- Following finalisation, a copy of this report should be provided to ACT Heritage for their review and approval.

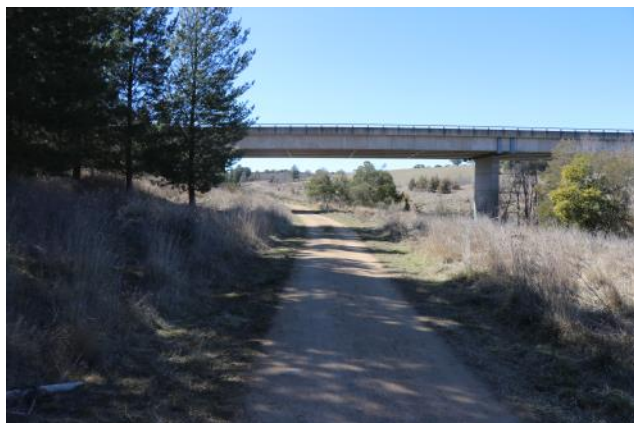
**Plate 6.7** View east across fire trail within project area, on the banks of the Molonglo River.

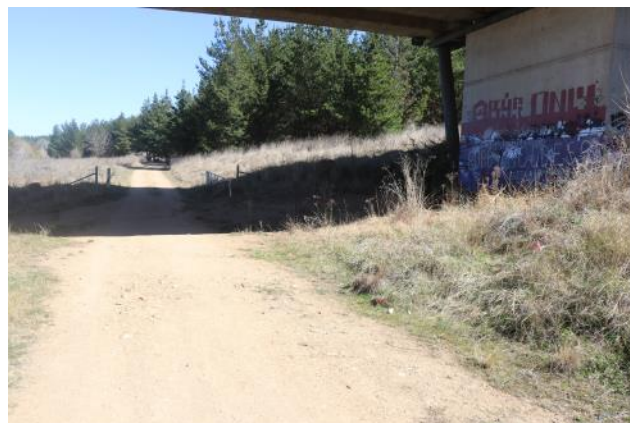
**Plate 6.8** View west across fire trail within project area, on the banks of the Molonglo River.

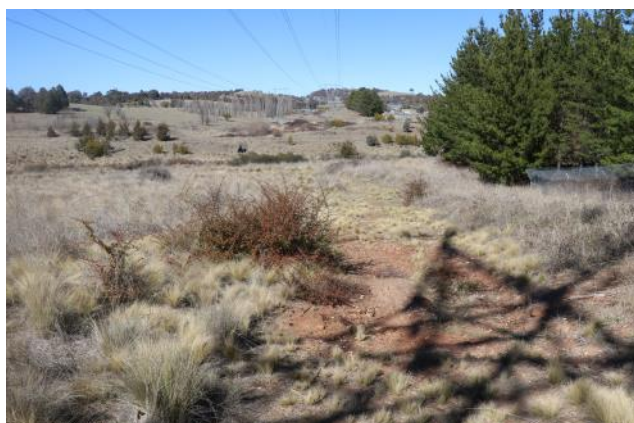
The lower slope that extends north in the eastern part of this survey area was heavily eroded, likely due to light vehicle movement. A number of naturally occurring cobbles were identified in this area, with signs of recent fracture due to this vehicle movement however these did not exhibit diagnostic features indicative of stone artefact manufacture [REDACTED]

**Plate 6.9** Example of the heavily eroded track, looking towards project area / Molonglo River.

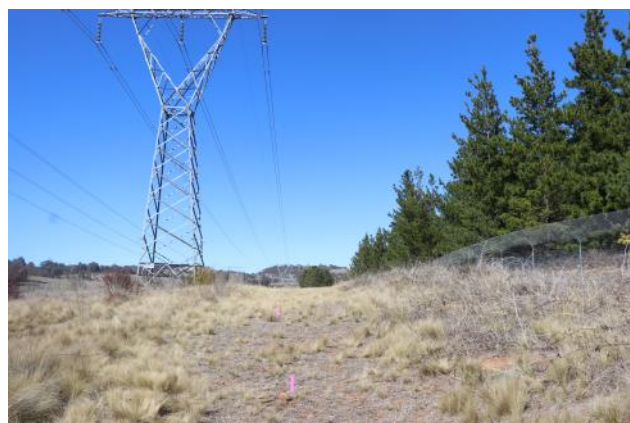
**Plate 6.10** Location of MV-HVL-IF-2 and MV-HVL-IF-3 on heavily eroded track, facing south towards the Molonglo River (not visible).
