# Hume Food Organics and Garden Organics Facility

## Preliminary Site Investigation

Transport Canberra and City Services

2 June 2023

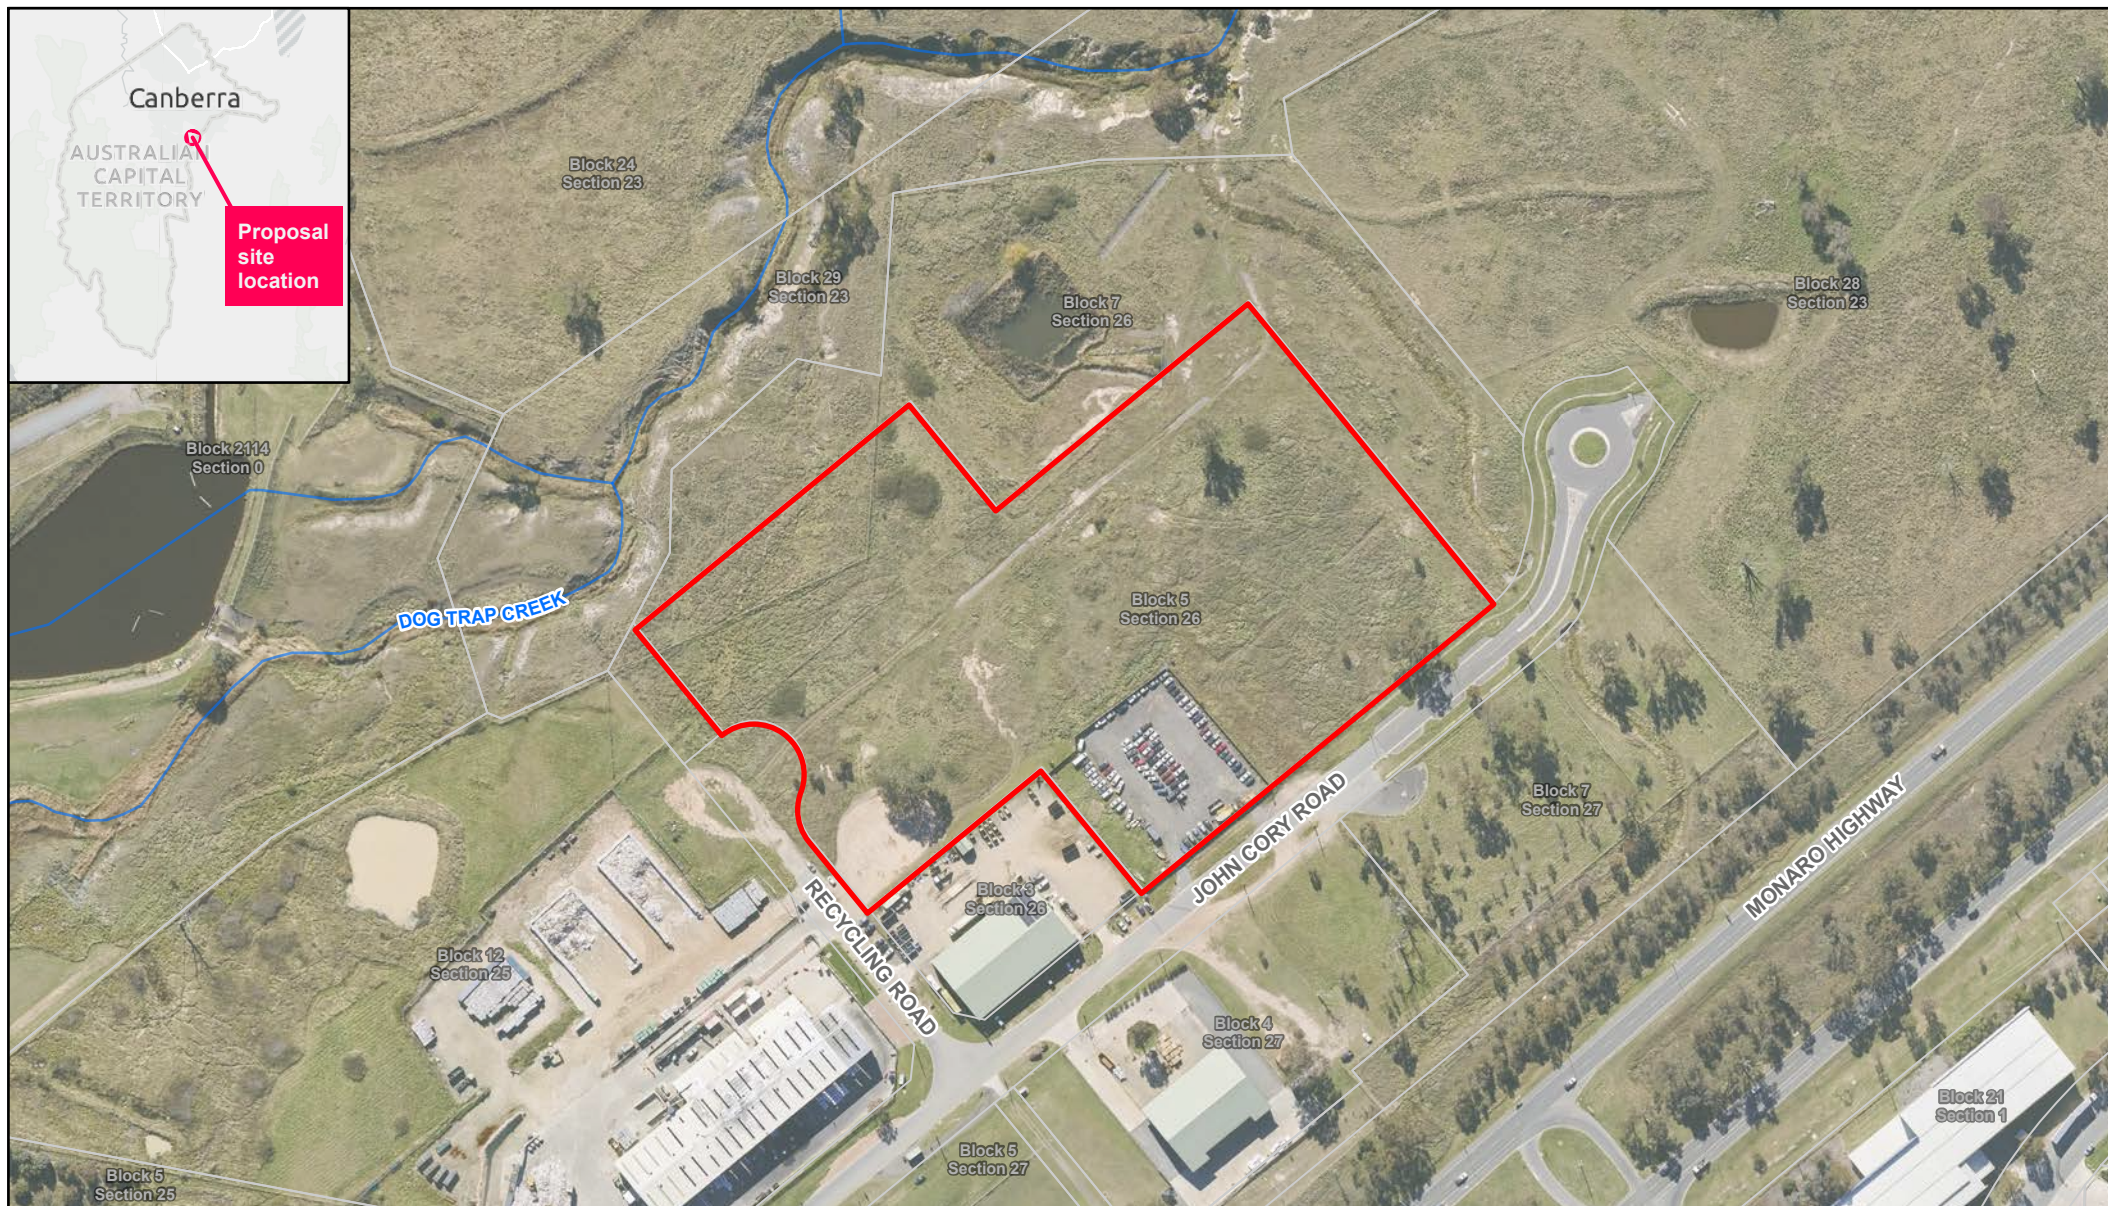
FIGURE 1

Proposal site locality

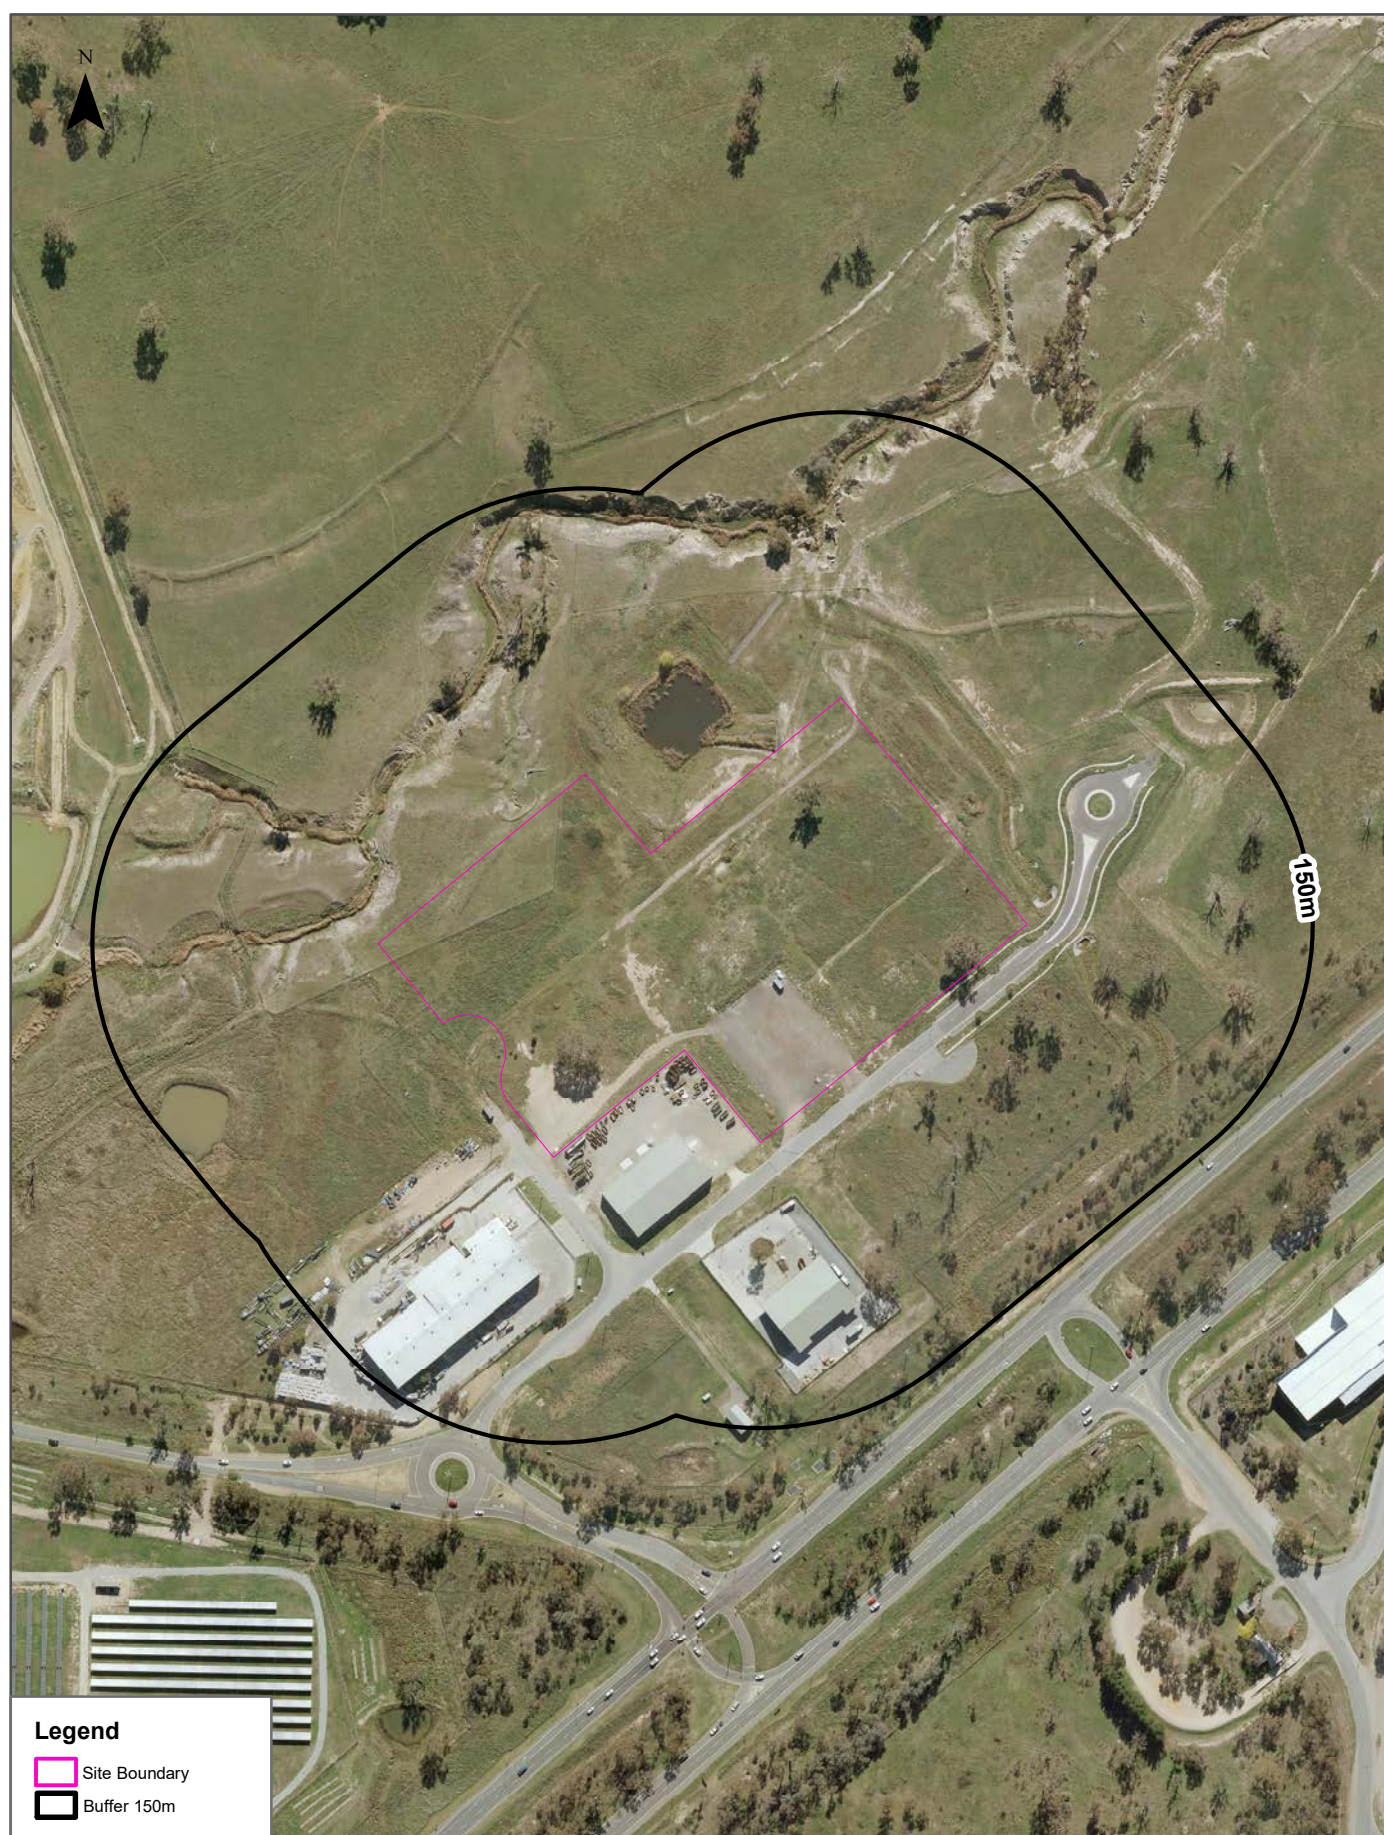
Aerial Imagery 2009

The historical aerial photographs show that the proposal site remained undeveloped until 2009, when it was likely used as a recycling facility with recycled material treated and stored at the site. It can be observed in the imagery that unknown material was stored on site while in this use. By 2017 the proposal site was no longer operational, and the site was cleared. It now consists of mostly grasslands.

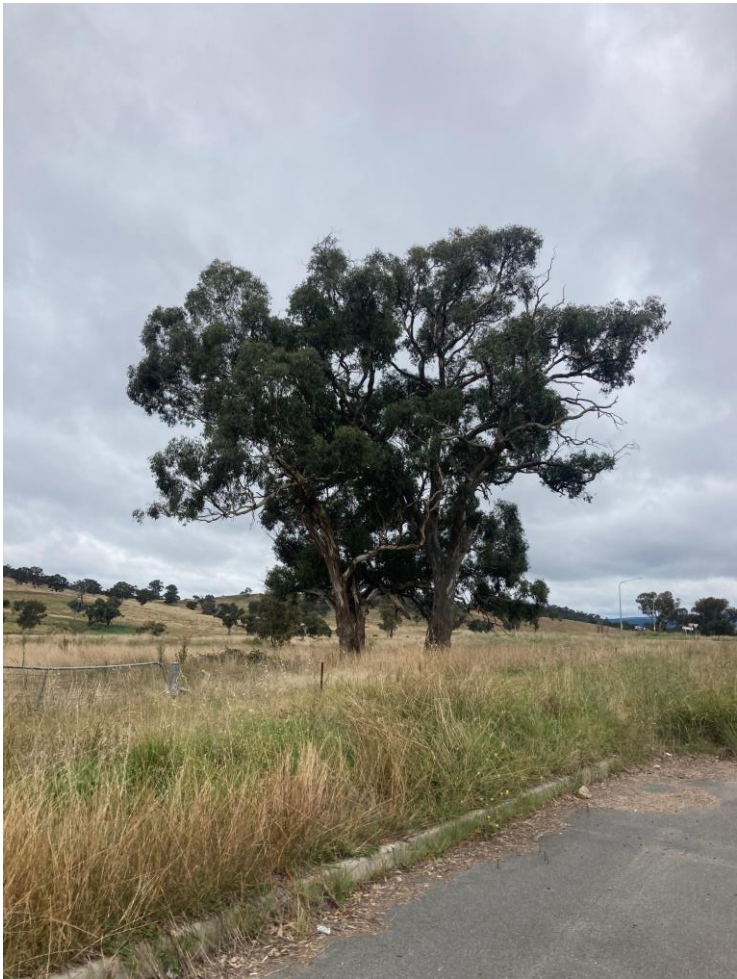
| Description | Photograph |
|---|---|
| <p><b>Photograph 1 - 27 April 2022</b></p> <p>Two large trees within site boundary (view towards the north east, photo from John Cory Road)</p> | |

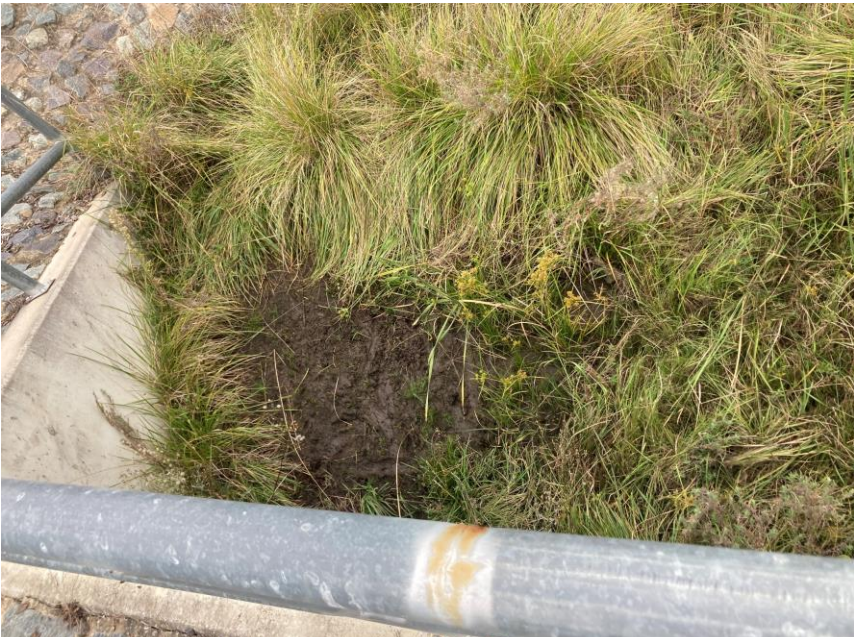
| Description | Photograph |
|---|---|
| <p><b>Photograph 2 – 27 April 2022</b></p> <p>Drainage line with small amount of water. Located external to site boundary on the eastern corner of block.</p> | |

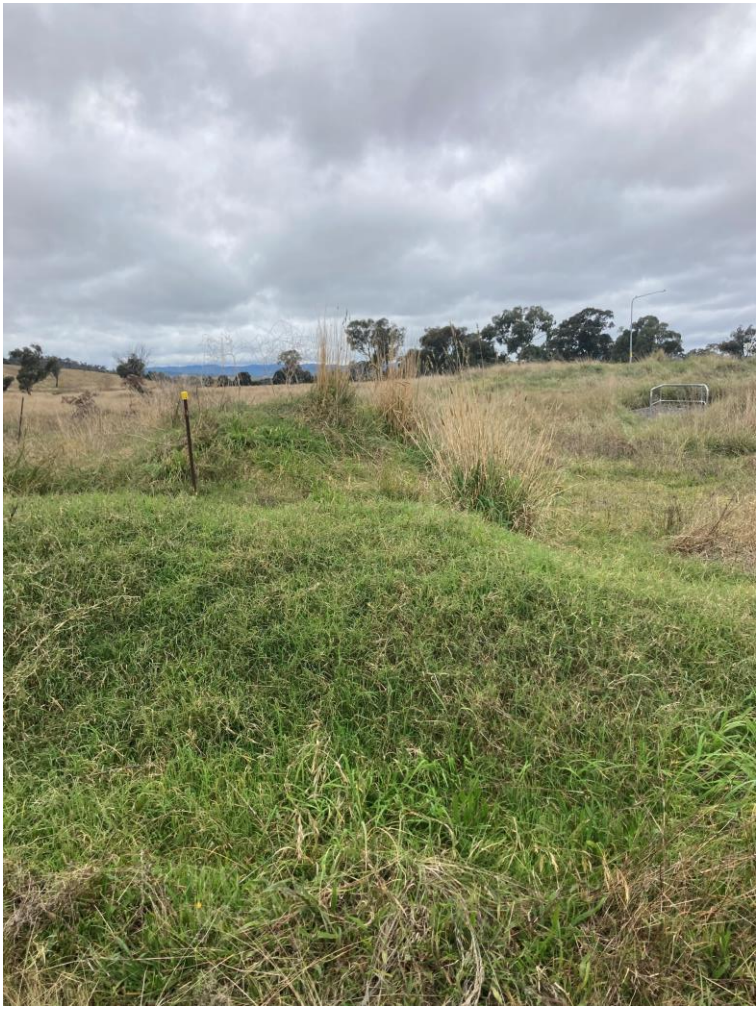
| Description | Photograph |
|---|---|
| <p>Photograph 3 – 27 April 2022</p> <p>Uncontrolled fill.<br/>Located external to north-eastern site boundary line</p> | |

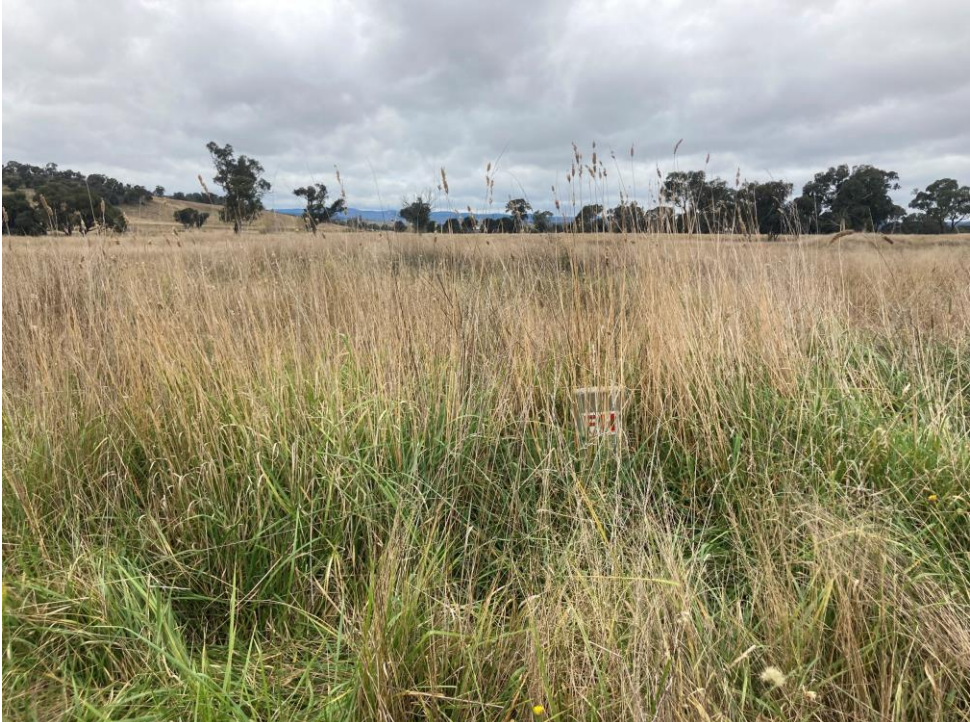
| Description | Photograph |
|---|---|
| <p>Photograph 4 – 27 April 2022</p> <p>Fire hydrant post.<br/>Located external to north-eastern site boundary line</p> | |

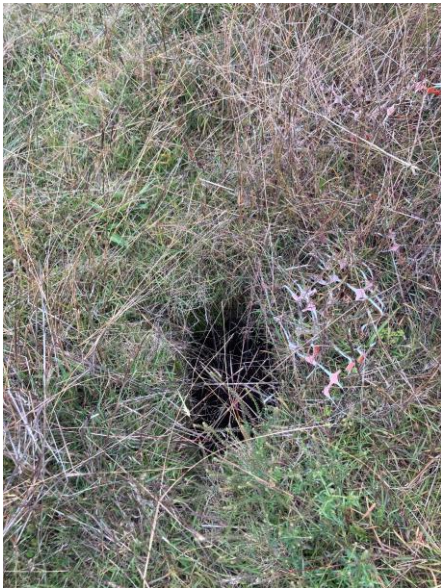
| Description | Photograph |
|---|---|
| <p><b>Photograph 5 - 27 April 2022</b></p> <p>Hole with evidence of previous fencing.. Located external to north-eastern site boundary line</p> | |

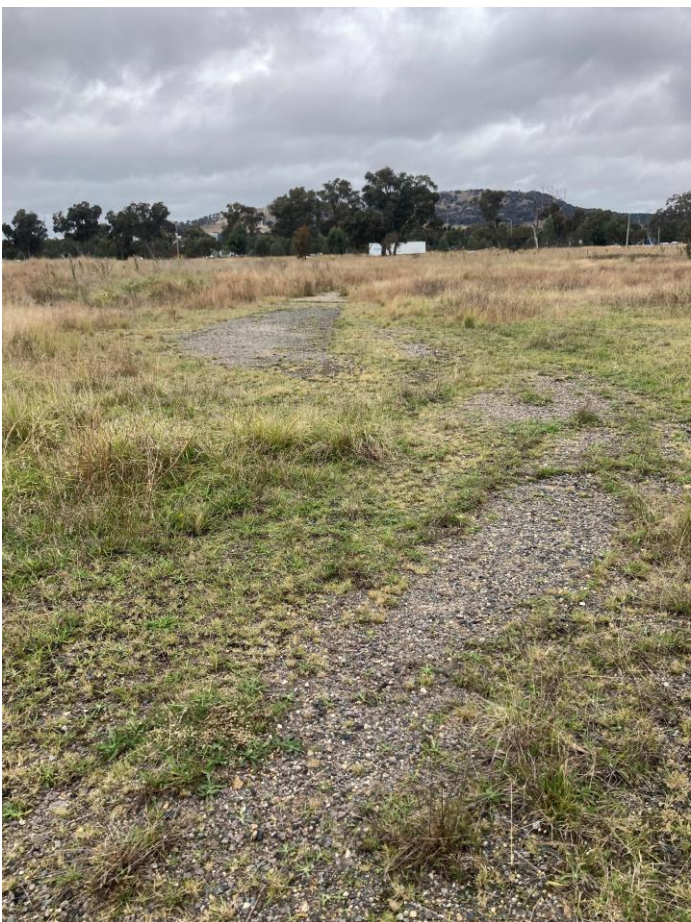
| Description | Photograph |
|---|---|
| <p><b>Photograph 6 - 27 April 2022</b></p> <p>Evidence of previous gravel road. Located external to northern site boundary line (view towards the south east)</p> | |

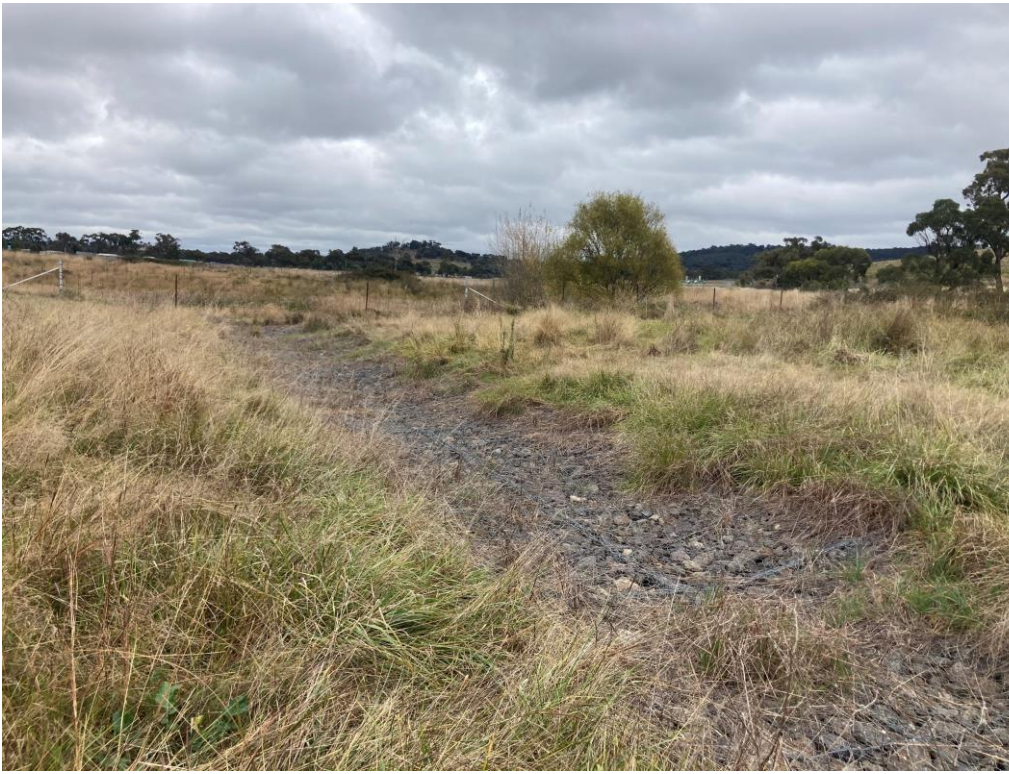
| Description | Photograph |
|---|---|
| <p><b>Photograph 7 - 27 April 2022</b></p> <p>Draining line leading from drainage pond to creek. Located external to northern site boundary line (view towards the south west)</p> | |

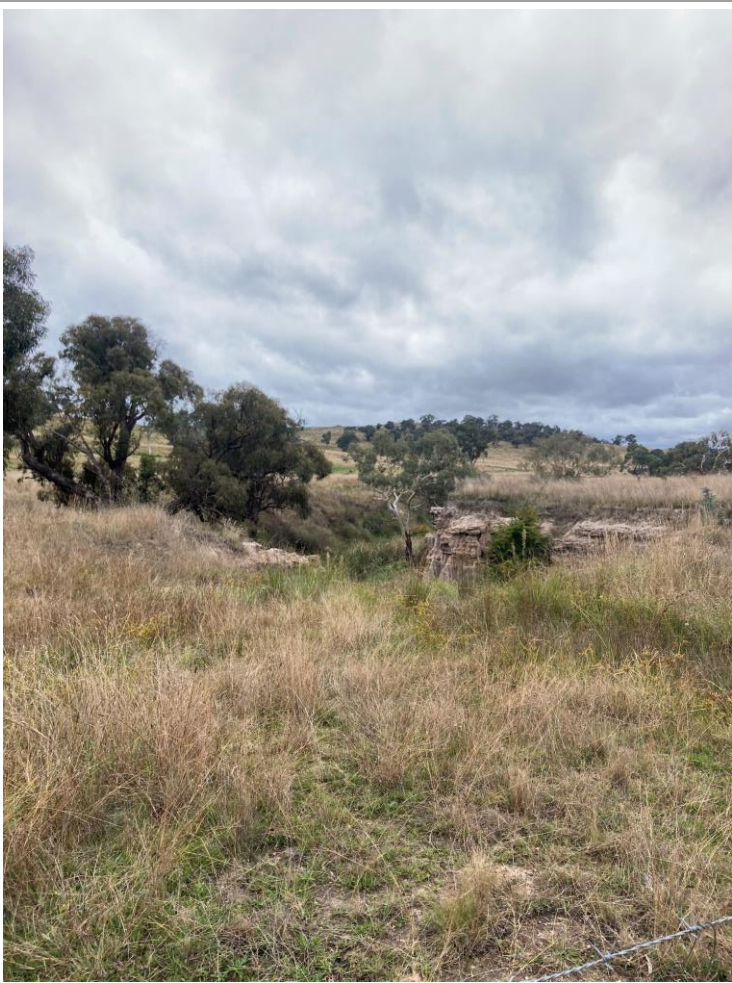
| Description | Photograph |
|---|---|
| <p><b>Photograph 8 - 27 April 2022</b></p> <p>Creek line that draining line leads into. Located north of the site (view to the north)</p> | |

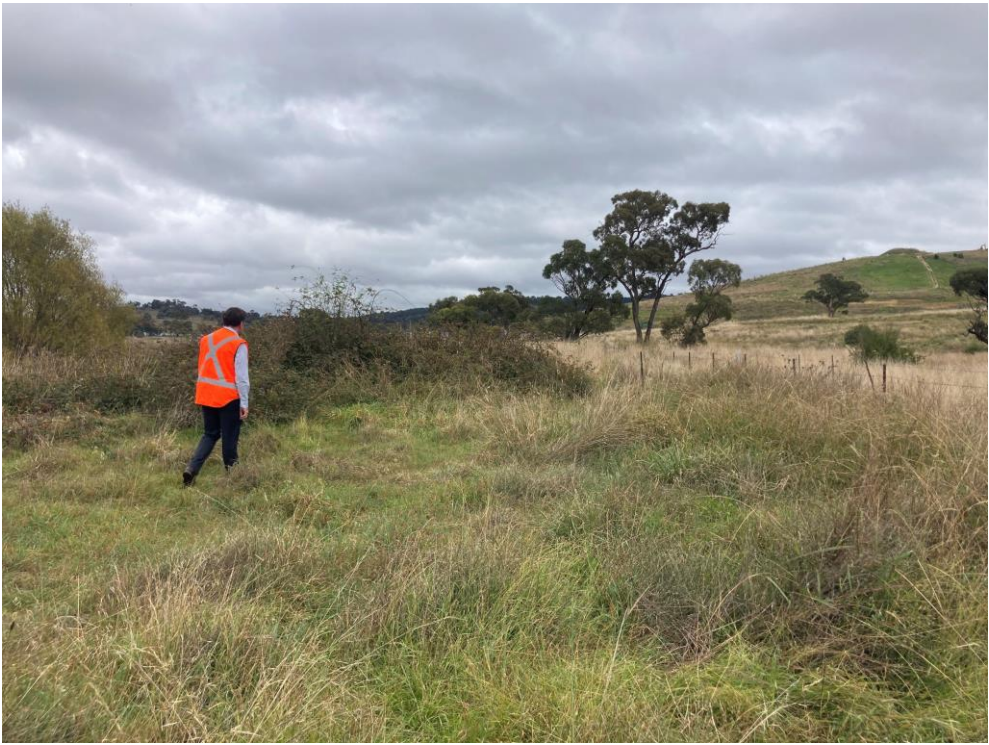
| Description | Photograph |
|---|---|
| <p><b>Photograph 9 - 27 April 2022</b></p> <p>Black berry bush north of the drainage pond, north of site boundary (view to the west)</p> | |

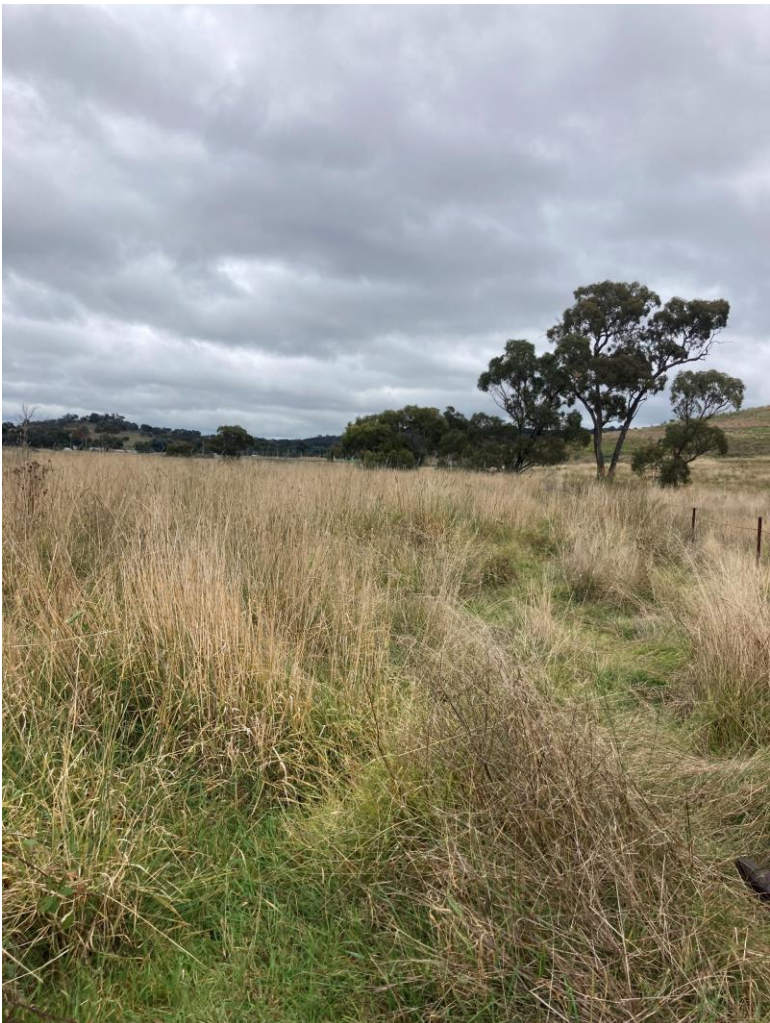
| Description | Photograph |
|---|---|
| <p><b>Photograph 10 - 27 April 2022</b></p> <p>Long grass with kangaroo trails. North of the drainage pond, north of site boundary. Odour of decay (view to the west)</p> | |

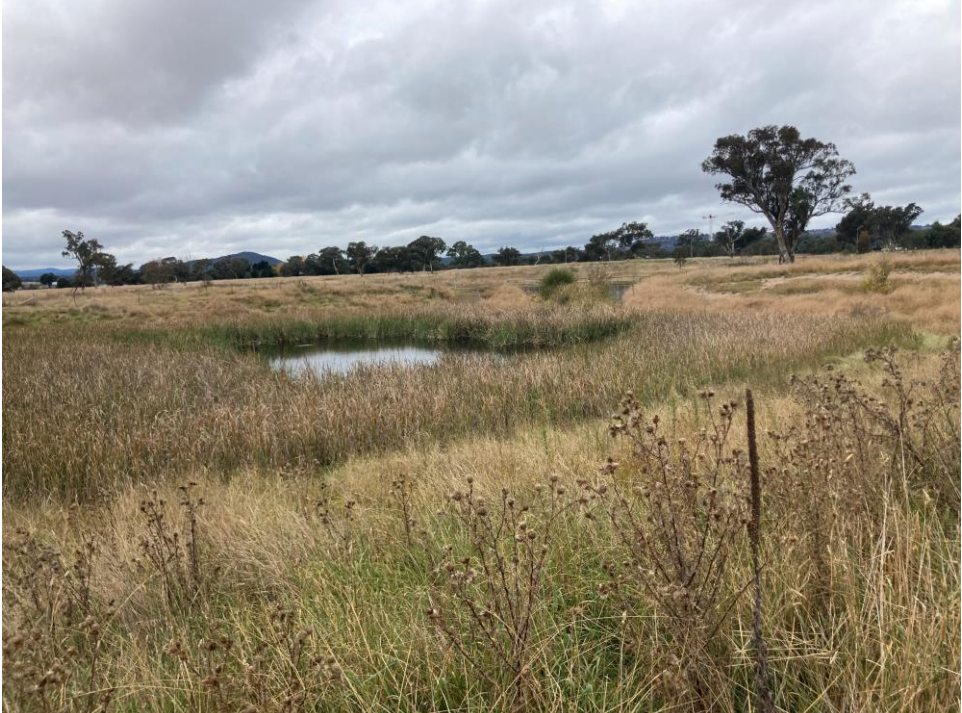
| Description | Photograph |
|---|---|
| <p><b>Photograph 11 - 27 April 2022</b></p> <p>Drainage pond, north of site boundary. No slip observed on the water (view to the east)</p> | <p>A landscape photograph showing a small, calm drainage pond nestled within a field of tall, golden-brown grass and reeds. In the background, a line of trees and distant hills are visible under a heavy, overcast sky. The view is oriented towards the east.</p> |

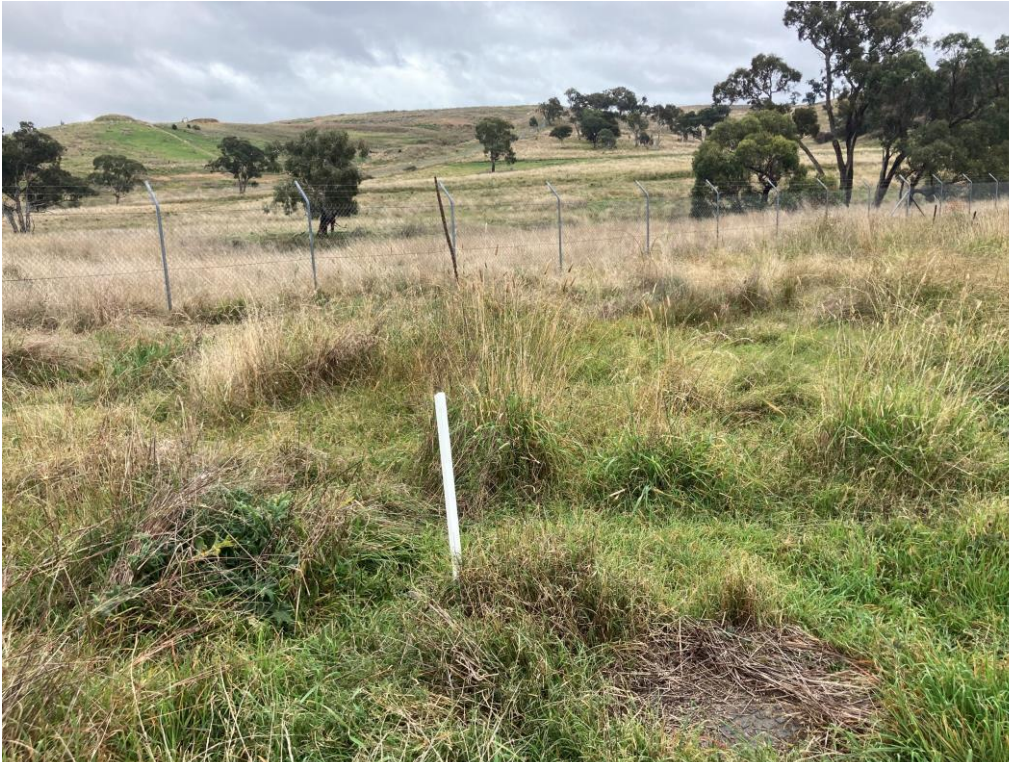
| Description | Photograph |
|---|---|
| <p><b>Photograph 12 - 27 April 2022</b></p> <p>Post and man-hole north west corner of of site south west of drainage pond. (view to the north west)</p> | <p>A photograph of a grassy field with a wire fence running across the middle ground. A single white post is visible in the foreground. The background features rolling hills and scattered trees under a cloudy sky. The view is oriented towards the north west.</p> |

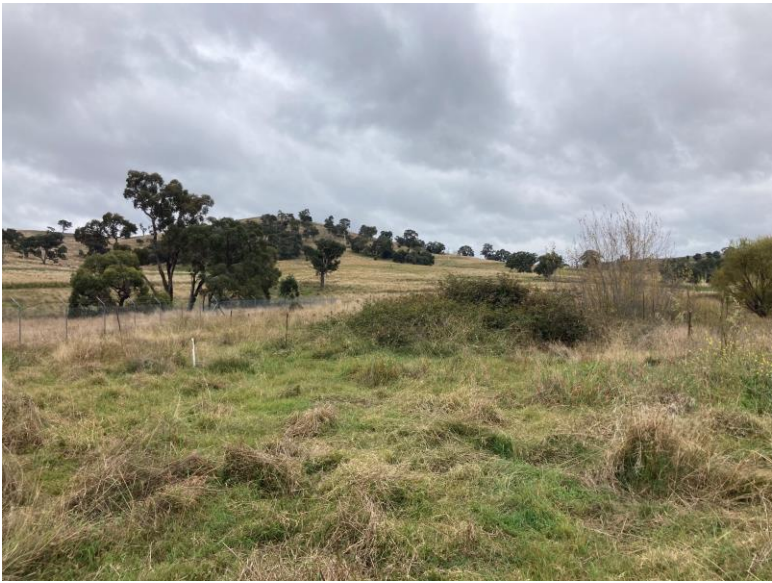
| Description | Photograph |
|---|---|
| <p><b>Photograph 13 - 27 April 2022</b></p> <p>Blackberries clump, with view of photograph 12.</p> | |

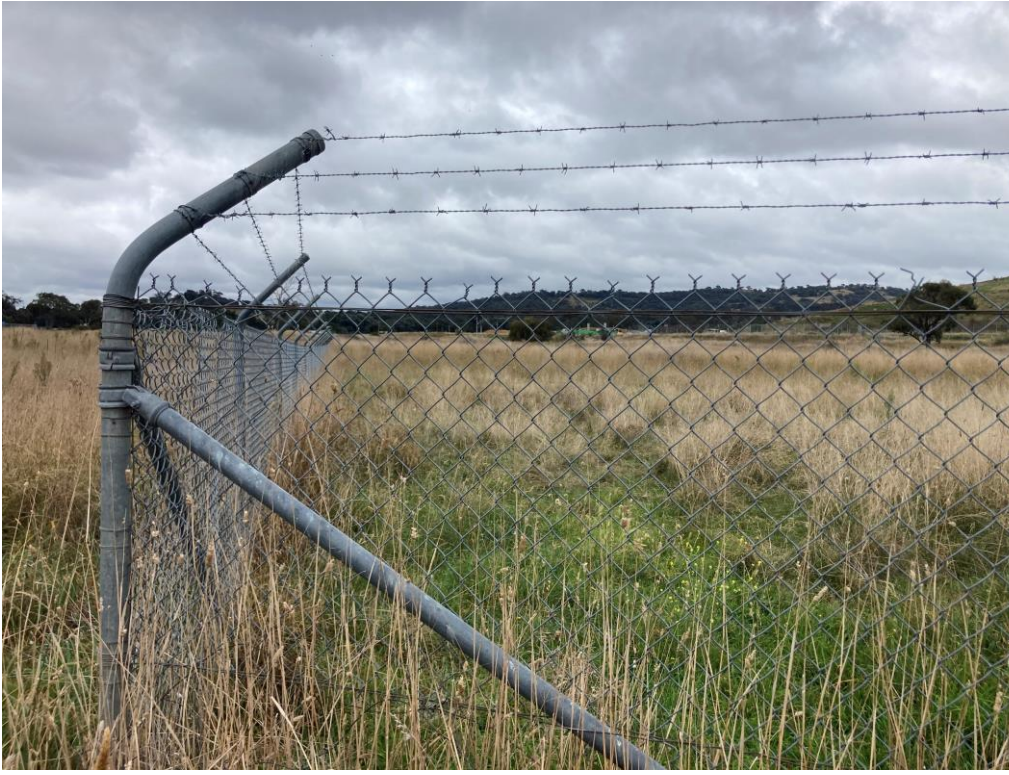
| Description | Photograph |
|---|---|
| <p><b>Photograph 14 - 27 April 2022</b></p> <p>Fence line blocking access to the western edge of site. (view to the west)</p> | |

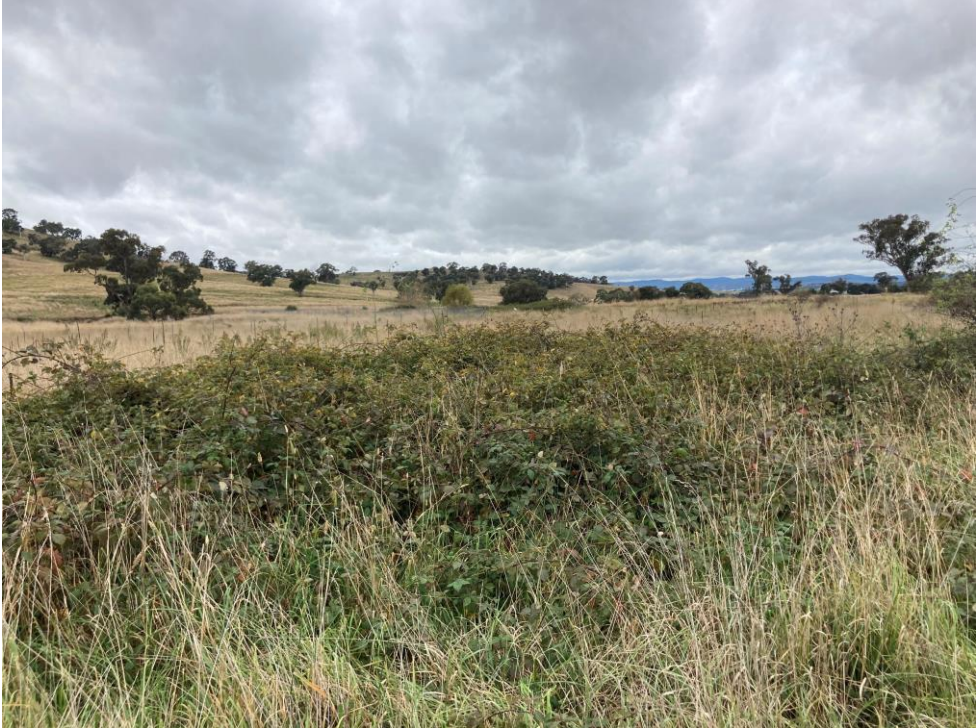
| Description | Photograph |
|---|---|
| <p><b>Photograph 15 - 27 April 2022</b></p> <p>Blackberries clump. Location at the north west of site approximately 10m from fence line running west (view facing north west)</p> | |

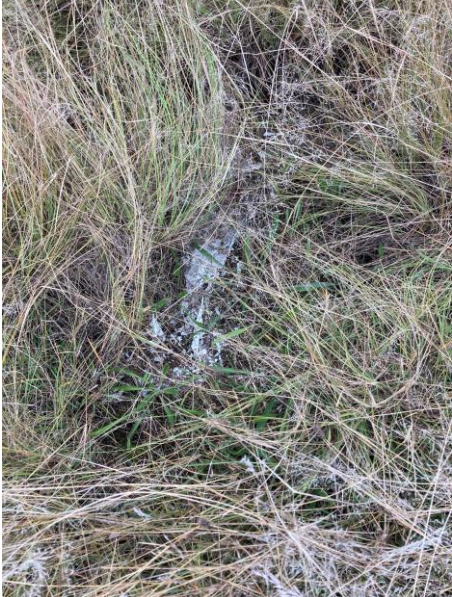
| Description | Photograph |
|---|---|
| <p><b>Photograph 16 - 27 April 2022</b></p> <p>Plastic debris observed on the ground, ~10m from south west boundary line</p> | |

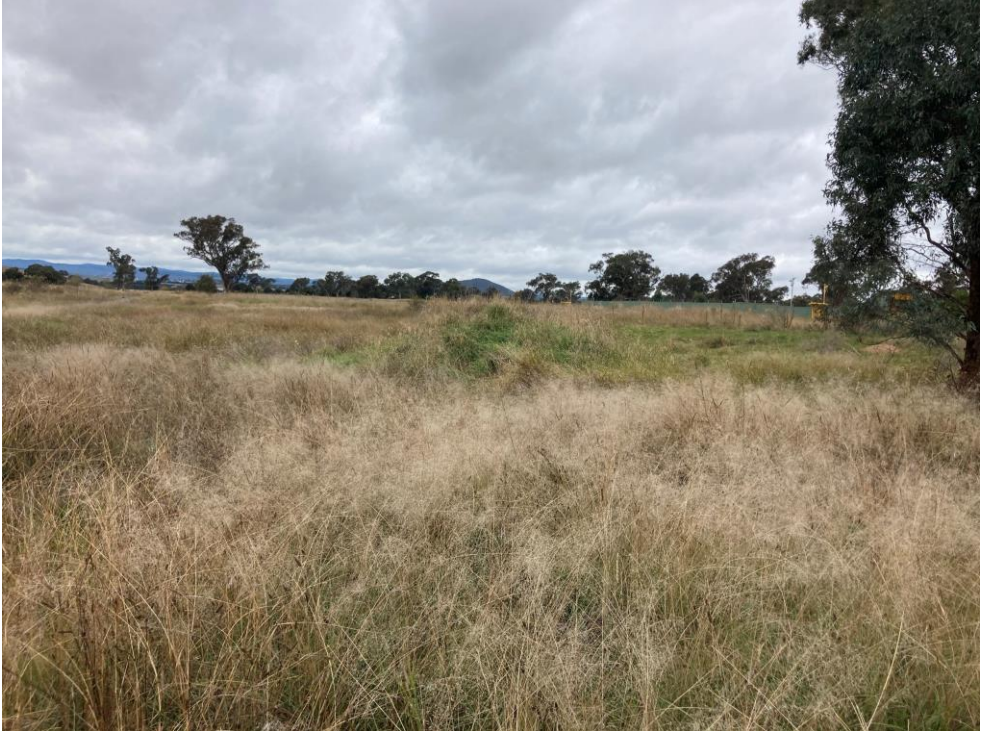
| Description | Photograph |
|---|---|
| <p><b>Photograph 17 - 27 April 2022</b></p> <p>Uncontrolled fill, west of south of site, north east of large tree next to gravelled area (view facing north)</p> | |

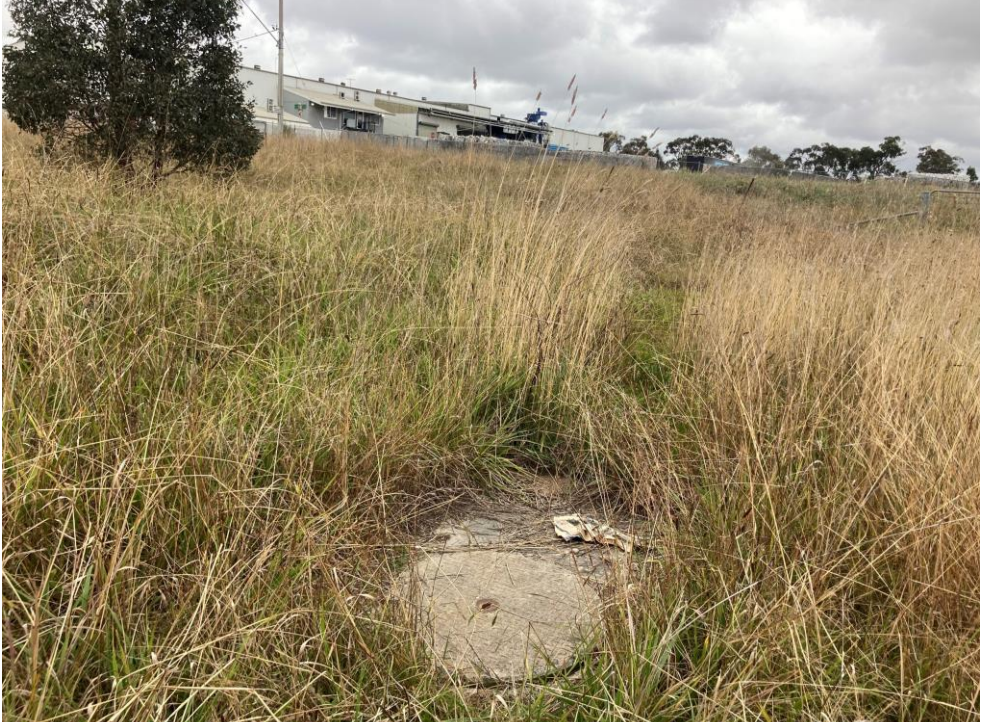
| Description | Photograph |
|---|---|
| <p><b>Photograph 18 - 27 April 2022</b></p> <p>Manhole ~ 10m from southwestern site boundary, north west of gravelled area (view to the south east)</p> | |

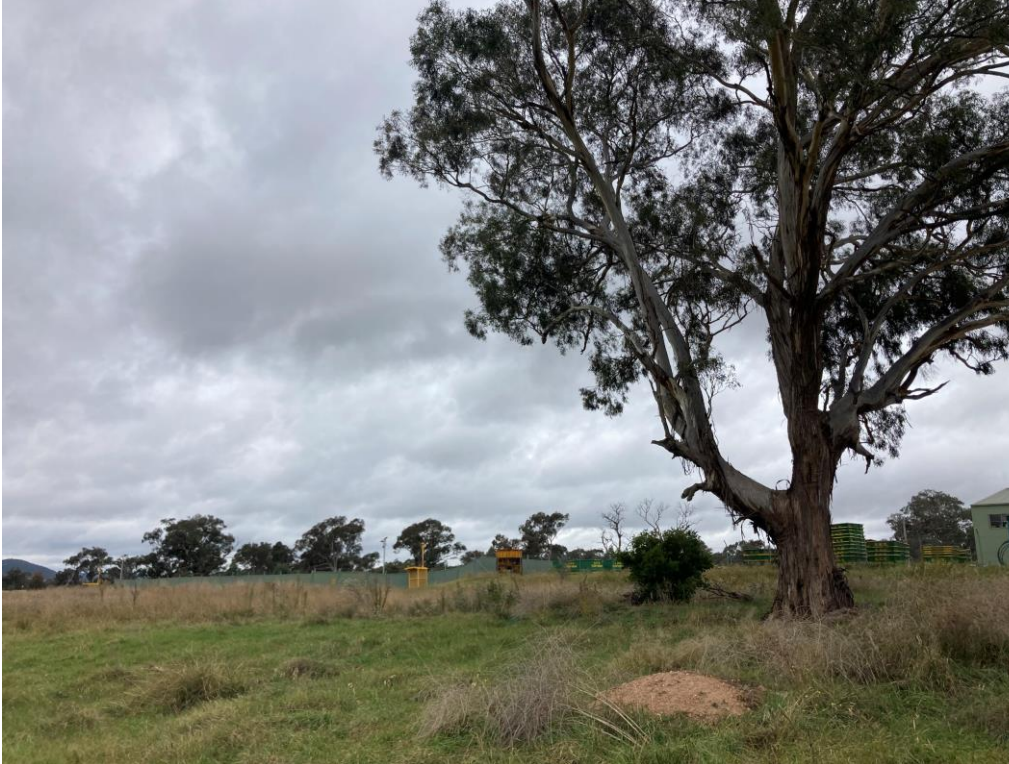
| Description | Photograph |
|---|---|
| <p><b>Photograph 18 - 27 April 2022</b></p> <p>More recent stockpile, south west of site, west of large tree and gravel area (View to the north)</p> | |

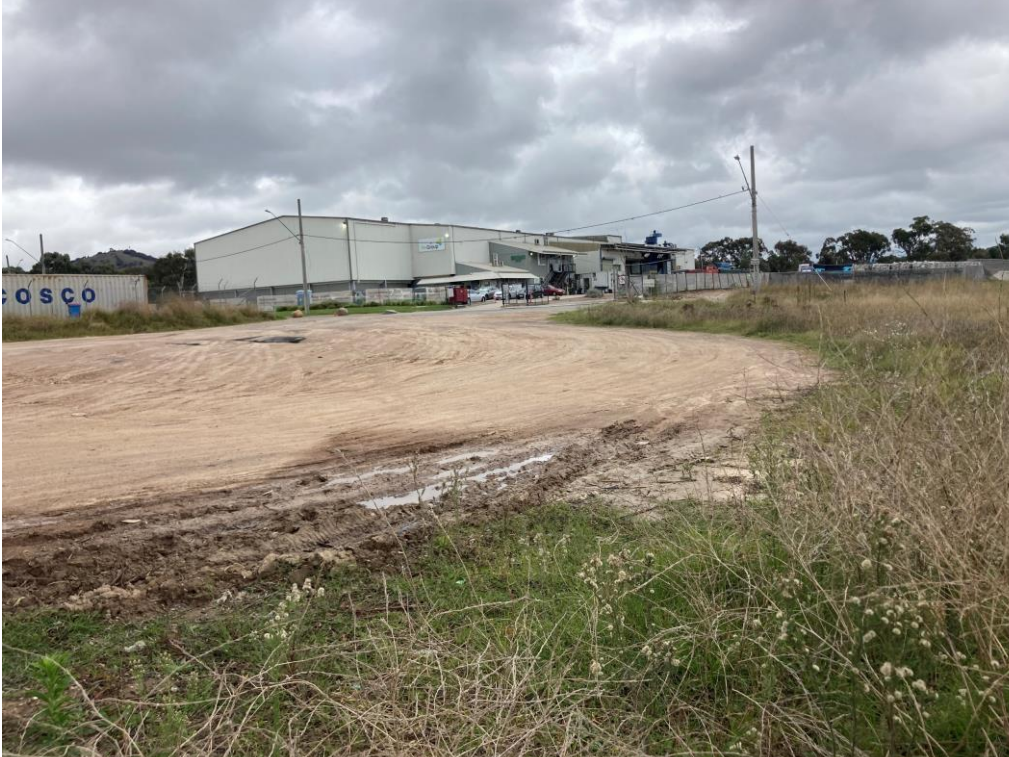
| Description | Photograph |
|---|---|
| <p><b>Photograph 19 - 27 April 2022</b></p> <p>Graveled turn around area, patch of bitumen in the middle (view facing south)</p> | |

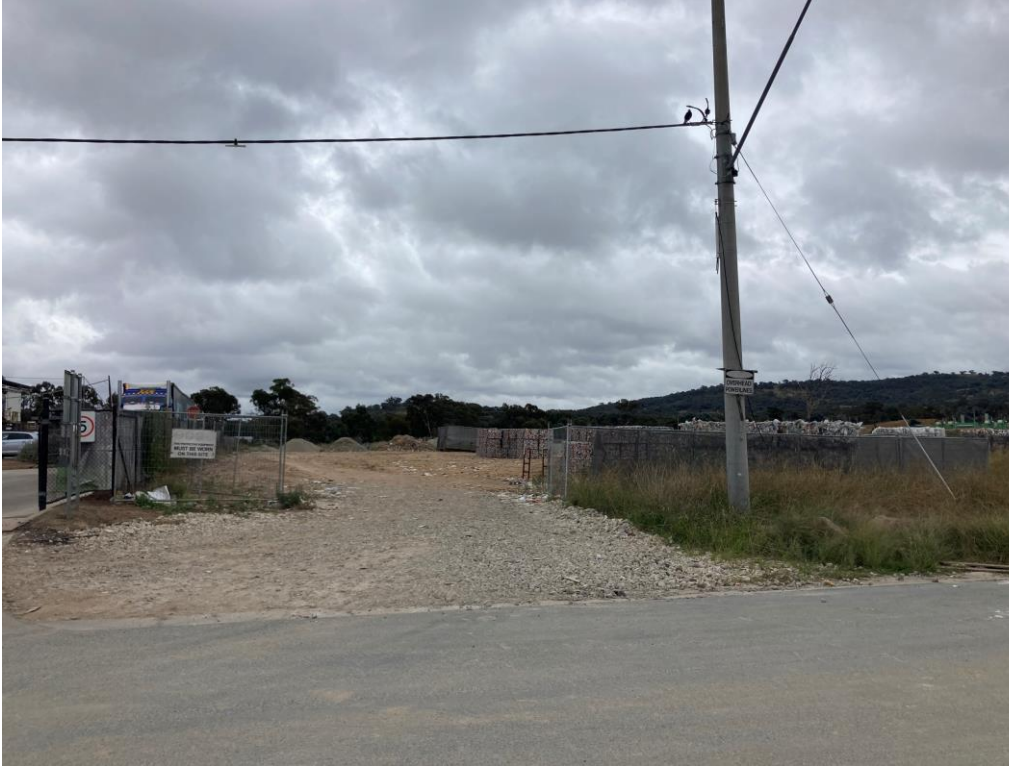
| Description | Photograph |
|---|---|
| <p><b>Photograph 20 - 27 April 2022</b></p> <p>Recycling road, offsite (view to the southwest).</p> | |

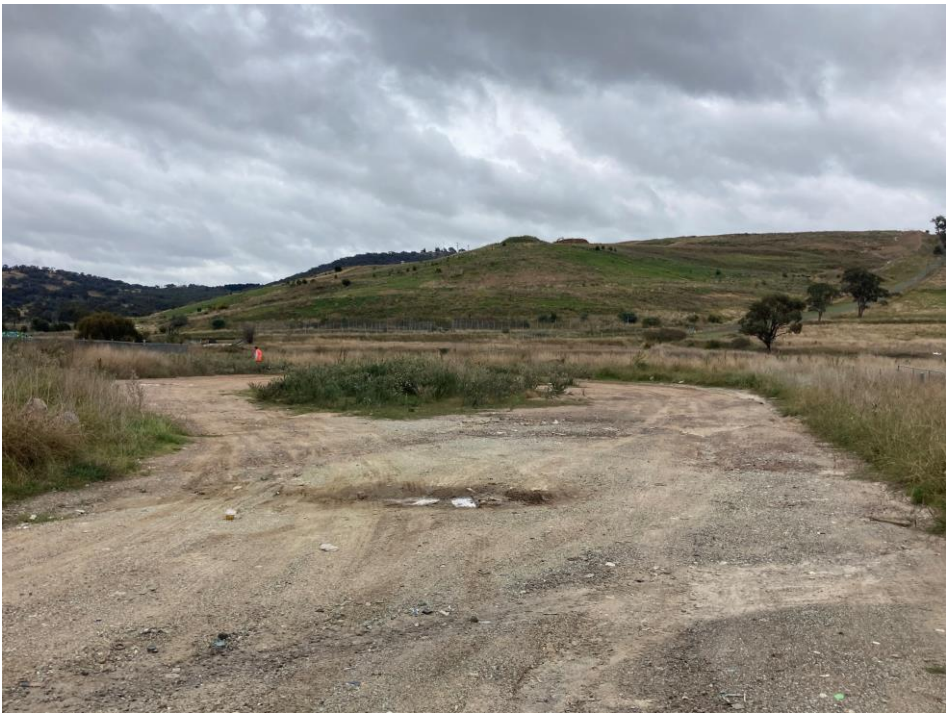
| Description | Photograph |
|---|---|
| <p><b>Photograph 21 - 27 April 2022</b></p> <p>Recycling Road, offsite (view to the northwest)</p> | |

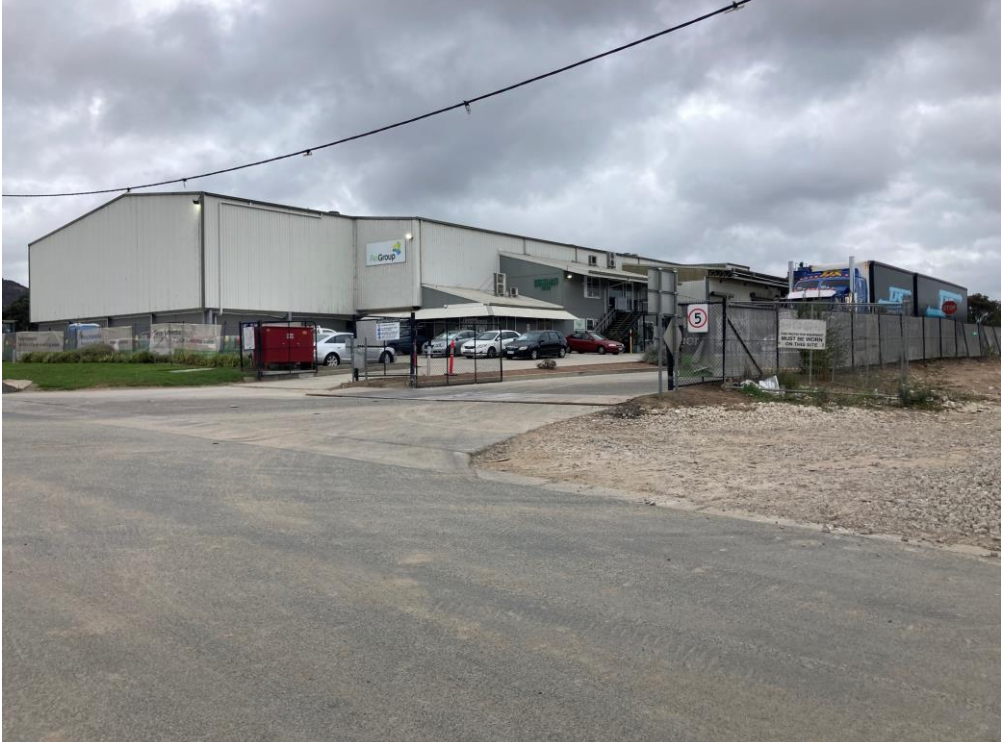
| Description | Photograph |
|---|---|
| <p><b>Photograph 21 - 27 April 2022</b></p> <p>Recycling Road, offsite (view to the south)</p> | |

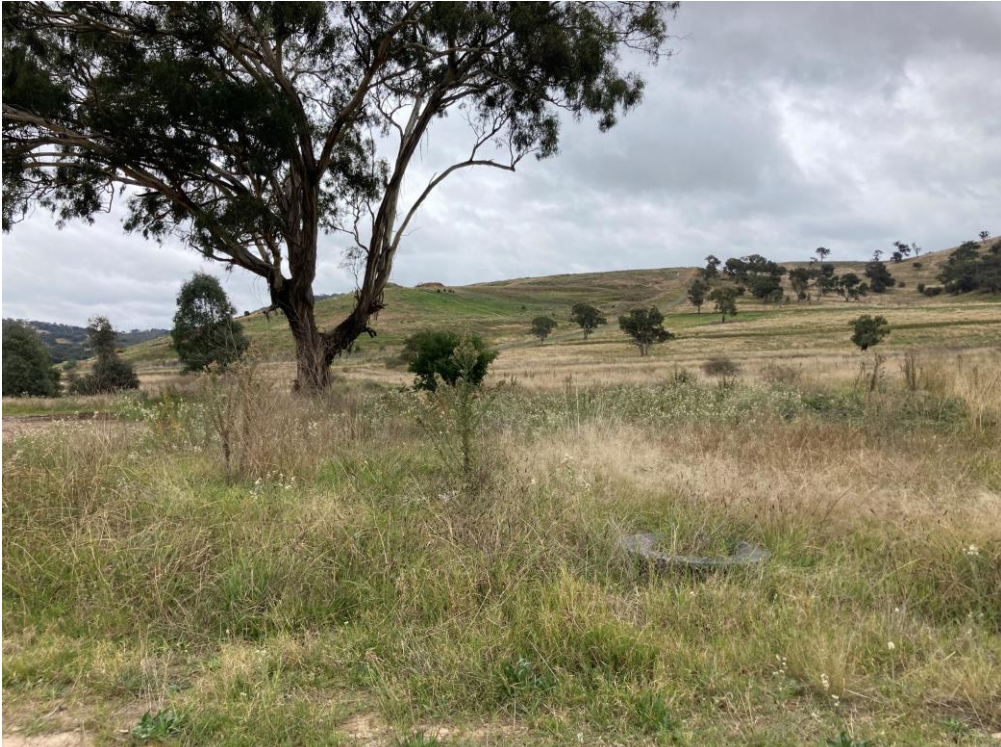
| Description | Photograph |
|---|---|
| <p><b>Photograph 22 - 27 April 2022</b></p> <p>Truck tyres (2) in south section of site, north of large tree and graveled area (view to the northwest)</p> | |
