# Hume Food Organics and Garden Organics Facility

## Preliminary Site Investigation

Transport Canberra and City Services

2 June 2023

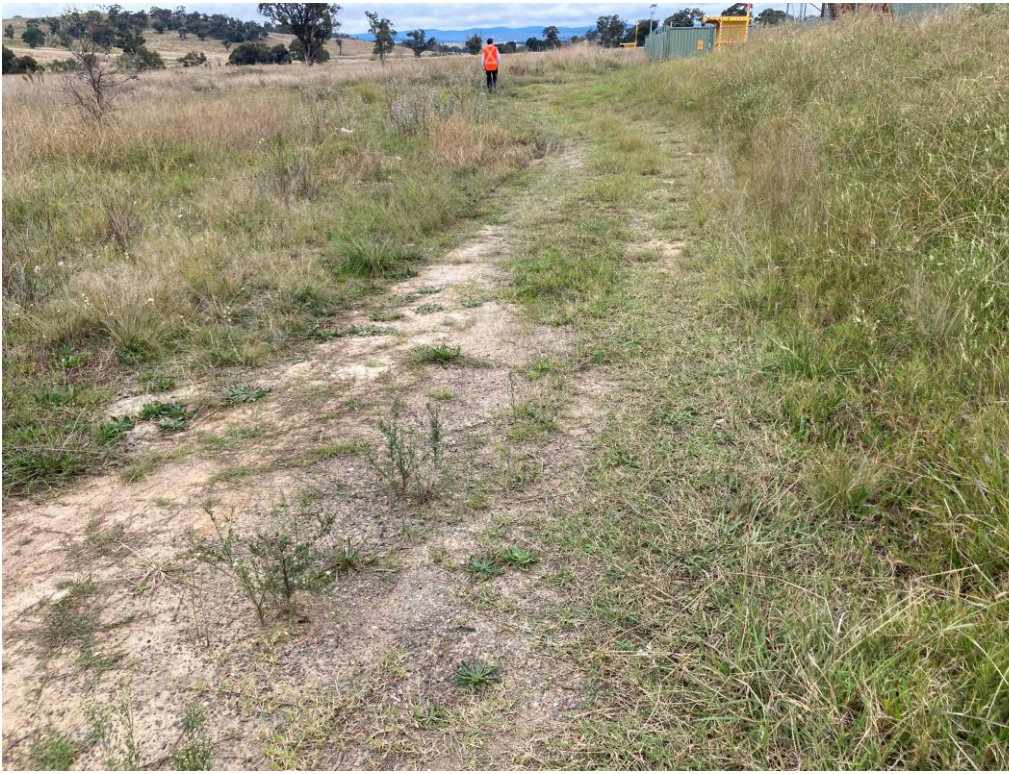
| Description | Photograph |
|---|---|
| <p><b>Photograph 23 - 27 April 2022</b></p> <p>Dirt road leading up southern boundary to enclosed area to the east (view to the north)</p> | <p>A photograph showing a dirt road leading up a grassy slope. In the background, a person in an orange shirt is visible near a yellow container. The view is towards the north.</p> |

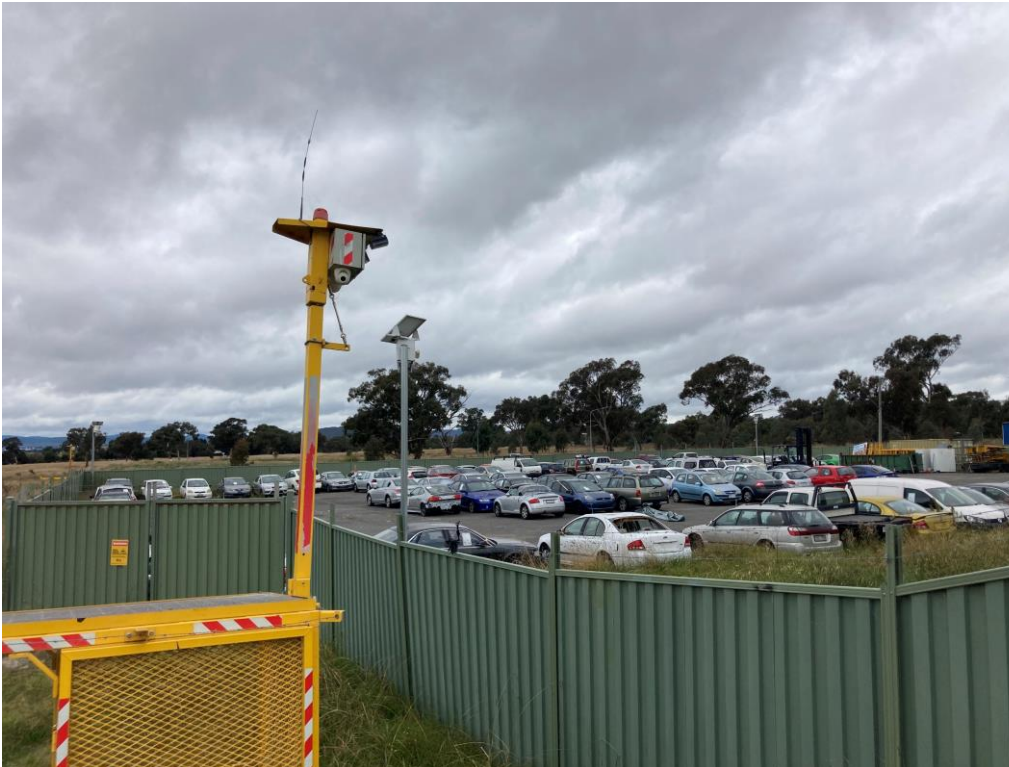
| Description | Photograph |
|---|---|
| <p><b>Photograph 23 - 27 April 2022</b></p> <p>Fenced area to the south east of site. Double door gate and security tower. (view to the north east)</p> | <p>A photograph showing a fenced area with a double door gate and a security tower. The area is filled with parked cars. The view is towards the north east.</p> |

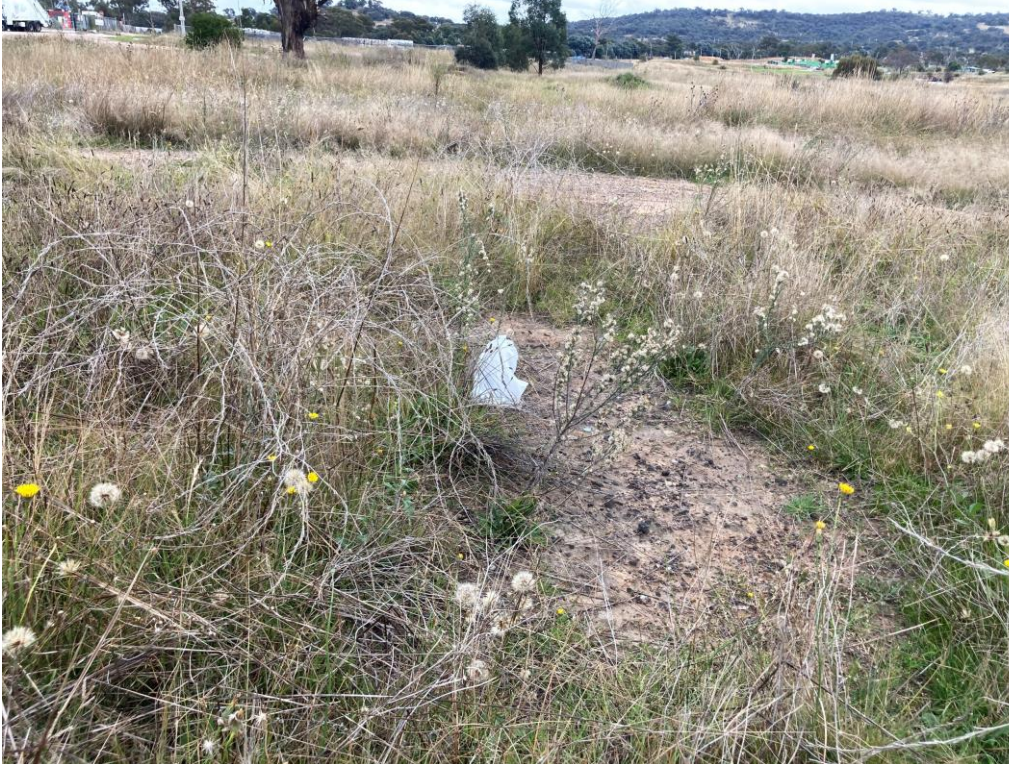
| Description | Photograph |
|---|---|
| <p><b>Photograph 24 - 27 April 2022</b></p> <p>Spot of no growth located ~20 m west of fenced area</p> | <p>This photograph shows a field of tall, dry, yellowish-brown grass. In the center, there is a patch of bare, brownish ground. A white plastic bag is lying on this patch. The background shows a line of trees and a distant hill under a clear sky.</p> |

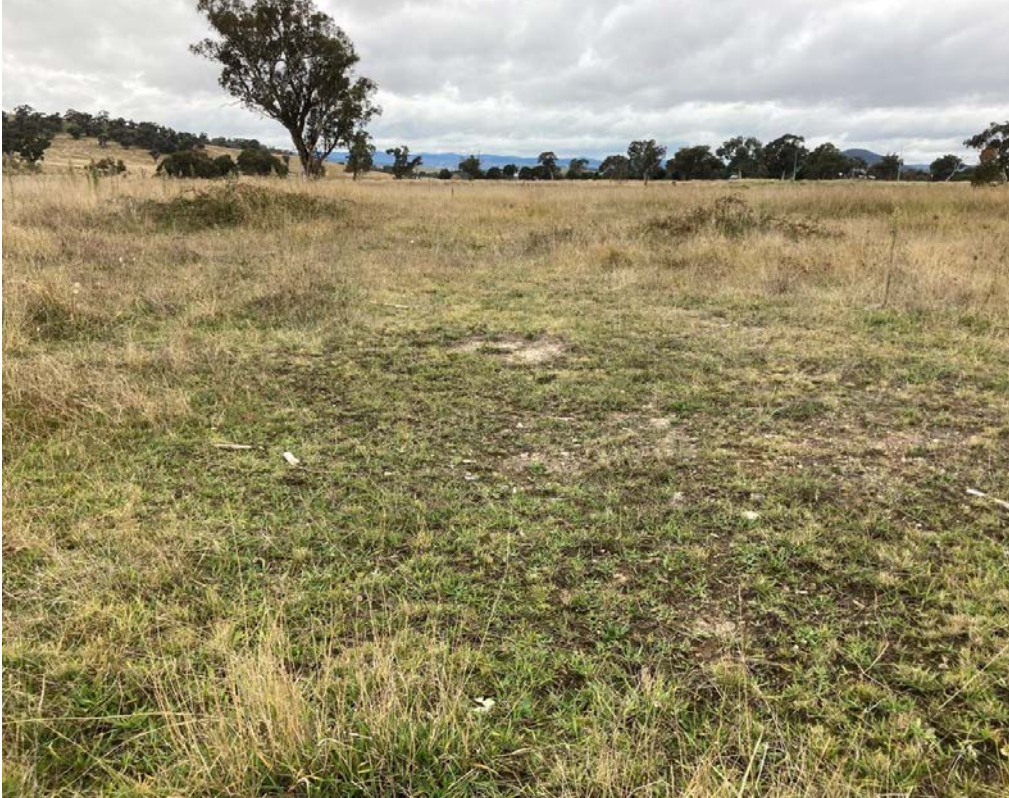
| Description | Photograph |
|---|---|
| <p><b>Photograph 25 - 27 April 2022</b></p> <p>Spot of low vegetation and rubble / rubbish on the ground, ~20 m west of fenced area (view to the north)</p> | <p>This photograph shows a wide view of a field with low, green and yellowish vegetation. In the background, there is a large, dark tree on the left, a line of smaller trees in the center, and a distant hill under a cloudy sky.</p> |

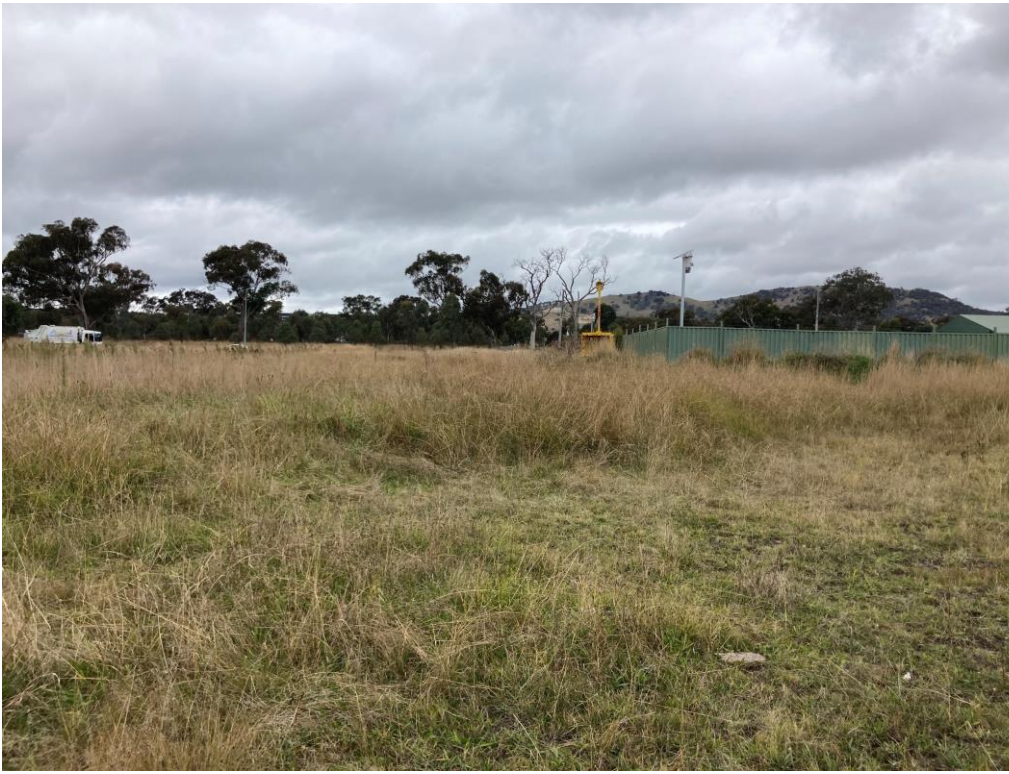
| Description | Photograph |
|---|---|
| <p><b>Photograph 25 - 27 April 2022</b></p> <p>North corner of fenced area (view to the east)</p> | |

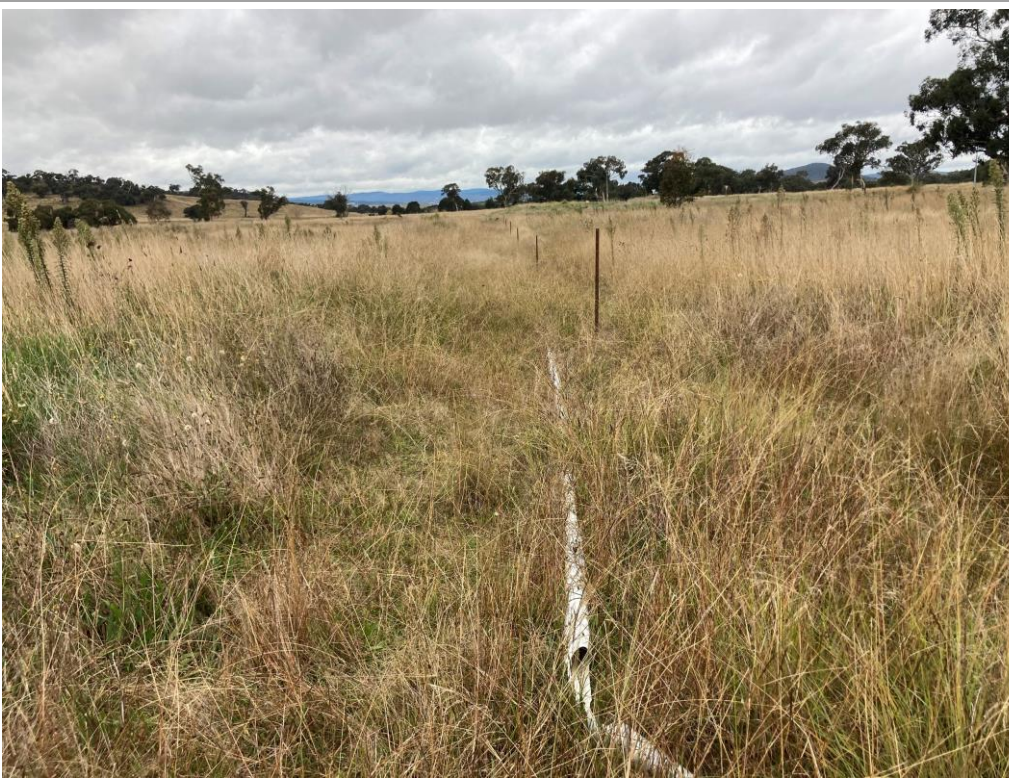
| Description | Photograph |
|---|---|
| <p><b>Photograph 25 - 27 April 2022</b></p> <p>Broken pipe and steaks leading north west of site. (view to the north west)</p> | |

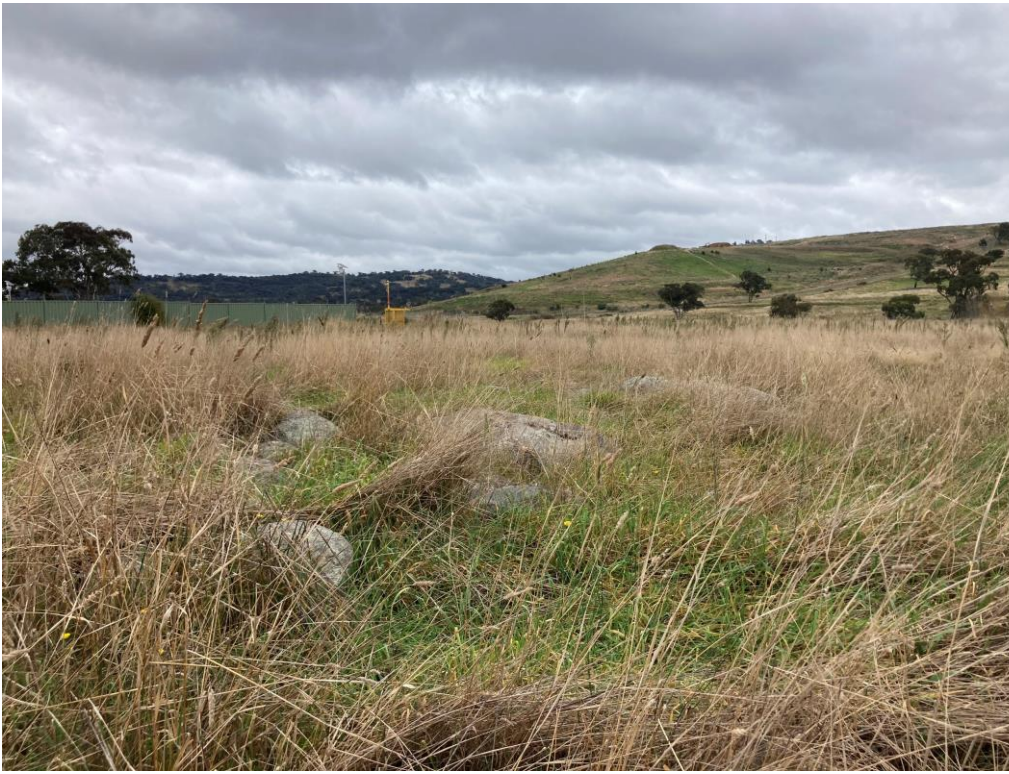
| Description | Photograph |
|---|---|
| <p><b>Photograph 25 -<br/>27 April 2022</b></p> <p>Boulders located to the north of fenced area (view to the west)</p> | |

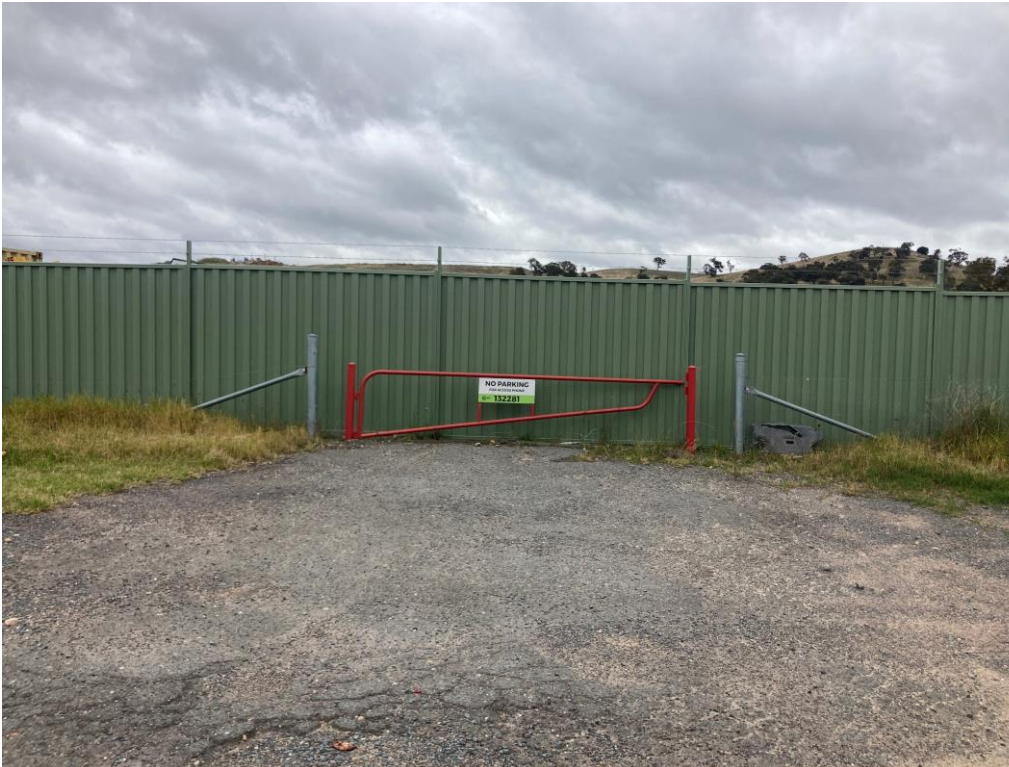
| Description | Photograph |
|---|---|
| <p><b>Photograph 26 -<br/>27 April 2022</b></p> <p>Fenced area gate (one of two) off John Cory Road (view to the west)</p> | |

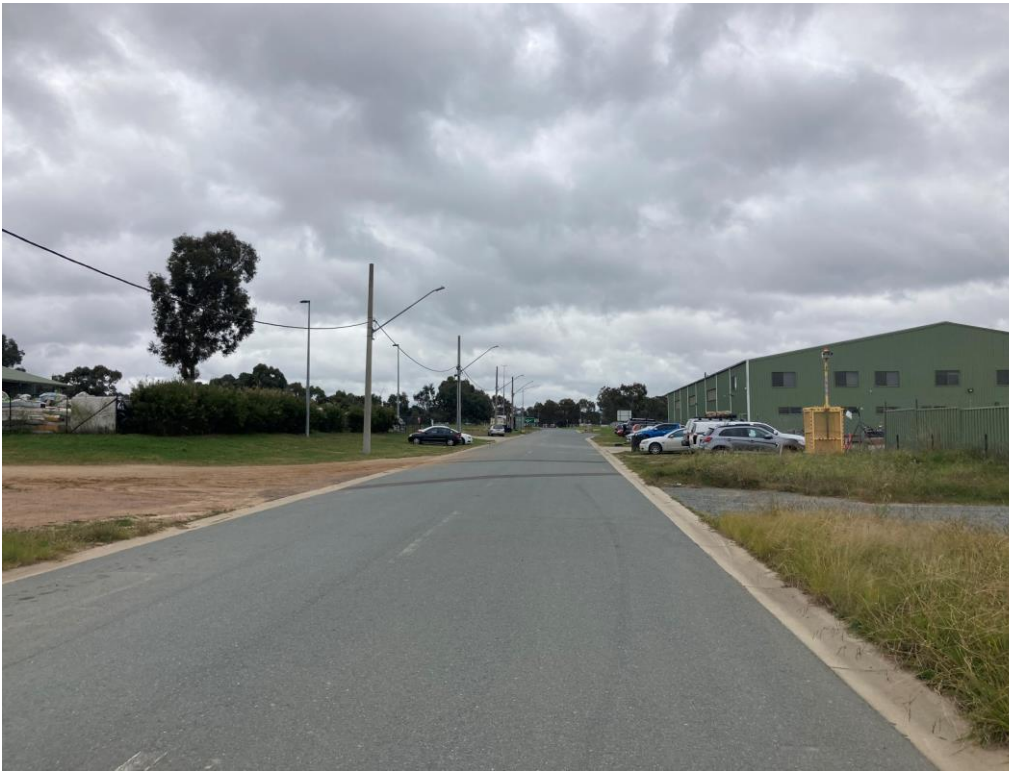
| Description | Photograph |
|---|---|
| <p><b>Photograph 27 -<br/>27 April 2022</b></p> <p>John Cory Road<br/>(view to the south<br/>west)</p> | |
