Advice on EIS

Blocks 9 & 11 Section 8, Fyshwick

Capital Recycling Solutions (CRS)

Prepared for Capital Recycling
Solutions (CRS)
Project Name Blocks 9 & 11 Section 8,
Fyshwick
File Reference Design Acceptance Report
Job Reference 50518021
Date 8 February 2018

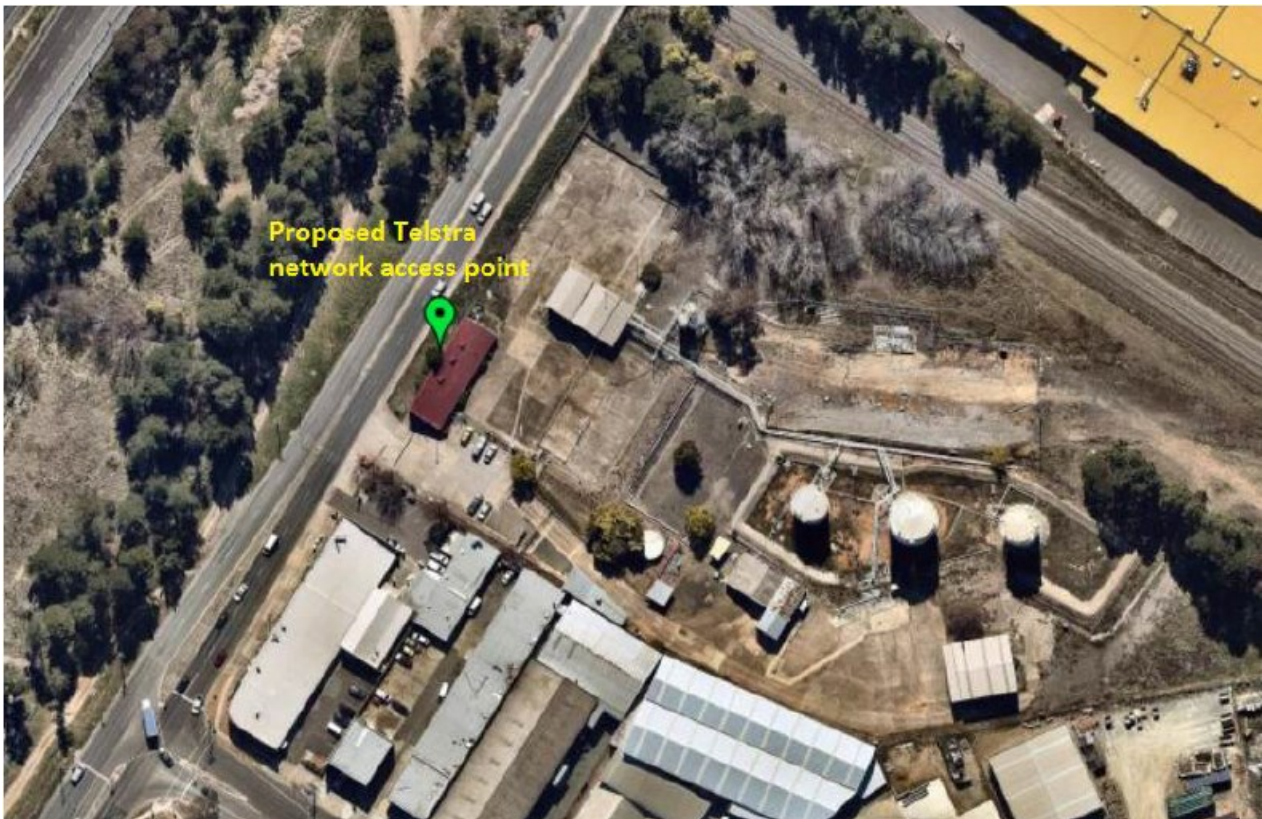
Figure 4-1 Proposed Telstra Network Access Point (Source: Telstra)

The civil consultant and contractor will liaise with Telstra Network Integrity team during detailed design and construction to ensure all existing Telstra asset affected by development are protected.

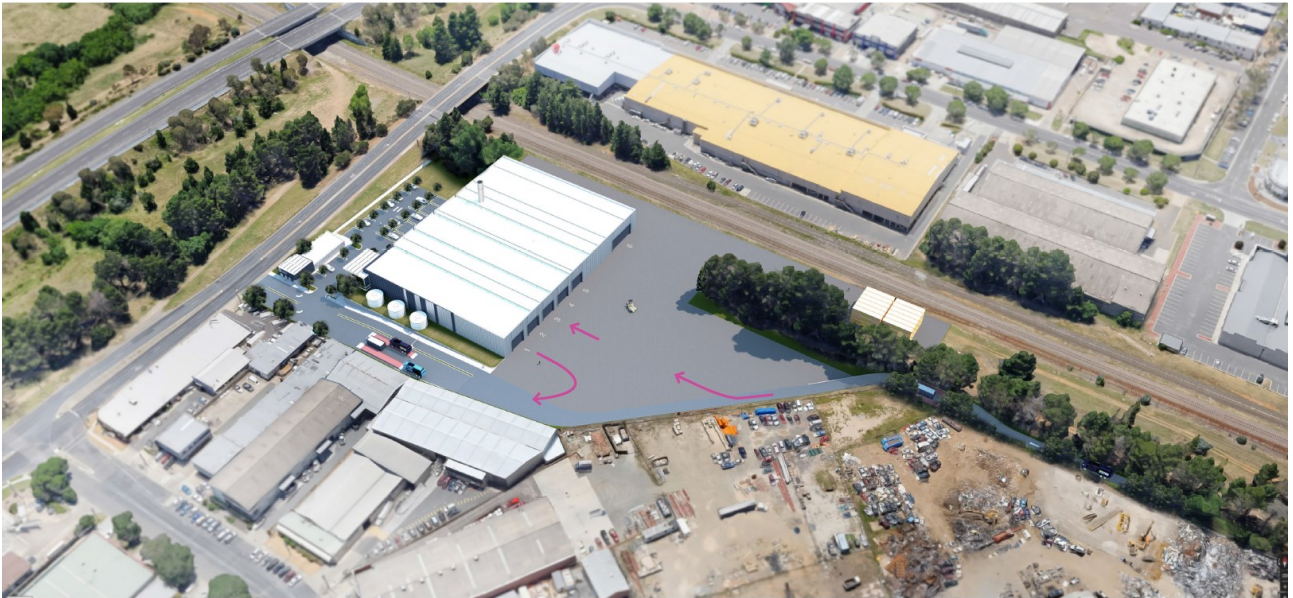
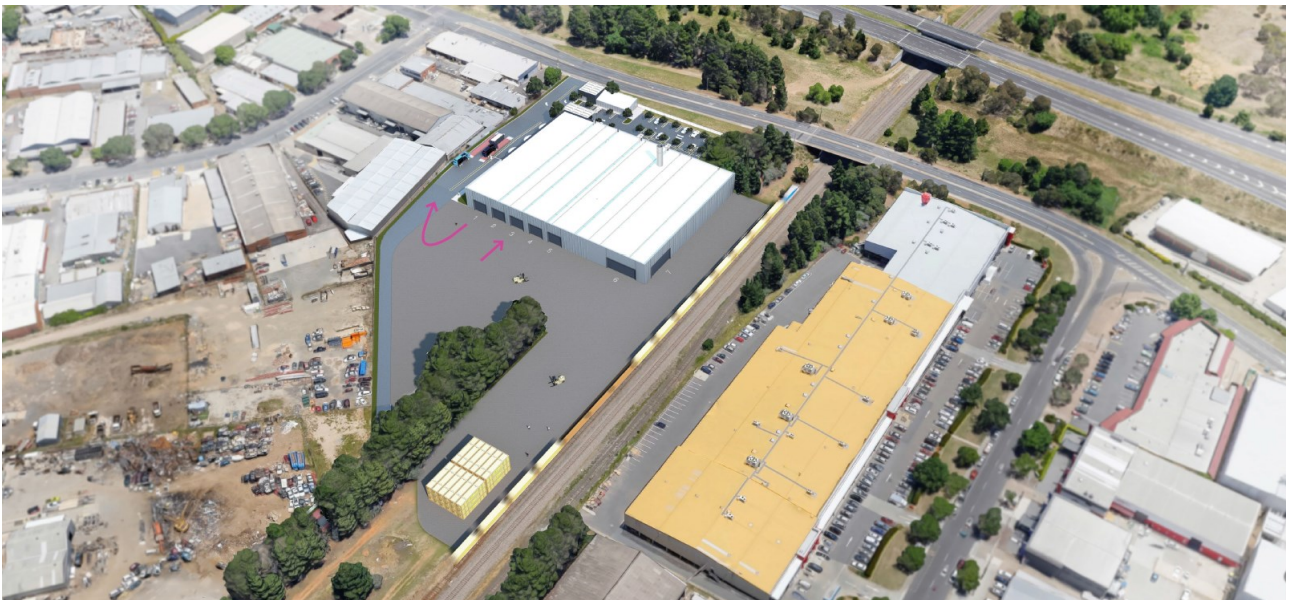
Figure 10-2 Conceptual Vehicle Movement Plan

A detailed Vehicle Movement Plan will be a part of detailed design, including required traffic control signage and pavement marking.

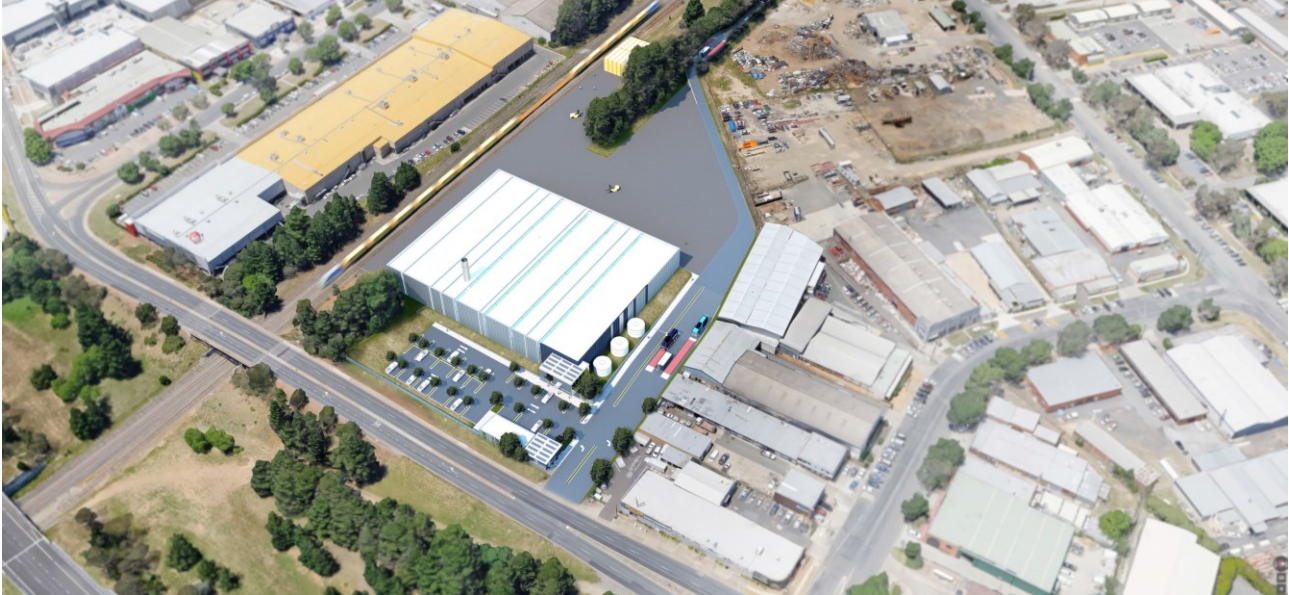
Figure 10-3 Loading and Parking

An on-site carpark is proposed west of the site for light vehicles for employees and visitors. Heavy vehicles enter the site continuously for drop-off only, unloading will take place within MRF shed, no other loading / parking area is required. Packed waste from the site will be transported by rail; the rail side hardstand is the designated forklift-operating zone, to load on to trains.

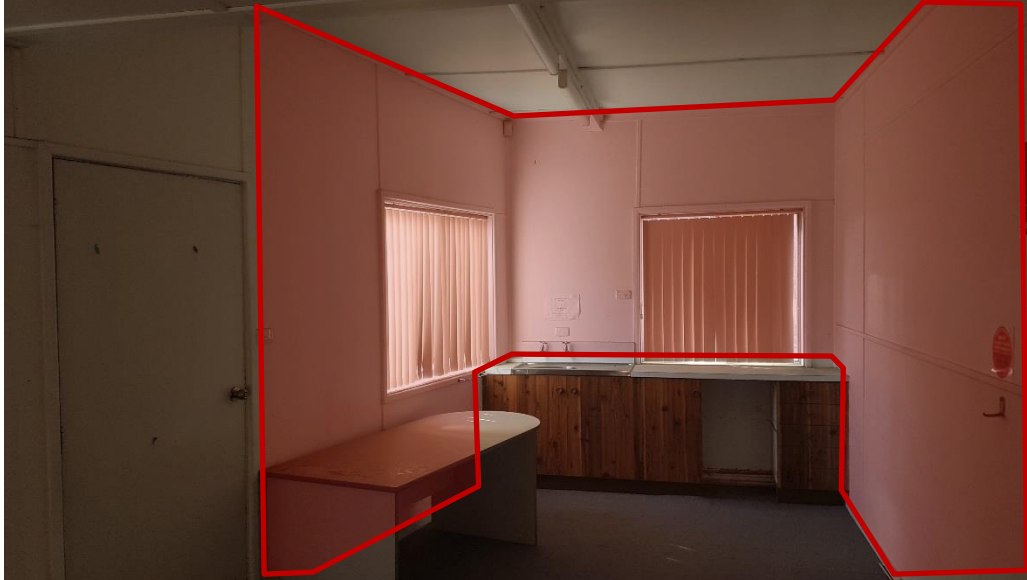
Photograph A1
Store Office
Wall sheet to SE end of building

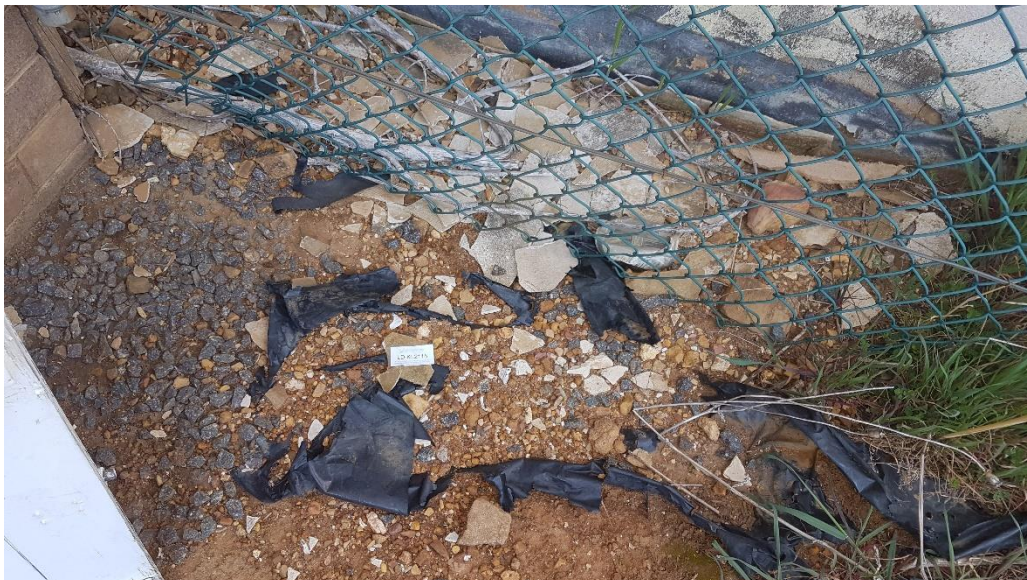
Photograph A2
Around store office
External sheet debris (mixed with non-asbestos material)

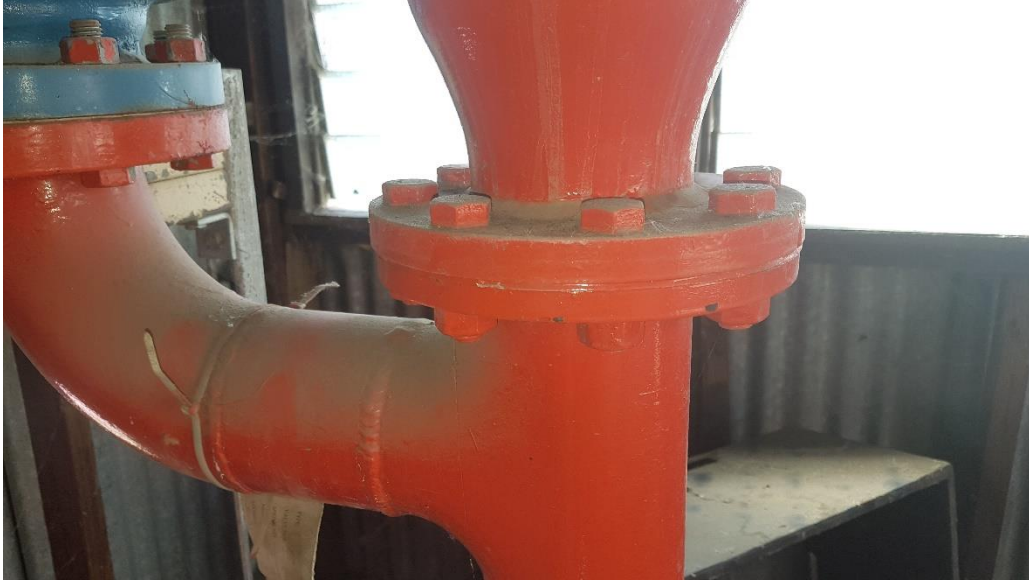
Photograph A3
Fire pump shed
Pipe flange joints

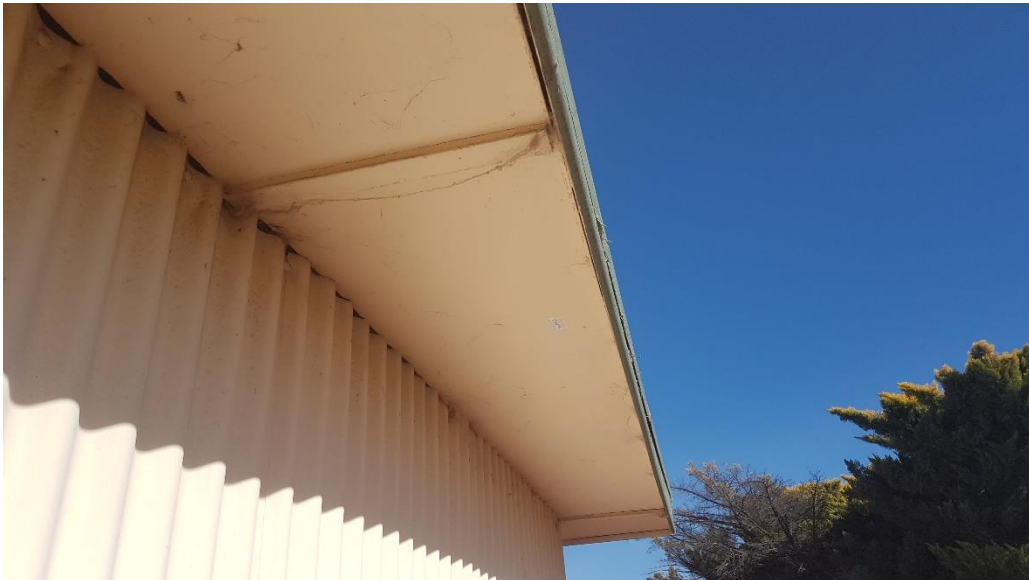
Photograph A4
Fire pump shed
Eave sheets

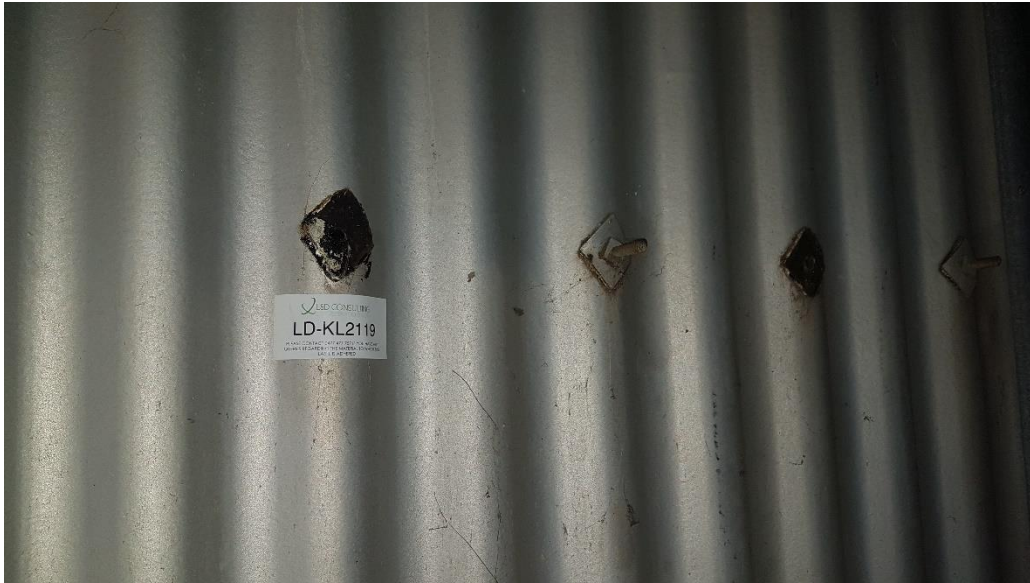
Photograph A5
Store shed (rear)
Bitumen layer beneath tin screws

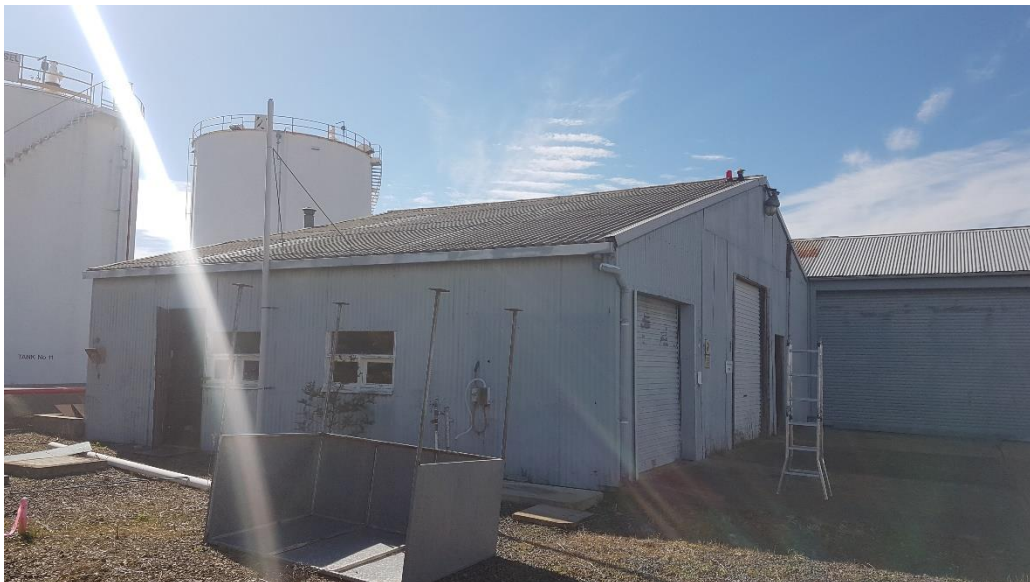
Photograph A6
Store shed (front)
Corrugated sheet roof

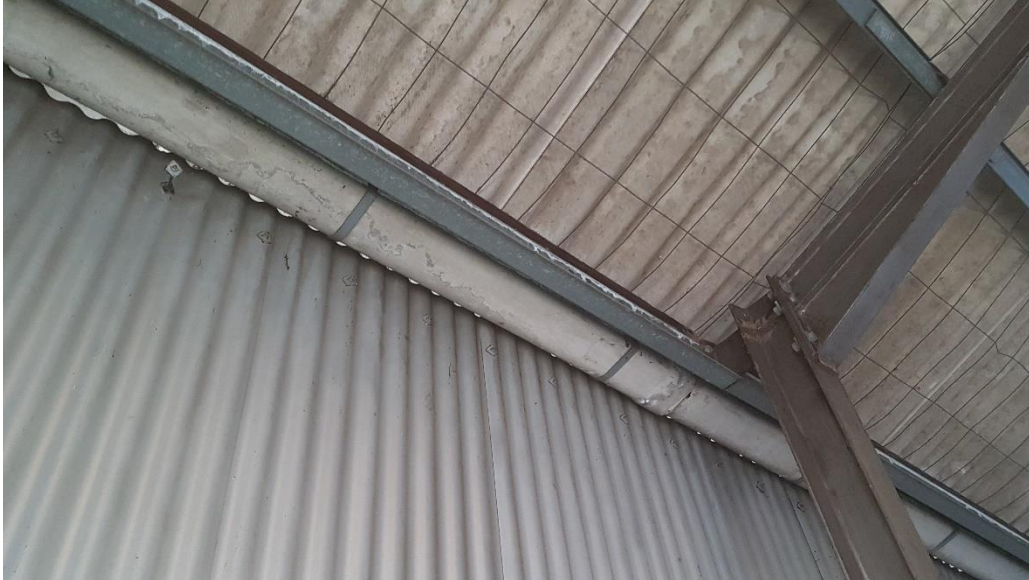
Photograph A7
Store shed (front)
Guttering to roof

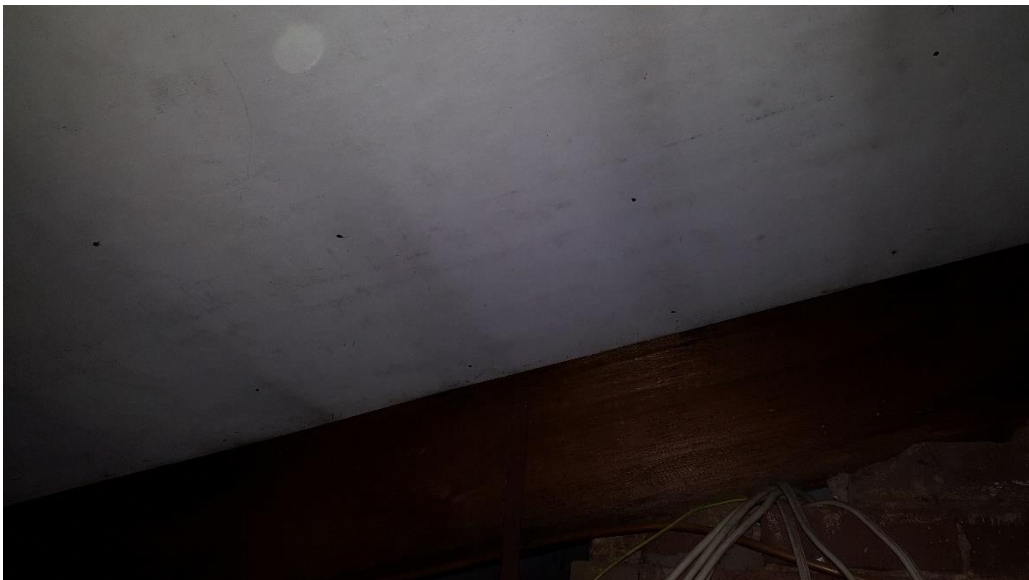
Photograph A8
Main Office
Sheet lining to ceiling void

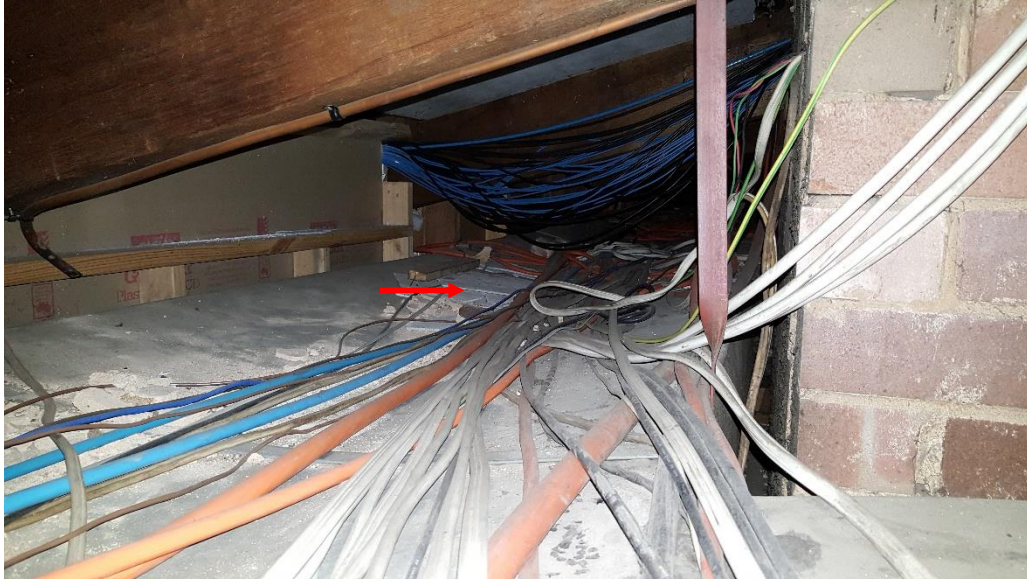
Photograph A9
Main Office
Sheet debris to ceiling void

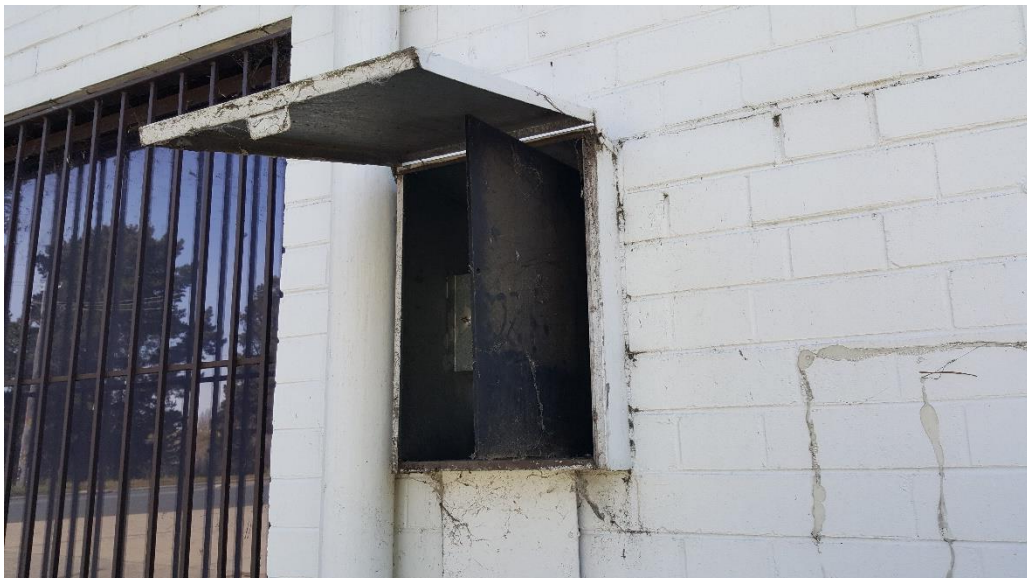
Photograph A10
Main Office
Switchboard backing panel

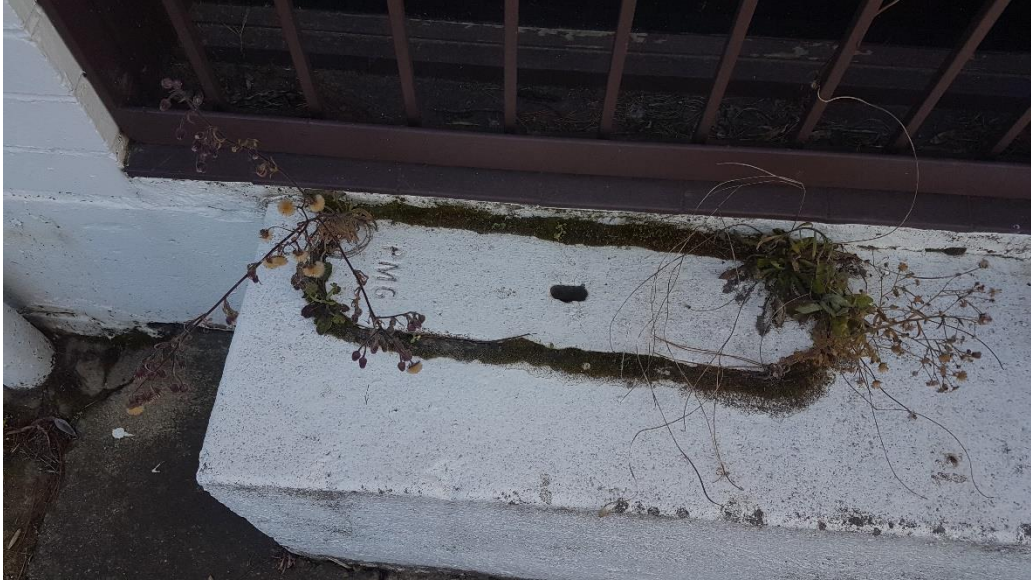
Photograph A11
Various
PMG pits

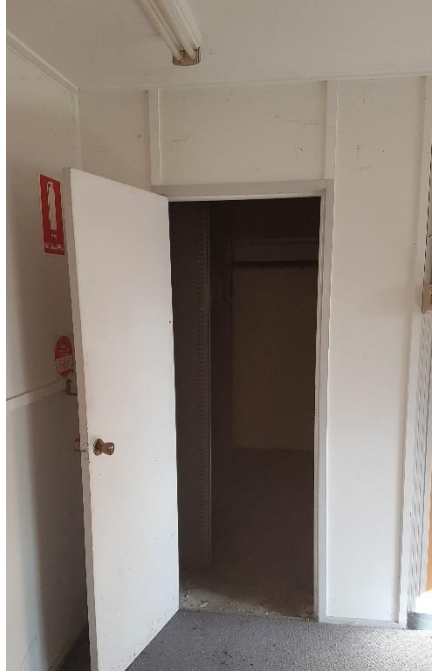
Photograph NA1

Wall sheet around doorway to storeroom

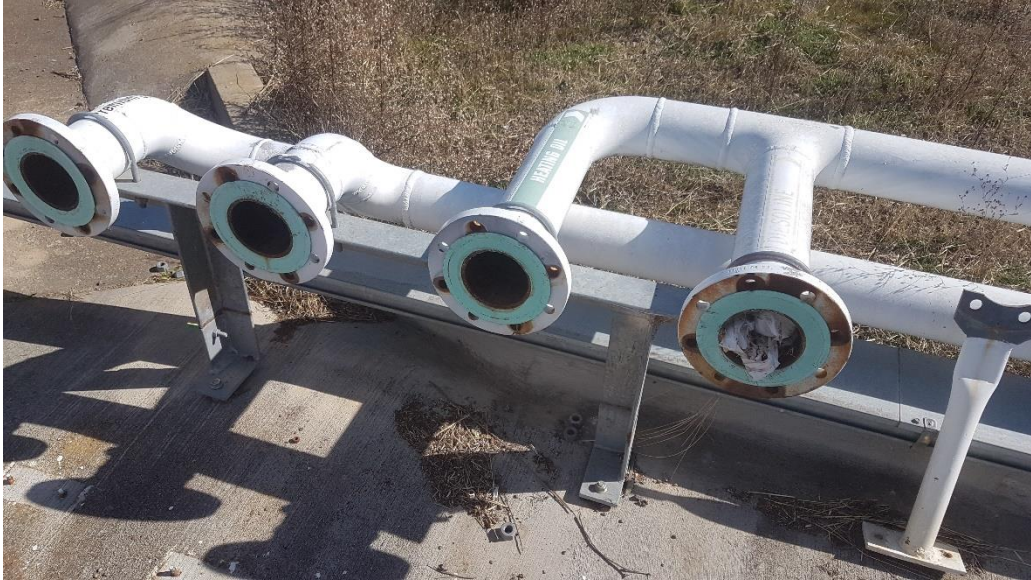
Photograph NA3
Pipe flange joints adjacent road bridge

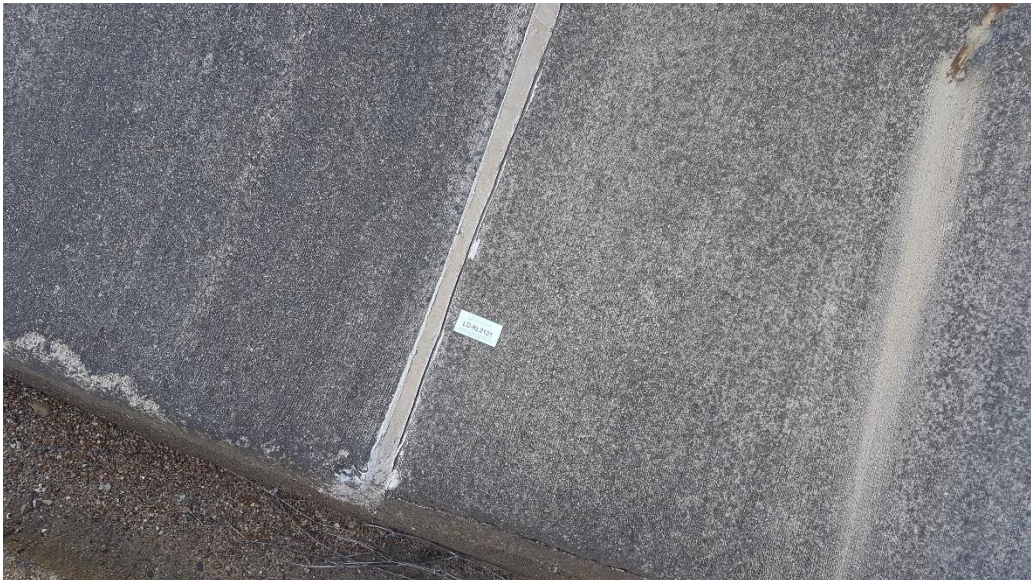
Photograph NA4
Expansion joints to fuel tank concrete pads

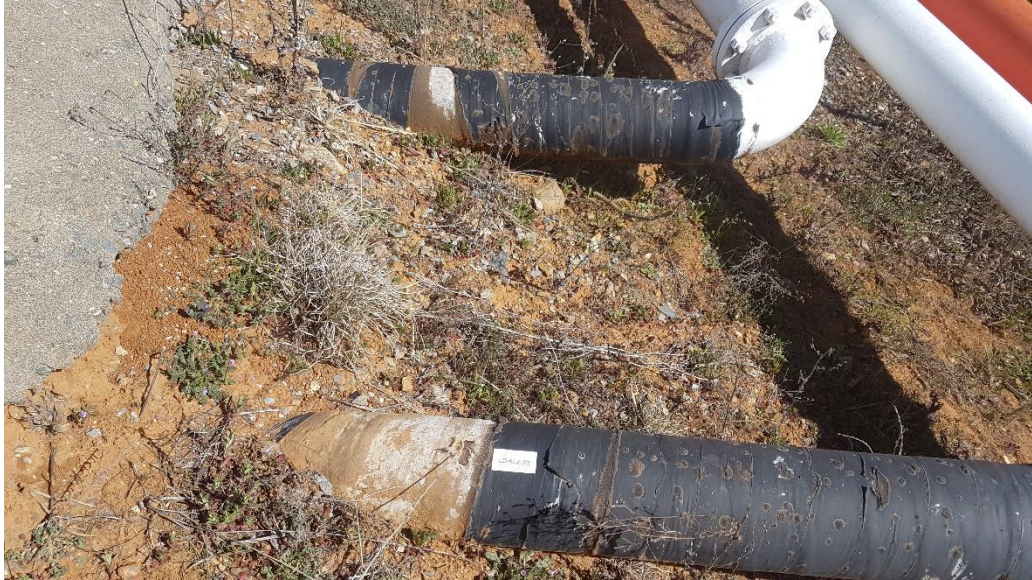
Photograph NA5

Wrap to pipes at northern end of site

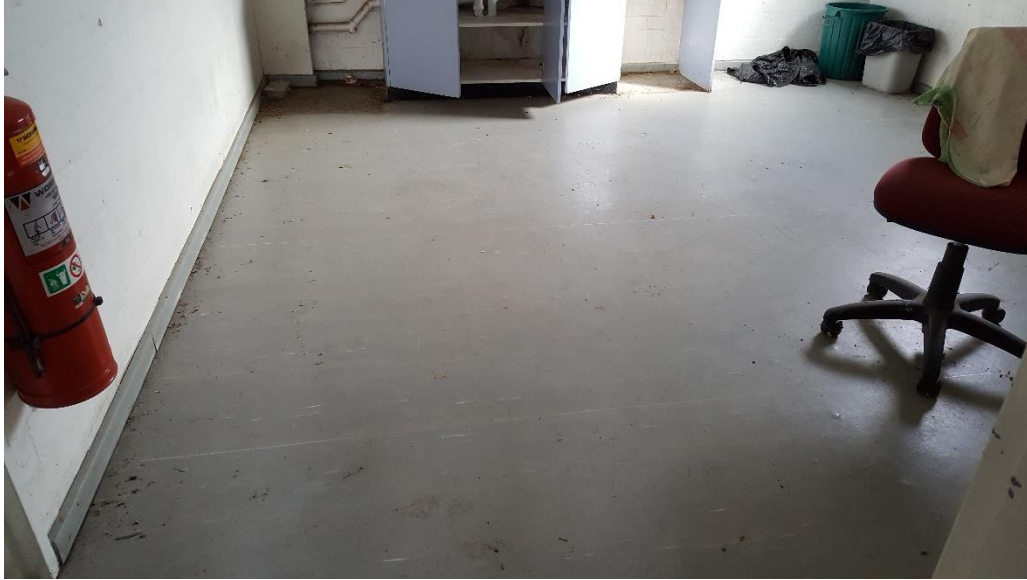
Photograph NA7

Vinyl flooring to Main Office building

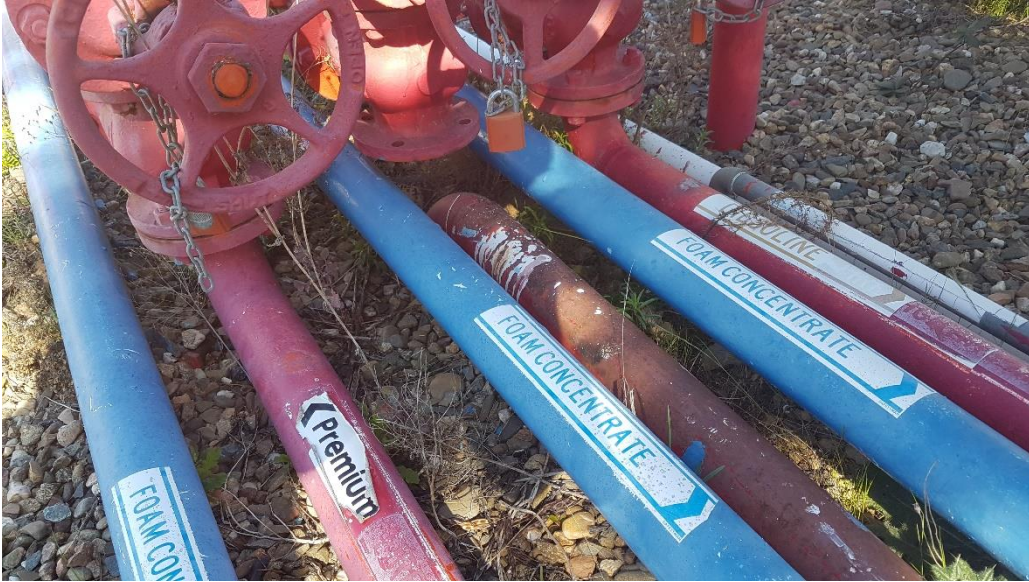
Photograph LP1

Pipes throughout - red paint (Lead paint)
