Report Figures from WSP (Feb 2017) DSI RAP

2270207A - Remedial Action Plan
Māngonlo Valley Stage 3 (Area B)

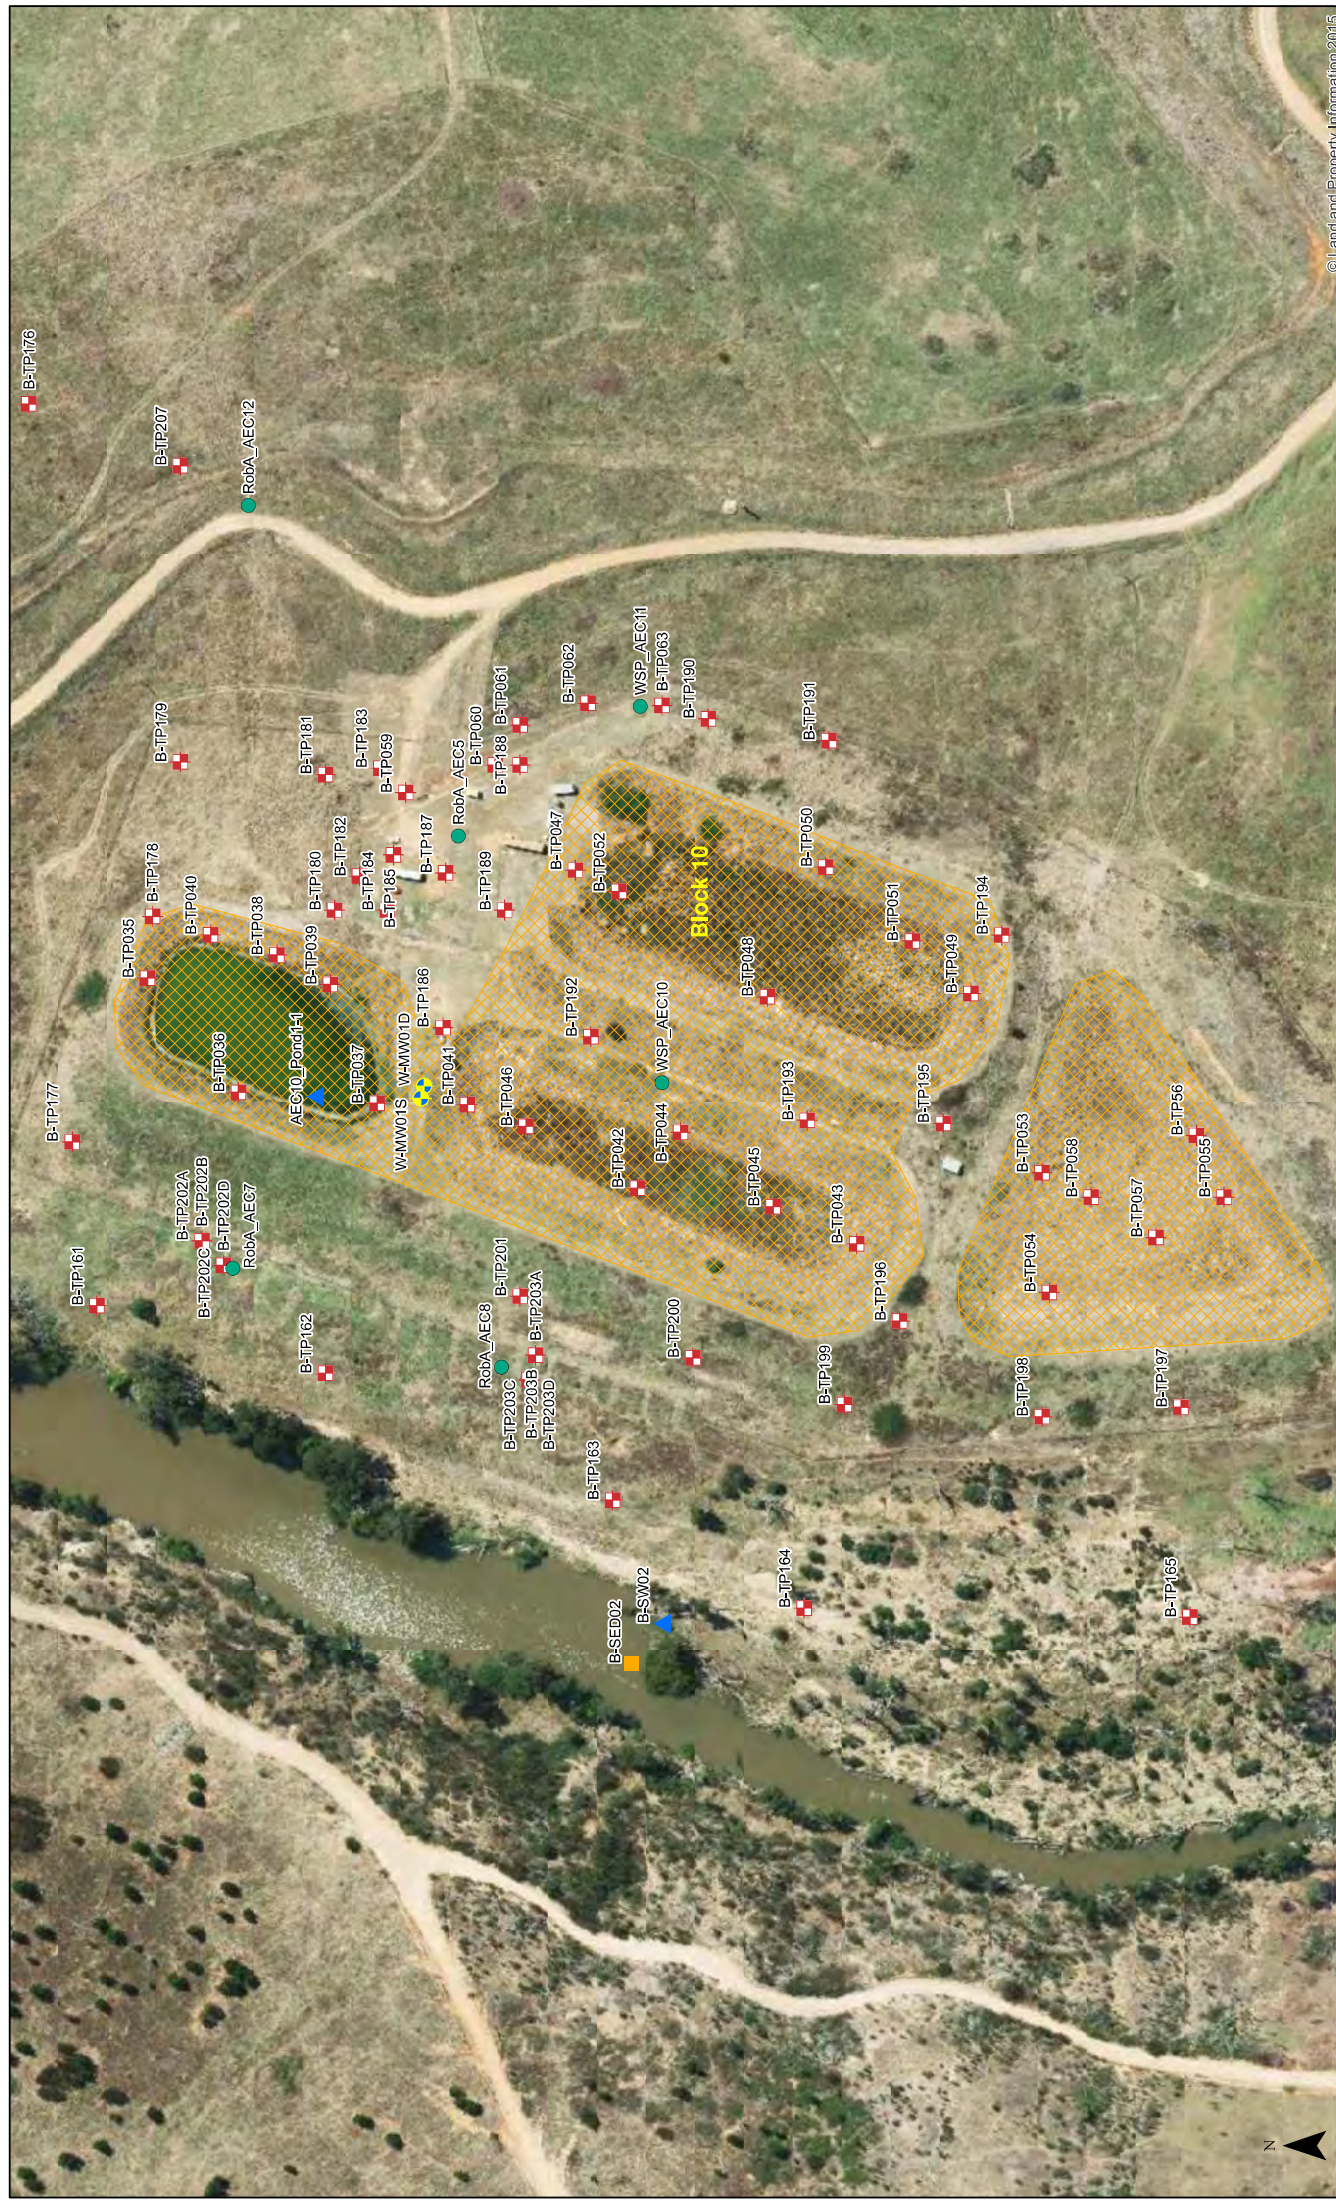
Figure 4 - Remediation Area WSP_AEC10
Former Sludge Ponds

Test Pit
Monitoring Well
Sediment
SoilBore
Surface Water

Remediation Area

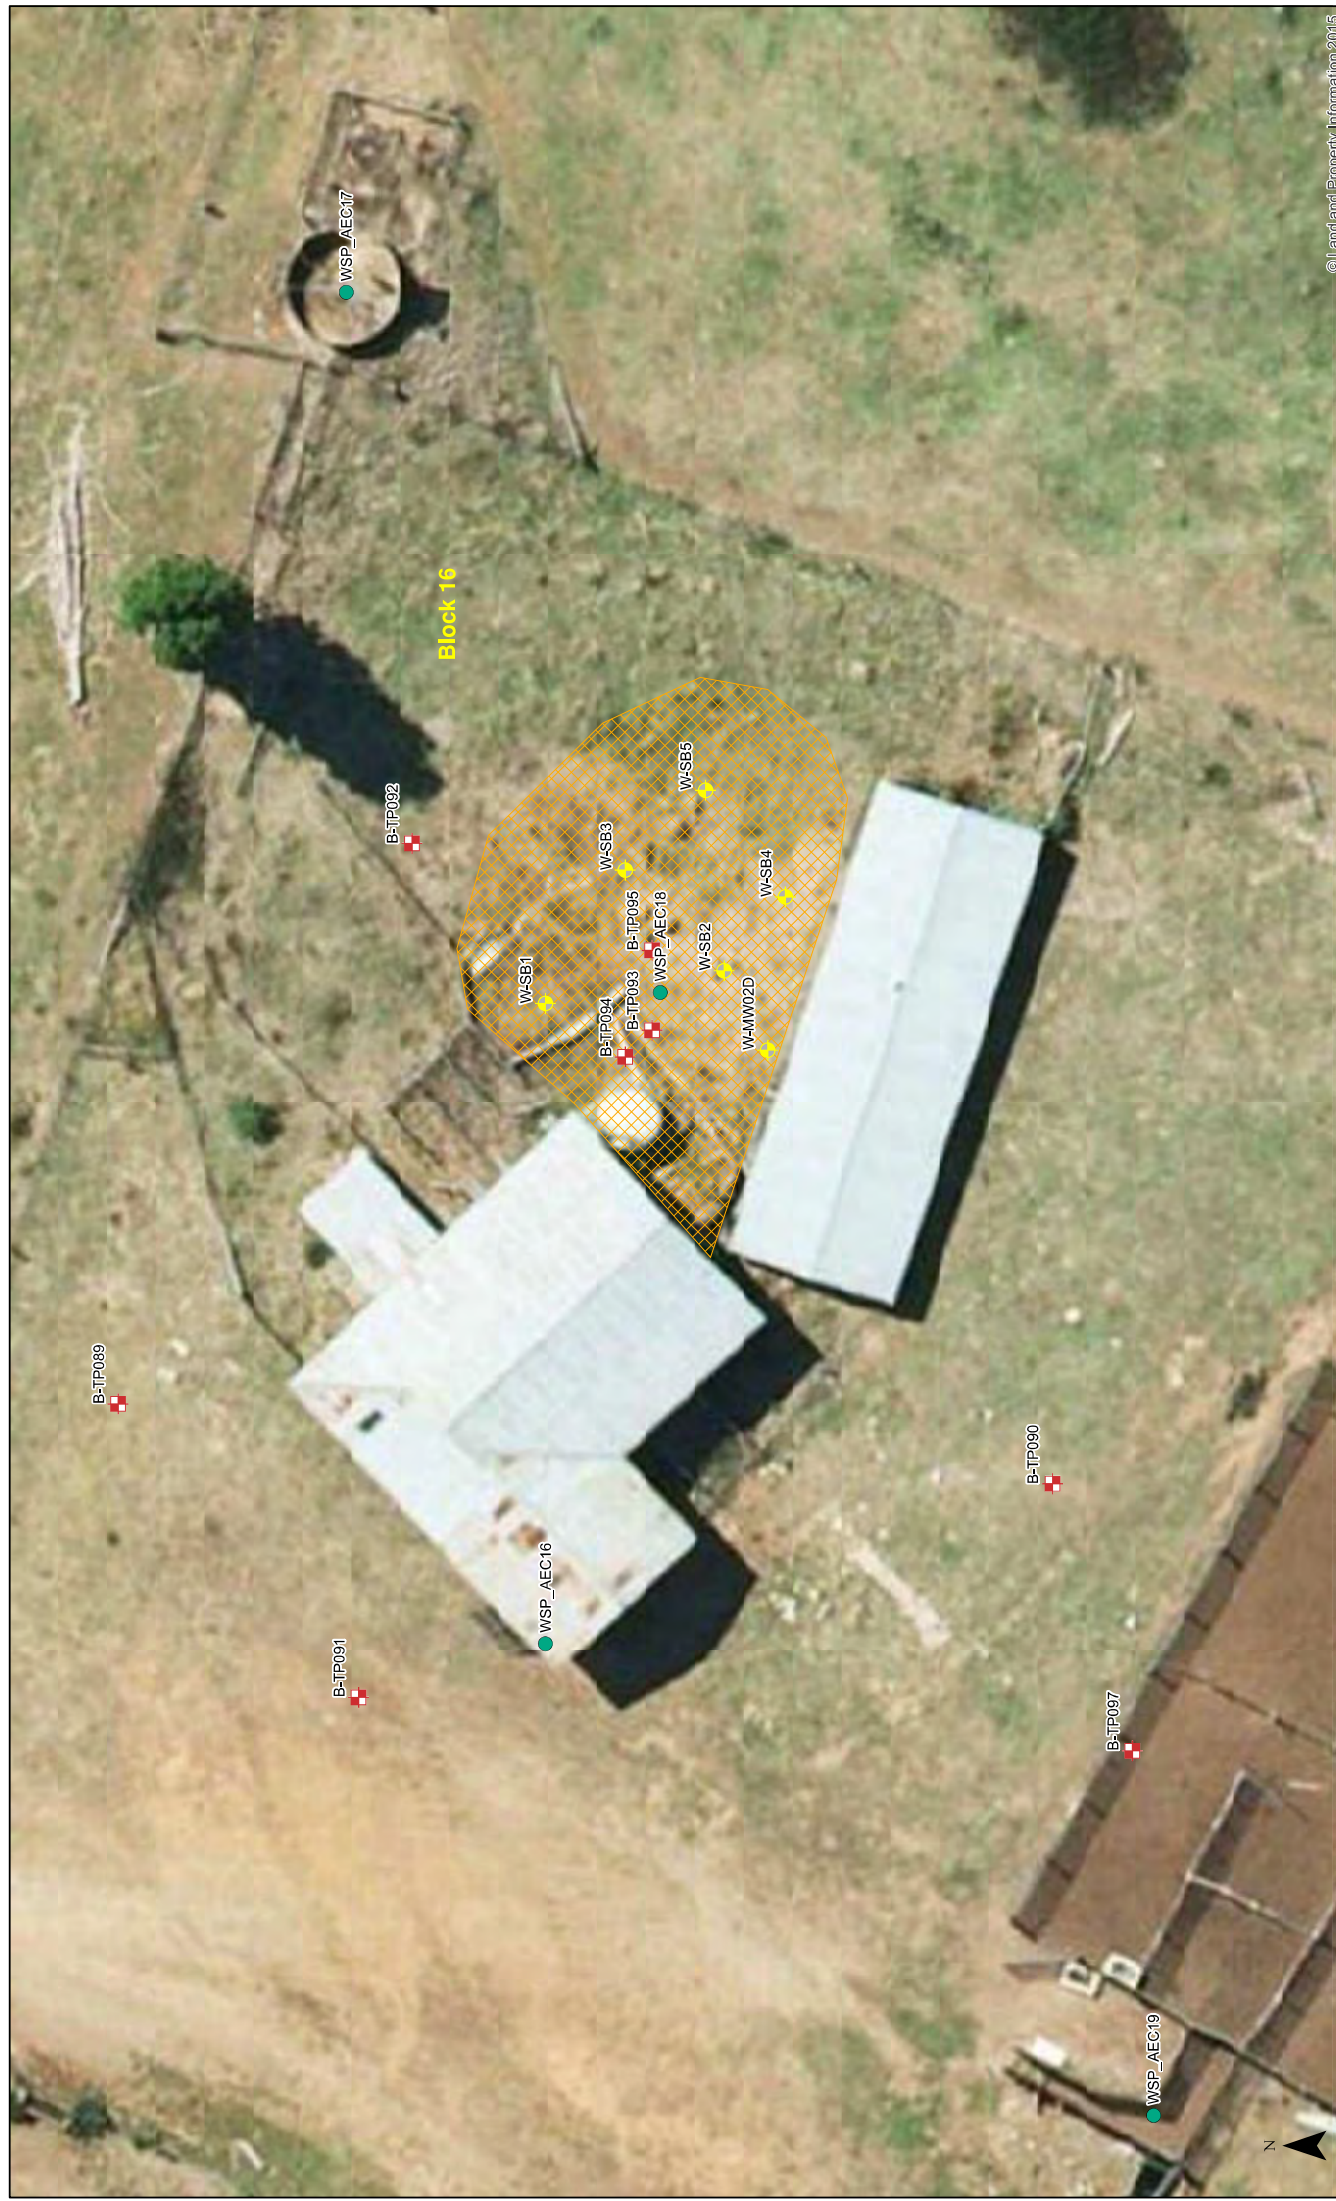
Figure 5 - Remediation Area WSP_AEC18 Livestock Plunge Dip and Yards
 2270207A - Remedial Action Plan
 Molonglo Valley Stage 3 (Area B)
 WSP_AEC10 (Sludge Ponds)
 WSP_AEC18 (Livestock Plunge Dip)
 RobC_AEC22 (Glenloch Sheep Dip)

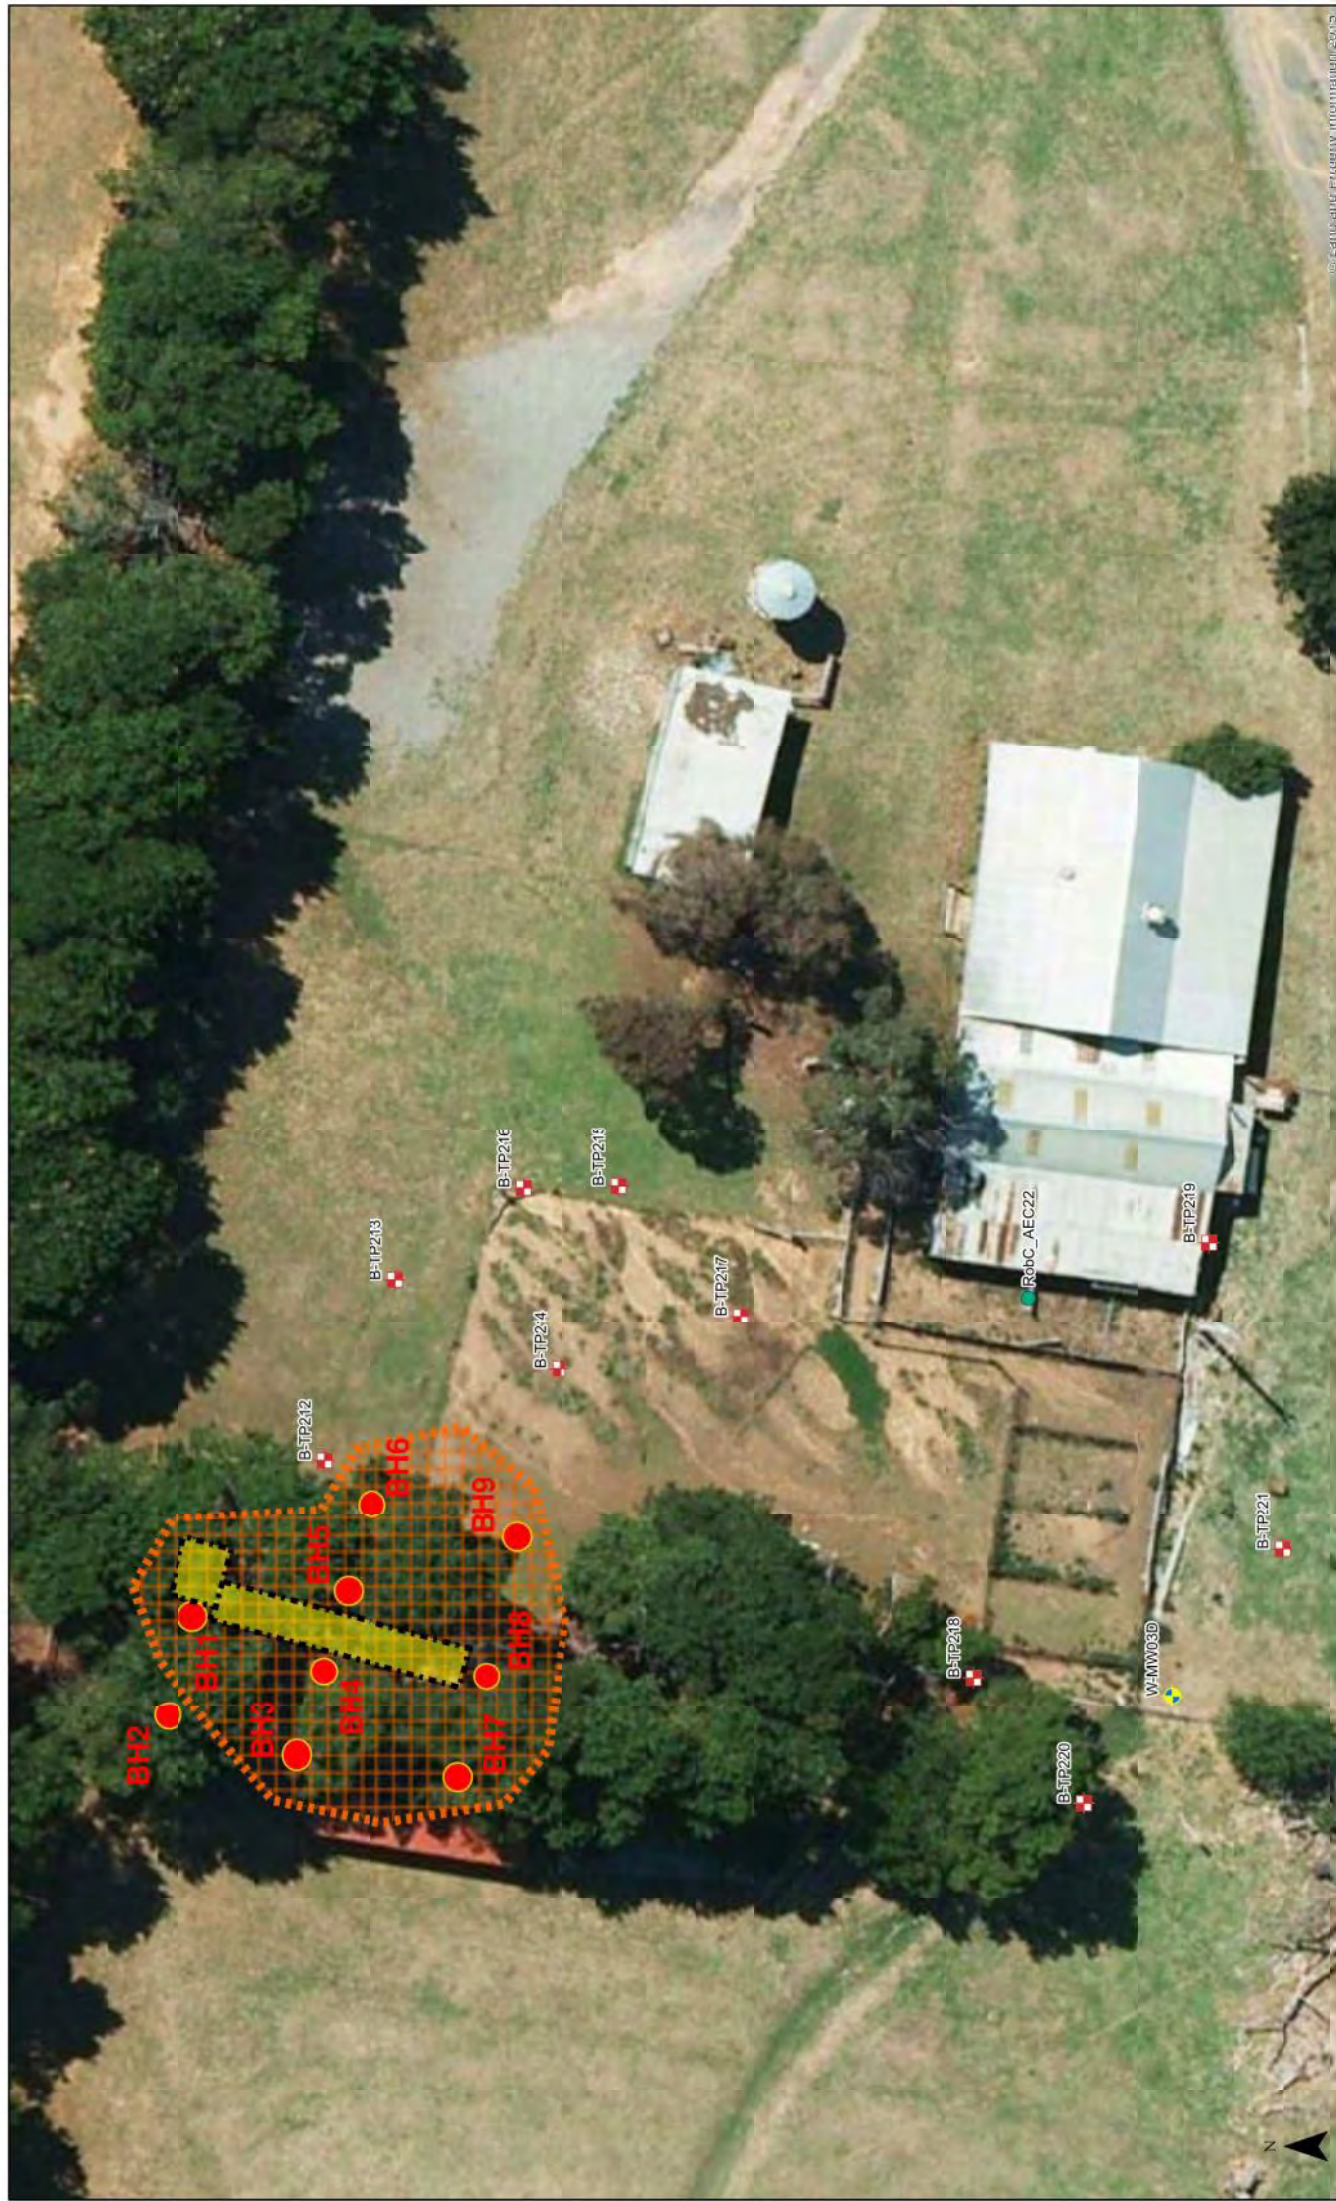
Figure 6 - Remediation Area RobC_AEC22
Genoch Sheep Dip
 2270207A - Remedial Action Plan
 Molonglo Valley Stage 3 (Area B)
 WSP_AEC10 (Sludge Ponds)
 WSP_AEC18 (Livestock Plunge Dip)
 RobC_AEC22 (Genloch Sheep Dip)

- Hand Augur Soil Location August 2016
- Concrete Sheeps Dip Location / Drain Pan
- Test Pit
- Indicative Remedial Area (arsenic)
- Monitoring Well
