Report on  
Geotechnical Investigation

Proposed TRG Bushfire Response and Training  
Centre  
Block 45 Section 3, Hume

Prepared for  
Forestrack Pty Ltd

Project 103038.00  
August 2021

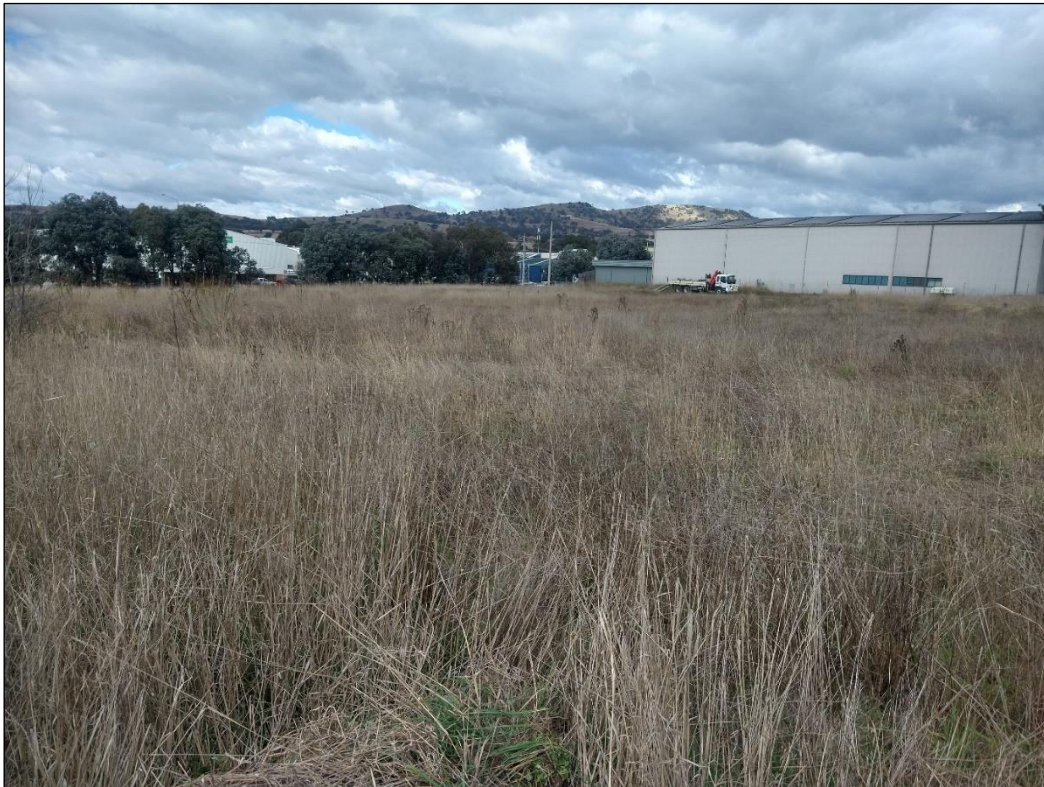
**Figure 1: View of site looking south from Pit 15.**

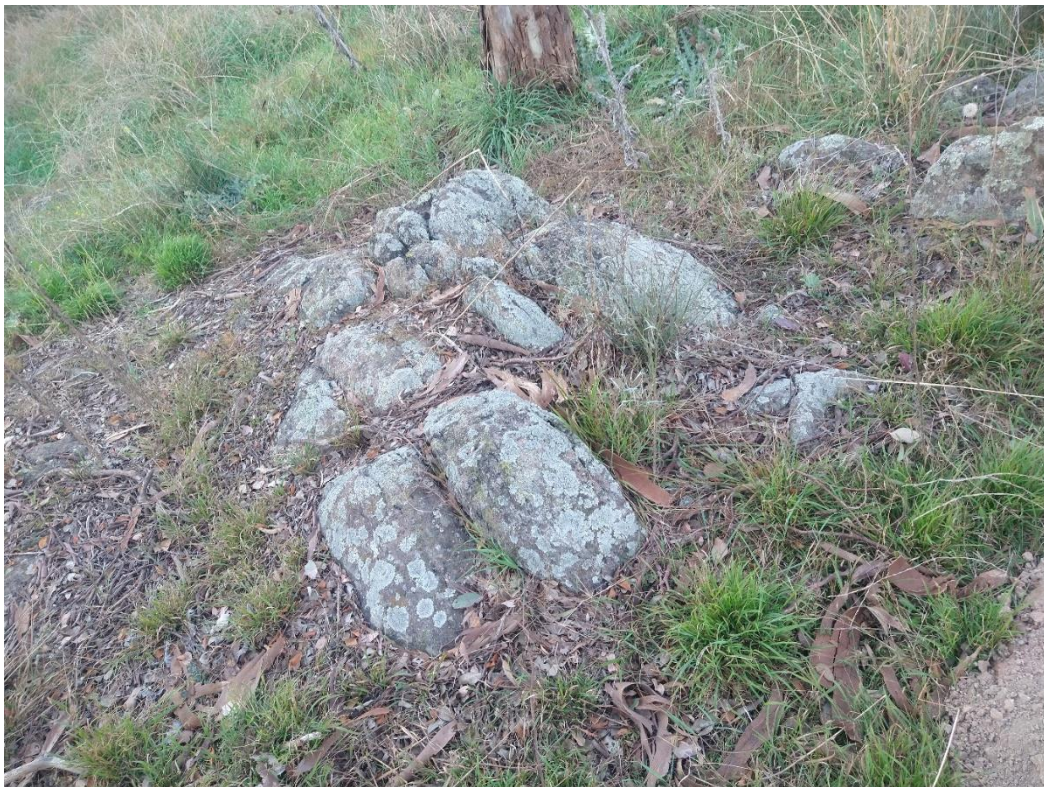
**Figure 2: View of high strength corestones in the northern/north-east corner of the site, near Pit 12.**

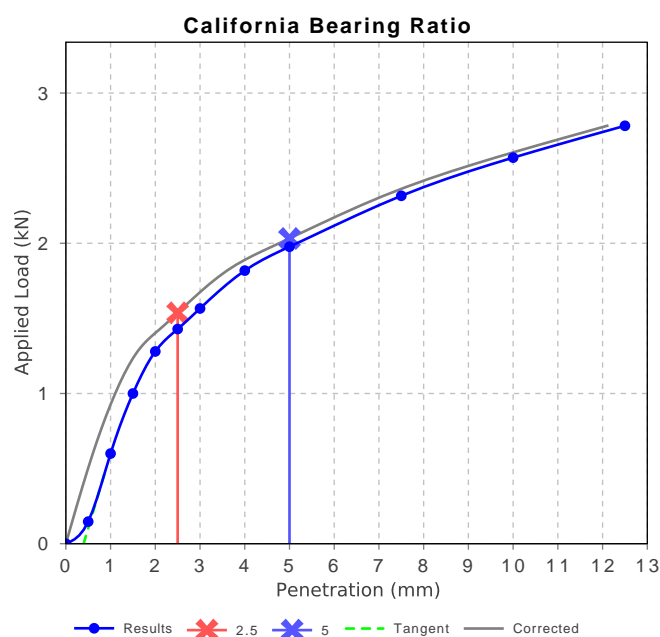
California Bearing Ratio (AS 1289 6.1.1 & 2.1.1)		Min	Max
CBR taken at	2.5 mm		
CBR %	12.0		
Method of Compactive Effort	Standard		
Method used to Determine MDD	AS 1289 5.1.1 & 2.1.1		
Method used to Determine Plasticity	Visual Assessment		
Maximum Dry Density (t/m <sup>3</sup> )	1.62		
Optimum Moisture Content (%)	22.0		
Laboratory Density Ratio (%)	100.0		
Laboratory Moisture Ratio (%)	100.5		
Dry Density after Soaking (t/m <sup>3</sup> )	1.61		
Field Moisture Content (%)	21.5		
Moisture Content at Placement (%)	22.3		
Moisture Content Top 30mm (%)	25.2		
Moisture Content Rest of Sample (%)	23.8		
Mass Surcharge (kg)	4.5		
Soaking Period (days)	4		
Curing Hours	24.8		
Swell (%)	0.5		
Oversize Material (mm)	19		
Oversize Material Included	Excluded		
Oversize Material (%)	0		
<b>Moisture Content (AS 1289 2.1.1)</b>			
Moisture Content (%)		21.5

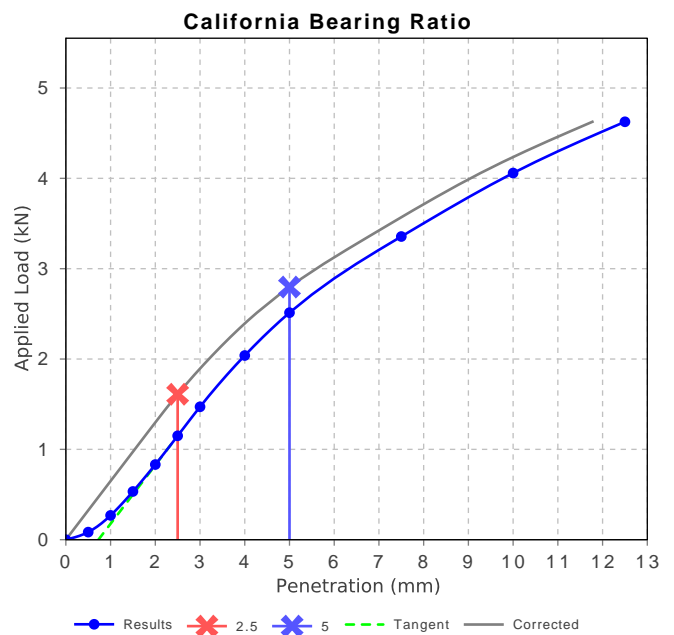
California Bearing Ratio (AS 1289 6.1.1 & 2.1.1)		Min	Max
CBR taken at	5 mm		
CBR %	14.0		
Method of Compactive Effort	Standard		
Method used to Determine MDD	AS 1289 5.1.1 & 2.1.1		
Method used to Determine Plasticity	Visual Assessment		
Maximum Dry Density (t/m <sup>3</sup> )	1.93		
Optimum Moisture Content (%)	12.0		
Laboratory Density Ratio (%)	100.0		
Laboratory Moisture Ratio (%)	101.5		
Dry Density after Soaking (t/m <sup>3</sup> )	1.93		
Field Moisture Content (%)	9.9		
Moisture Content at Placement (%)	12.3		
Moisture Content Top 30mm (%)	14.3		
Moisture Content Rest of Sample (%)	13.4		
Mass Surcharge (kg)	4.5		
Soaking Period (days)	4		
Curing Hours	72.2		
Swell (%)	0.0		
Oversize Material (mm)	19		
Oversize Material Included	Excluded		
Oversize Material (%)	7.8		
<b>Moisture Content (AS 1289 2.1.1)</b>			
Moisture Content (%)			9.9

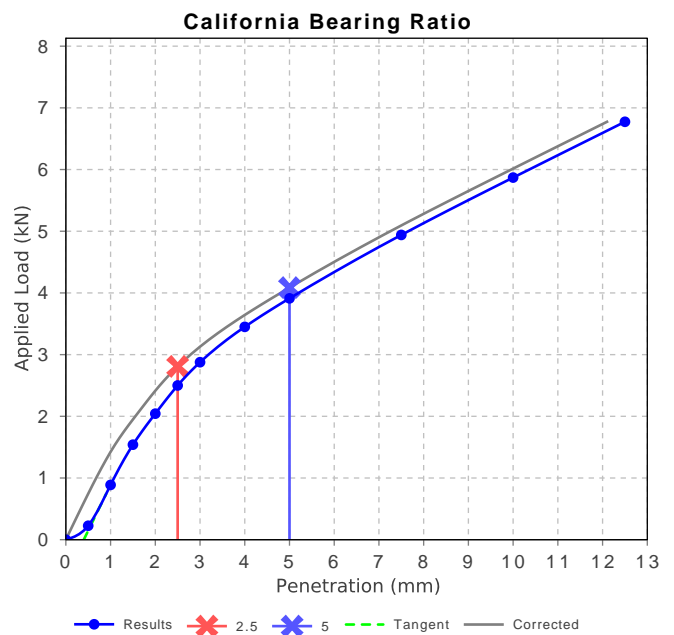
California Bearing Ratio (AS 1289 6.1.1 & 2.1.1)		Min	Max
CBR taken at	2.5 mm		
CBR %	<b>20.0</b>		
Method of Compactive Effort	Standard		
Method used to Determine MDD	AS 1289 5.1.1 & 2.1.1		
Method used to Determine Plasticity	Visual Assessment		
Maximum Dry Density (t/m <sup>3</sup> )	1.88		
Optimum Moisture Content (%)	14.0		
Laboratory Density Ratio (%)	100.0		
Laboratory Moisture Ratio (%)	99.5		
Dry Density after Soaking (t/m <sup>3</sup> )	1.88		
Field Moisture Content (%)	16.1		
Moisture Content at Placement (%)	14.1		
Moisture Content Top 30mm (%)	16.9		
Moisture Content Rest of Sample (%)	15.4		
Mass Surcharge (kg)	4.5		
Soaking Period (days)	4		
Curing Hours	24.7		
Swell (%)	0.0		
Oversize Material (mm)	19		
Oversize Material Included	Excluded		
Oversize Material (%)	0		
<b>Moisture Content (AS 1289 2.1.1)</b>			
Moisture Content (%)		16.1
