Phase 1 Site Investigation Report

Blocks 9, 10 & 11, Section 21 Hume
(Stage 3, Hume West Estate)

Prepared for
Land Development Agency (LDA)

6th June 2016

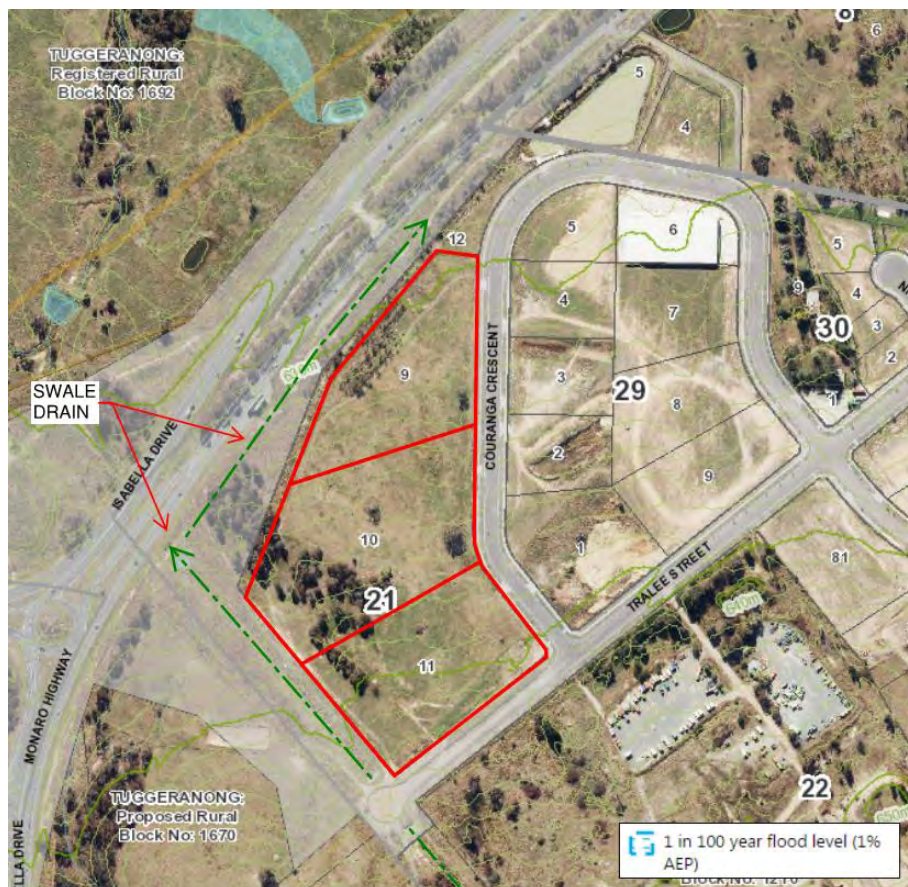
Figure 5-1 Predicted 1 in 100year Flood Affected Areas (2004 ACTmap1 contours)

Review of the ACTmap1 1 in 100 year flood map indicates that neither Blocks 9, 10 or 11 are within a potential flood zone, refer to Figure 5-1.

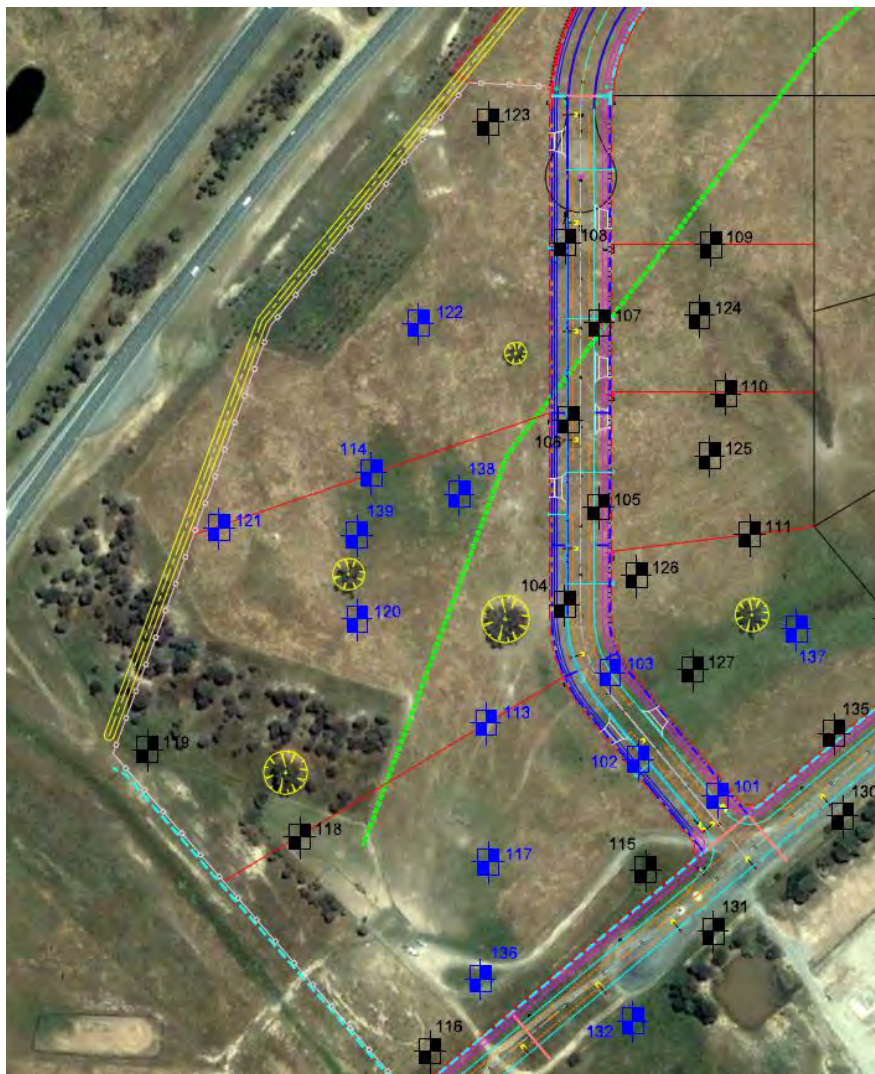
Figure 6-1 Test Pits Which Encountered Groundwater

The initial investigation (August 2012) carried out 27 test pits (101 – 127) to a depth of 2.5m across the site while the follow up investigation (September 2012) carried out an additional 12 test pits (128 – 139) to depths of 3.8m. The test pits found groundwater seepage almost site wide across Section 21 and in isolated locations around Block 1 in Section 29. **Figure 6-1** presents the test pit locations which found groundwater seepages.

The report concludes by suggesting a network of deep subsoil drains in order to attempt to control the groundwater seepages and possibly enable conventional construction within the blocks. Given the likely concentration of flows along the south western stage boundary and the Tralee Street boundary, it is recommended that the main collector drains be installed along or under Couranga Crescent, Tralee Street and along the south western boundary of the stage with feeder drains along the side and front boundaries of the blocks.

Cardno understands that the advice was accepted by the LDA and the subsoil drainage measures for Section 29 were installed while the measures for Blocks 9-11 are due for construction in mid-late 2016. Details of the proposed drainage system along the block boundaries is provided on **Drawing T-C0095.00** within **Appendix A**.

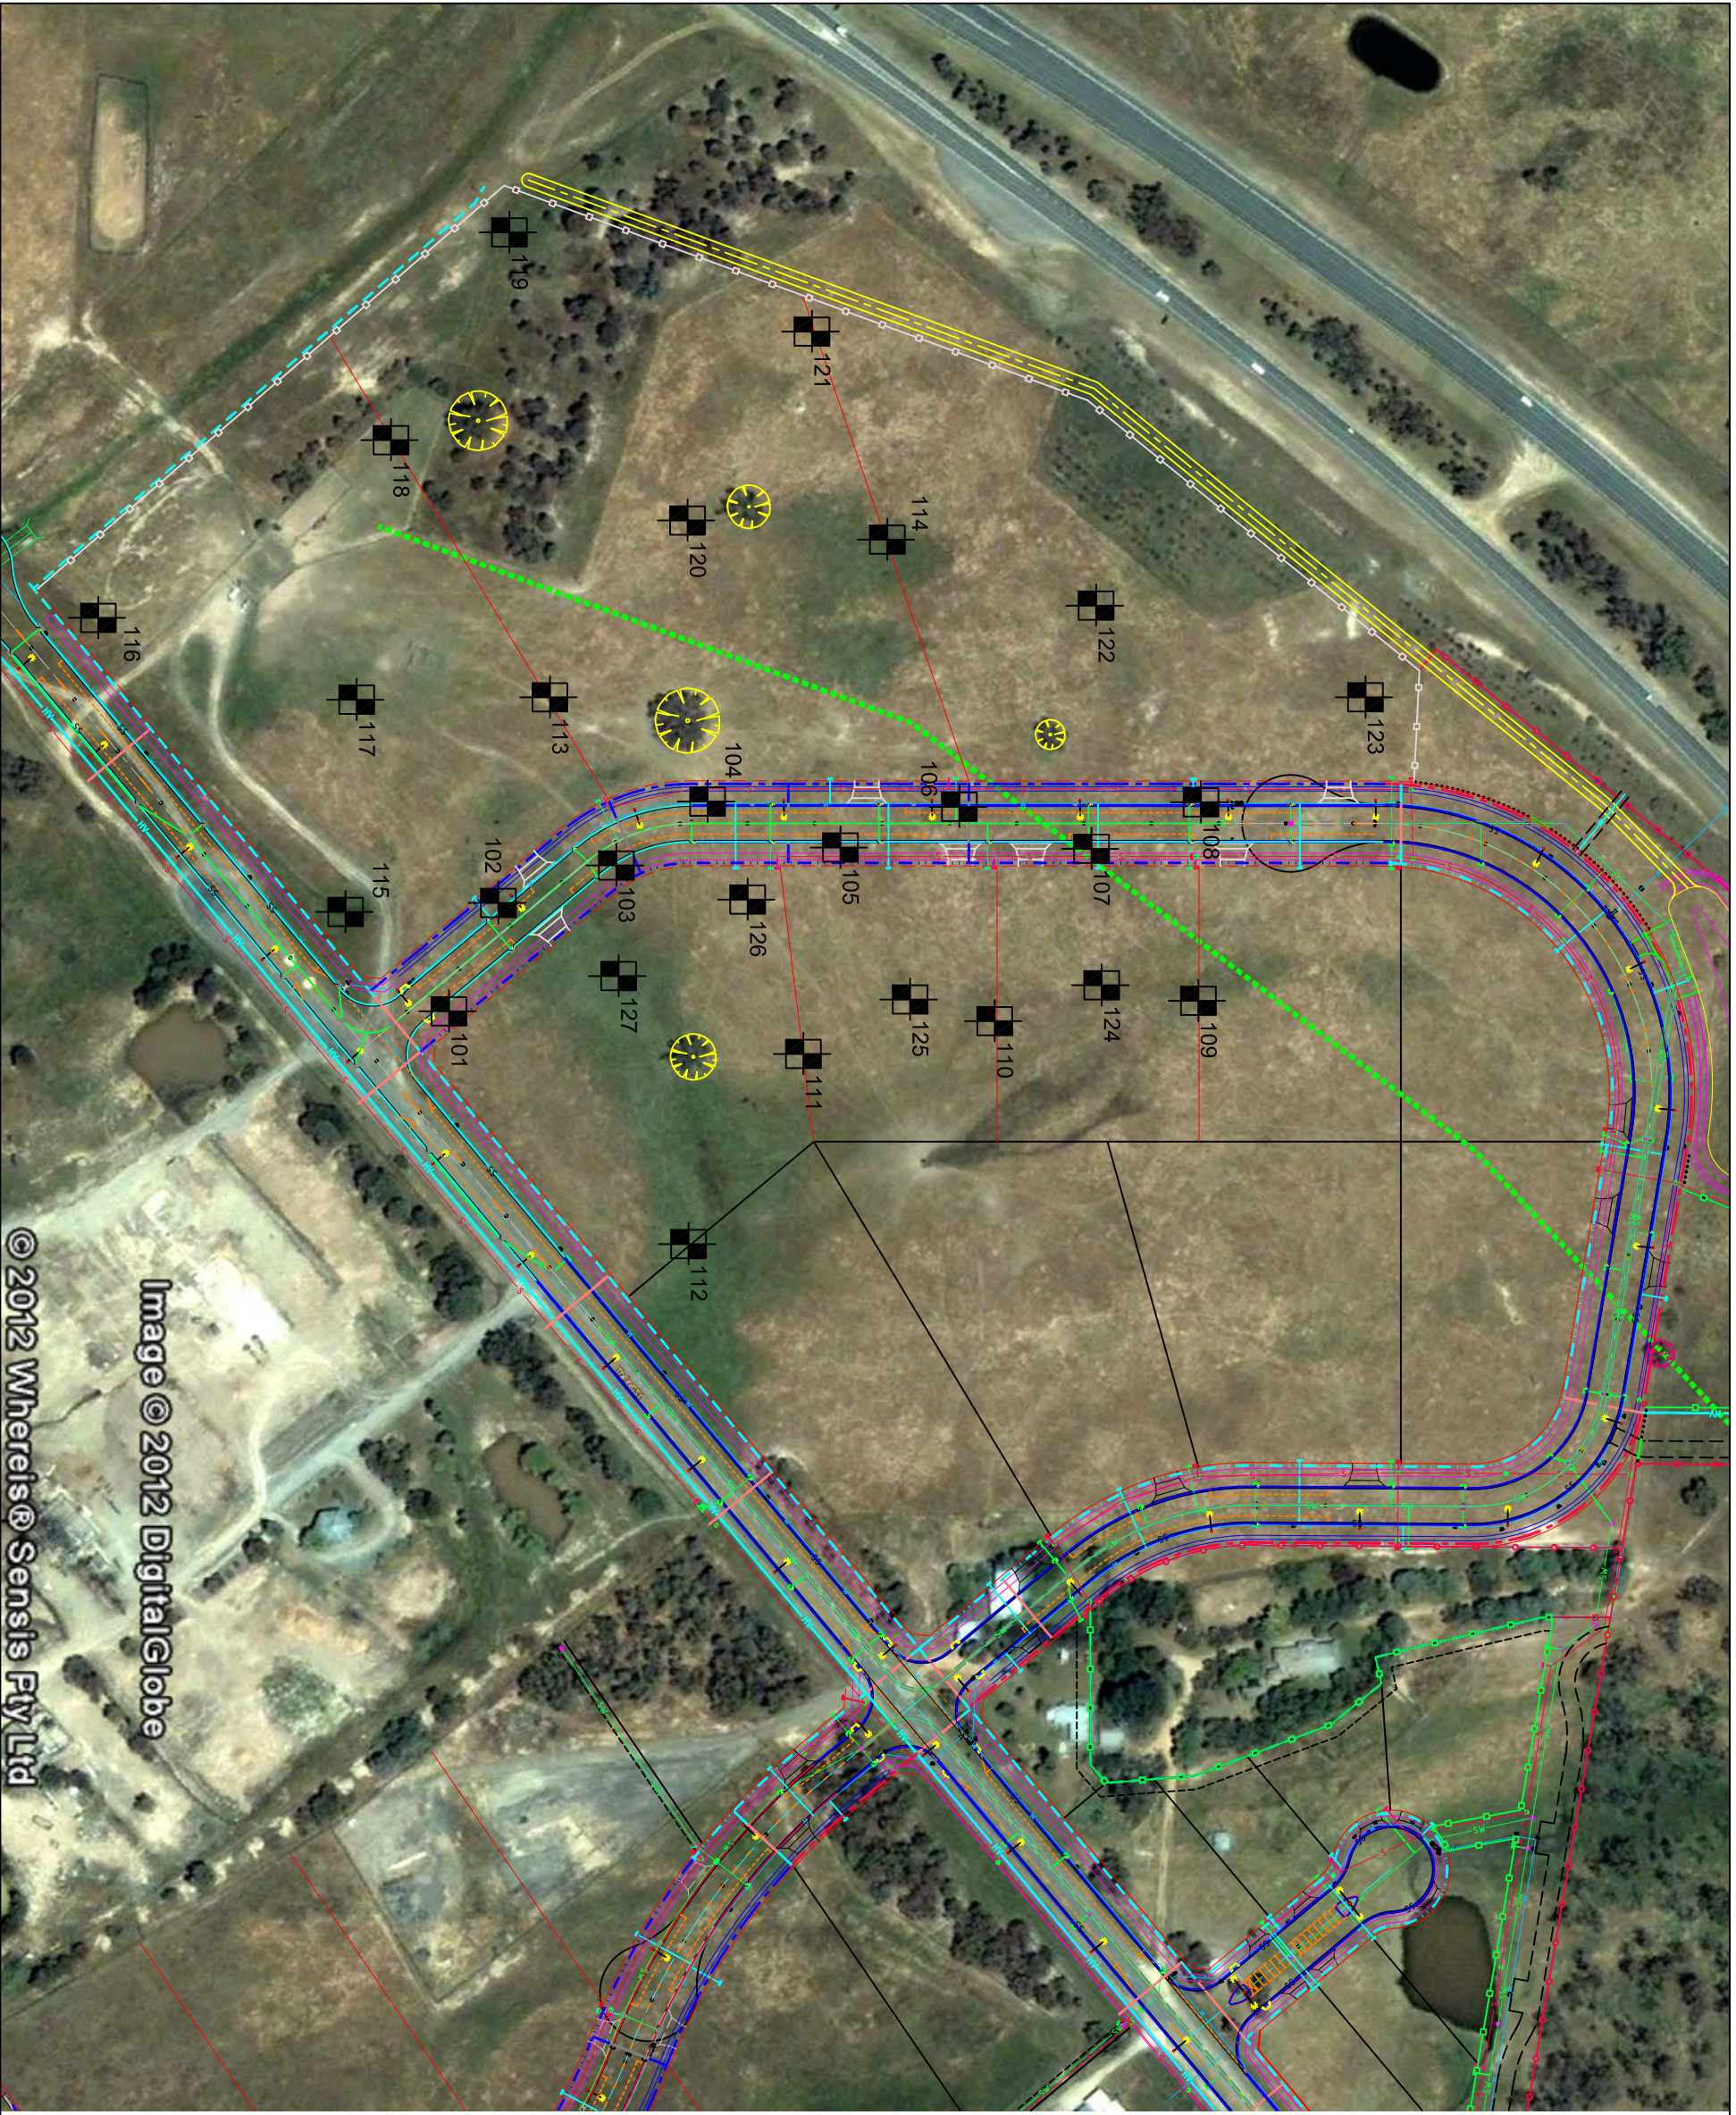
Drawing 1 – Test Pit Location

A review of aerial photographs from Google Earth has indicated a history of the presence of moisture (groundwater) in parts of the site. The aerial photograph shown in Drawing 1 (Appendix B) shows bright green areas across the site which roughly correlates with the presence of groundwater seepages encountered in the current test pits.

In order to attempt to control the groundwater seepages and possibly enable conventional construction within the blocks, the first stage of remedial measures is suggested to comprise a series of subsoil/cut-off drains installed along block boundaries. Given the likely concentration of flows along the Tralee Street boundary and the orientation of the blocks, it is recommended that the main collector drains be installed along or under Couranga Crescent and Tralee Street and potentially along the south western boundary of the stage with feeder drains along the side and front boundaries of the blocks. Careful attention to levels will be critical to enable the system to self drain.

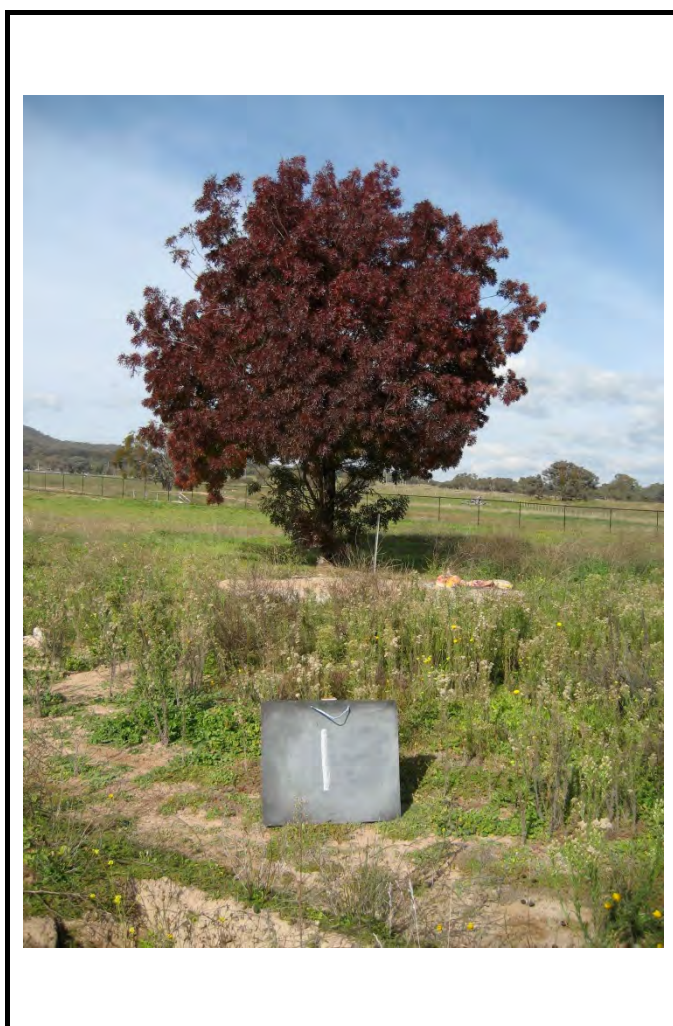
SUMMARY			
TREE NUMBER/GROUP			1
REGULATED TREE			N
REGISTERED TREE			
TREE ASSESSMENT			
ARBORCULTURAL ASSESSMENT			M
URBAN AMENITY ASSESSMENT			M
RECOMMENDATION	NAME		
Arborist	J.L. & S.T.		
Landscape Architect	Indesco		
GENERAL TREE DATA			
Assessment Date	30.4.14		
Species	Fraxinus oxycarpa 'Raywood'		
Common Name	Claret Ash		
LOCATION			
E:		N:	
Height (M)	7	Canopy (M)	8
Trunk Circum	900	No of Trunks	1
TREE MANAGEMENT			
POTENTIAL TO REDUCE RISK			1
POTENTIAL TO IMPROVE AMENITY			1
NOTES

ARBORCULTURAL CHARACTERISTICS	
	RATING
Canopy Density	3
Canopy Dead Wood	3
Insect Attack	3
Disease	3
Epicormic Growth	3
Mistletoe	3
Form	4
Age	3
Tolerance to Disturbance	3
Risk Potential	3
Health / Condition	3

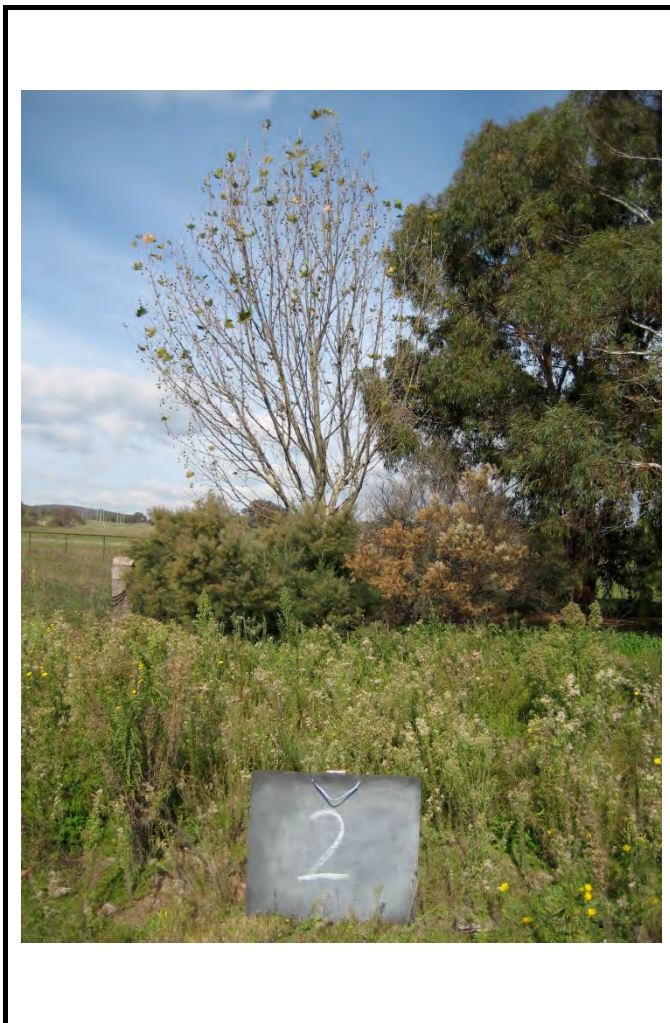
SUMMARY			
TREE NUMBER/GROUP			2
REGULATED TREE			N
REGISTERED TREE			
TREE ASSESSMENT			
ARBORCULTURAL ASSESSMENT			M
URBAN AMENITY ASSESSMENT			M
RECOMMENDATION	NAME		
Arborist	J.L. & S.T.		
Landscape Architect	Indesco		
GENERAL TREE DATA			
Assessment Date	30.4.14		
Species	Platanus acerifolia		
Common Name	London plane		
LOCATION			
E:		N:	
Height (M)	7	Canopy (M)	5
Trunk Circum	700	No of Trunks	1
TREE MANAGEMENT			
POTENTIAL TO REDUCE RISK			1
POTENTIAL TO IMPROVE AMENITY			1
NOTES

ARBORCULTURAL CHARACTERISTICS	
	RATING
Canopy Density	3
Canopy Dead Wood	3
Insect Attack	3
Disease	3
Epicormic Growth	3
Mistletoe	3
Form	4
Age	3
Tolerance to Disturbance	3
Risk Potential	3
Health / Condition	3

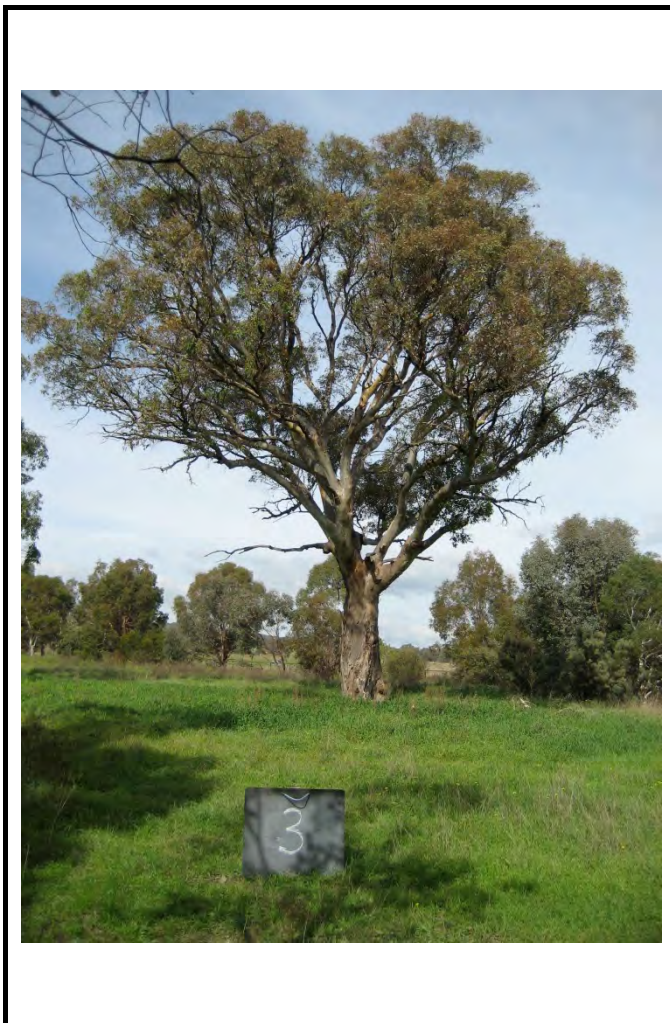
SUMMARY			
TREE NUMBER/GROUP			3
REGULATED TREE			Y
REGISTERED TREE			
TREE ASSESSMENT			
ARBORCULTURAL ASSESSMENT			H
URBAN AMENITY ASSESSMENT			H
RECOMMENDATION	NAME		
Arborist	J.L. & S.T.		
Landscape Architect	Indesco		
GENERAL TREE DATA			
Assessment Date	30.4.14		
Species	Eucalyptus blakelyi		
Common Name	Blakelys Red Gum		
LOCATION			
E: 212499.479		N: 590125.612	
Height (M)	19	Canopy (M)	19
Trunk Circum	3800	No of Trunks	1
TREE MANAGEMENT			
POTENTIAL TO REDUCE RISK			3
POTENTIAL TO IMPROVE AMENITY			3
NOTES			
Slightly aysmmetrical canopy

ARBORCULTURAL CHARACTERISTICS	
	RATING
Canopy Density	2
Canopy Dead Wood	3
Insect Attack	2
Disease	3
Epicormic Growth	3
Mistletoe	3
Form	4
Age	2
Tolerance to Disturbance	1
Risk Potential	2
Health / Condition	2

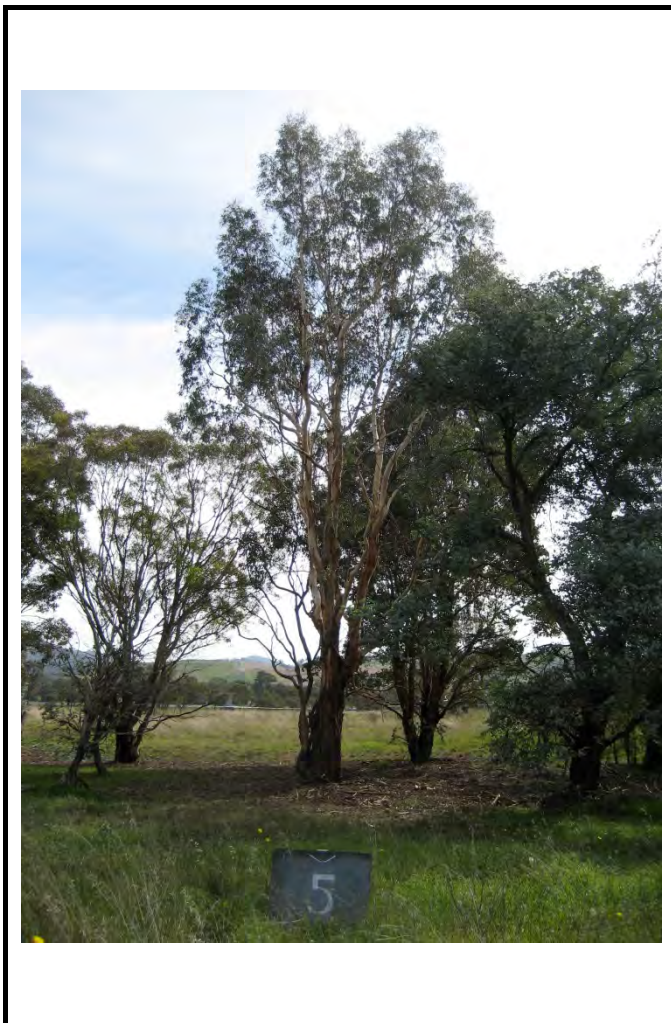
SUMMARY			
TREE NUMBER/GROUP			5
REGULATED TREE			Y
REGISTERED TREE			
TREE ASSESSMENT			
ARBORCULTURAL ASSESSMENT			M
URBAN AMENITY ASSESSMENT			M
RECOMMENDATION	NAME		
Arborist	J.L. & S.T.		
Landscape Architect	Indesco		
GENERAL TREE DATA			
Assessment Date	30.4.14		
Species	Eucalyptus rubida		
Common Name	Candle Bark Gum		
LOCATION			
E:		N:	
Height (M)	13	Canopy (M)	9
Trunk Circum	1700	No of Trunks	1
TREE MANAGEMENT			
POTENTIAL TO REDUCE RISK			2
POTENTIAL TO IMPROVE AMENITY			2
NOTES

ARBORCULTURAL CHARACTERISTICS	
	RATING
Canopy Density	2
Canopy Dead Wood	3
Insect Attack	3
Disease	3
Epicormic Growth	3
Mistletoe	3
Form	4
Age	3
Tolerance to Disturbance	2
Risk Potential	2
Health / Condition	2

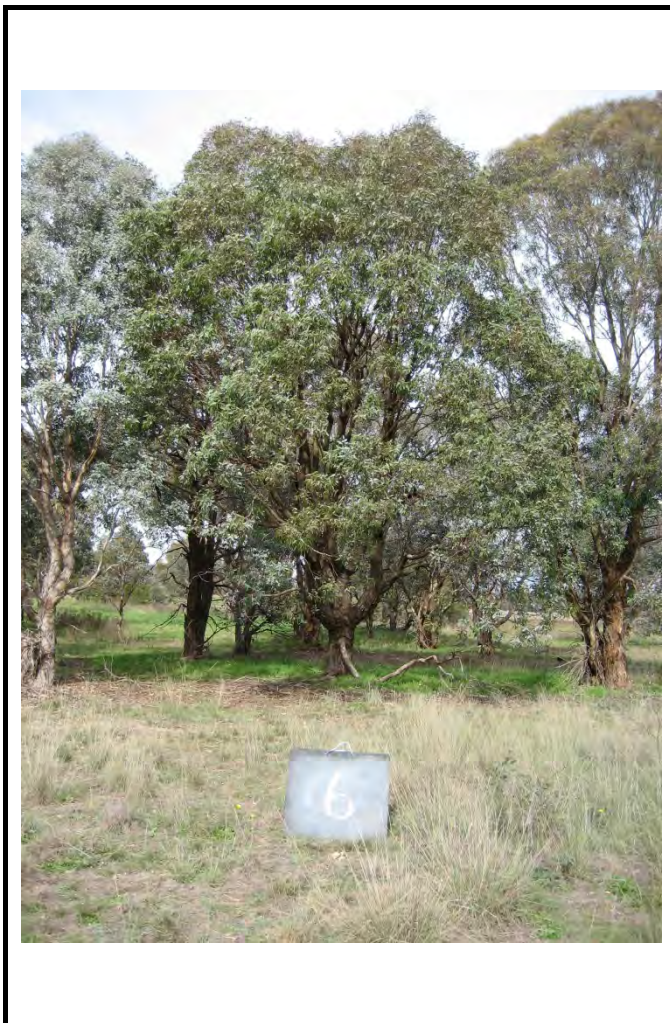
SUMMARY			
TREE NUMBER/GROUP			6
REGULATED TREE			Y
REGISTERED TREE			
TREE ASSESSMENT			
ARBORCULTURAL ASSESSMENT			M
URBAN AMENITY ASSESSMENT			M
RECOMMENDATION	NAME		
Arborist	J.L. & S.T.		
Landscape Architect	Indesco		
GENERAL TREE DATA			
Assessment Date	30.4.14		
Species	Eucalyptus bridgesiana		
Common Name	Apple Box		
LOCATION			
E:		N:	
Height (M)	10	Canopy (M)	10
Trunk Circum	1800	No of Trunks	1
TREE MANAGEMENT			
POTENTIAL TO REDUCE RISK			2
POTENTIAL TO IMPROVE AMENITY			2
NOTES

ARBORCULTURAL CHARACTERISTICS	
	RATING
Canopy Density	3
Canopy Dead Wood	3
Insect Attack	3
Disease	3
Epicormic Growth	3
Mistletoe	2
Form	3
Age	3
Tolerance to Disturbance	2
Risk Potential	2
Health / Condition	3
