## **Molonglo 3- Major Electrical Infrastructure Relocation Dismantling of the Overhead 132kV**

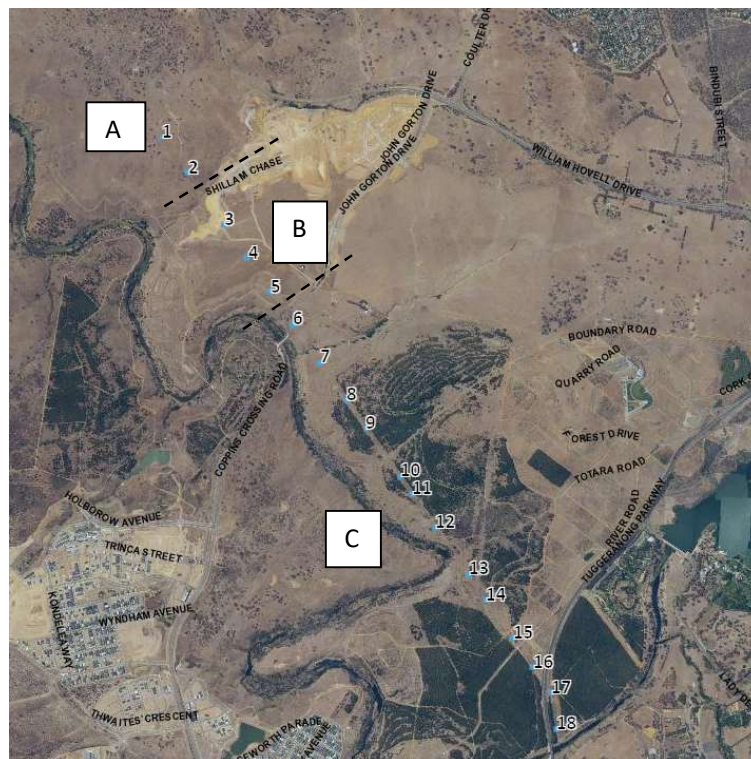
Figure 1: Route Alignment

Figure 1 shows the location of the proposed project in the ACT. The route has an approximate length of 5.1km extending from the Kama Reserve buffer (B1 S39 Molonglo Valley) to the Molonglo River over the Tuggeranong Parkway (Molonglo Valley RB27).

For the purpose of this report, the route has been divided into 3 segments as shown in Figure 1. The segments are as follows:

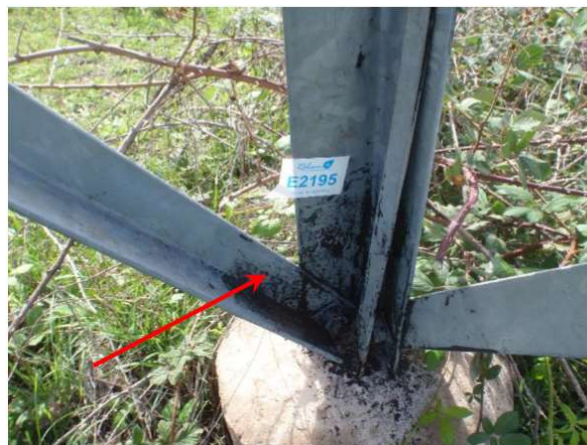
Photo 1: Tower 11 (STP 95830) - surface coating to lower section of main support leg – Fibrous contain Chrysotile Asbestos

The paint coating samples taken from the main legs of Transmission Towers 3,6,11 and 18 (Asset numbers STP95822, STP92825, STP95830 and STP95841) were found to contain chrysotile asbestos

The ACM paint coating to all Transmission Towers were found to be in a good and stable condition and remained in-situ provided it is not disturbed.

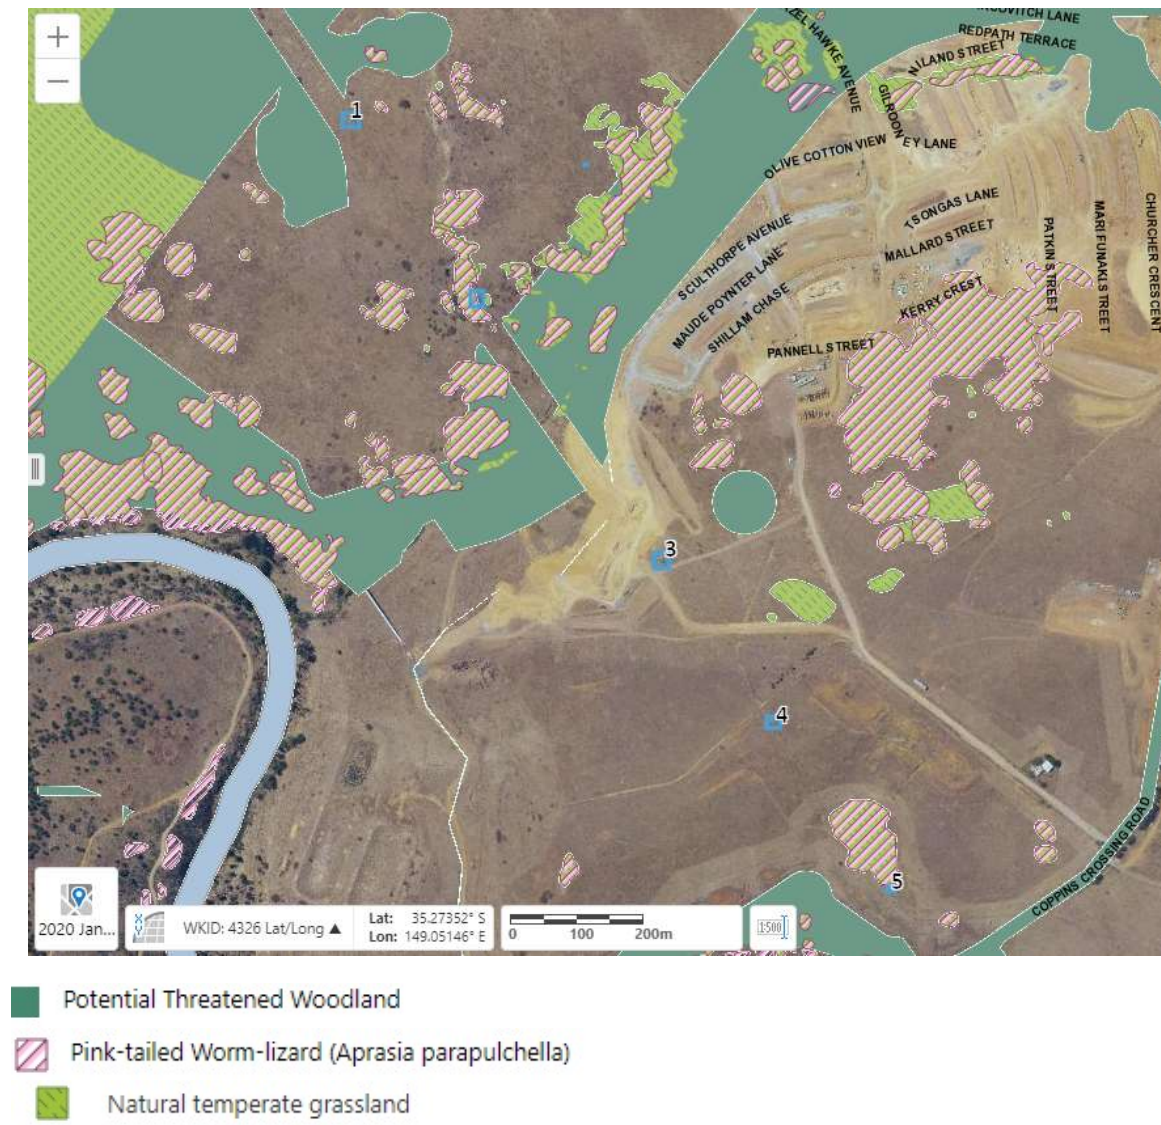
Figure 2: Segment A and B - Tower 1 to 5 -

- Tower 1 (refer to figure 2) is located approximately 115m from the north western boundary of the block. The 132kV relocation construction project will provide an access track to the UGOH (underground to overhead termination) located within meters of the tower.

- Tower 2 (refer to figure 2) is directly adjacent a water course and is beside an area of potential habitat for Pink-Tailed Worm Lizards. This tower will be accessed by the service vehicle driving across the paddock to the western edge of the water course and then walking to the site of the tower. The access to tower 2 will be facilitated by Whitlam development stage 4.

- Tower 3, 4 and 5 (refer figure 2) are located further south east of the block. There are no threatened species, offset areas or heritage items identified near towers 3 and 4. Tower 5 is close to an area of potential habitat suitable for Pink-Tailed Work Lizards. Whitlam development stage 3 will provide an access through Coppins Crossing Road for this Tower.
